991 – Clicking Noises from Centerlock Wheels

Vehicles Affected

Models	Model Year	Model Type	VIN Range	Vehicle-Specific Equipment
911 Carrera GTS, Turbo, Turbo S, GT3, GT3RS, GT2RS, Speedster	As of 2014 up to 2019	991	N/A	Centerlock wheel nuts, aluminum alloy wheels, and PCCB brake discs

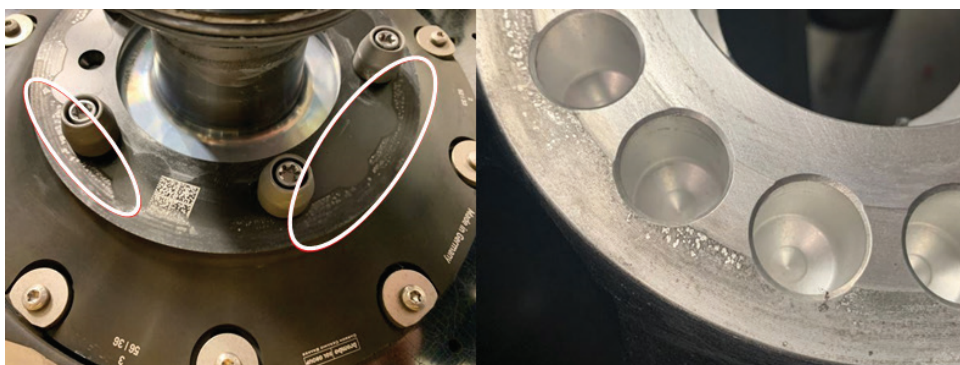
The wheels may experience "micro-movements" at the interface with the brake disc bell during driving. Micro-movements may be caused by an insufficient pretension of the centerlock nut, reduced friction values between multiple contact surfaces, or geometrical discrepancies between parts.

These micro-movements may cause material to be transferred from the aluminum alloy wheels to the brake disc bell. The transferred material may cold-weld to the brake disc bell, causing a "stick-slip" effect. The stick-slip effect produces clicking noises while turning.

Figure 2
Material Transfer to Brake Disc Bell (Left) from Wheel (Right)

3. Inspect the outer surface of the brake disc bell and the inner surface of the wheel that contacts the brake disc bell. If any material transfer or corrosion is present on either surface (Figure 2), gently and thoroughly clean the surface of both parts.

- a. To clean the surfaces, please use special tool **VAS 294009 – Wheel Hub Cleaner**.
 - i. **Only if special tool VAS 294009 is unavailable**, 3M Scotch-Brite Hand Pads 7445 (white) and 7448 (light gray) may also be used.

1. Begin by gently cleaning with pad 7445. If pad 7445 does not completely remove all corrosion and material transfer from the surfaces, gently clean the surfaces with pad 7448.

2. **Note: Do not use a more abrasive Scotch-Brite pad than pad 7448. Doing so may remove any protective coating from the surfaces of the wheel and brake disc bell.**

- b. If a surface cannot successfully be cleaned, replace **only** the component that cannot be cleaned.
 - i. If no parts are replaced, or if only the wheel is replaced, or if only the brake disc is replaced, continue to Step 4.
 - ii. If both the wheel and brake disc are replaced, skip to Step 6.

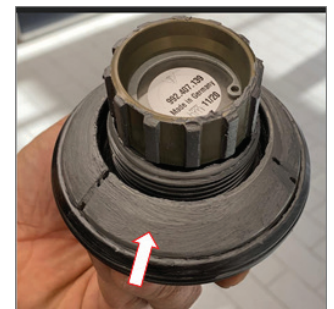
Figure 5
Application of Grease to
Centerlock Cone

7. Thoroughly clean the centerlock nut and apply a complete layer of Optimoly grease to the centerlock cone.

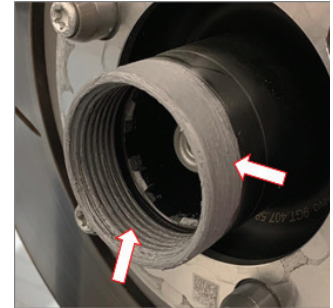
Figure 6
Application of Grease
to Wheel Hub

8. Thoroughly clean the wheel hub threads and apply a complete layer of Optimoly grease to both the inside threads and the outside diameter.

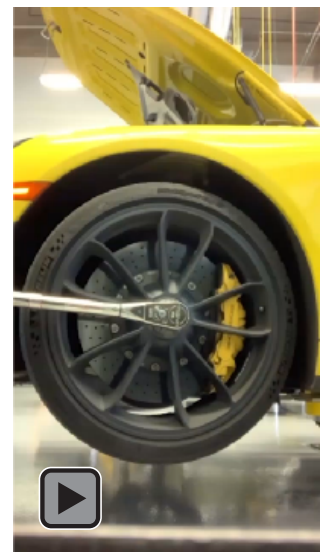
Figure 7
Proper Centerlock Tightening Motion (Video File)

11. Reinstall both wheels as instructed in *WM 440519 – Removing and installing wheel with central bolt, section on Installing wheel with central bolt*.
 - a. Please use recommended special tool **QD4RN800A – Torque Wrench** from Snap-on for the centerlock wheels. Note: When tightening the centerlock nuts, **ensure that the nuts are tightened in one continuous motion**. This guarantees that the prescribed tightening torque is achieved. Please see sections 6.1–6.3, within section on Installing wheel with central bolt, for proper tightening procedure and tightening torque values.
