1990 Porsche 928 S4 Auto B2 Brake Band Piston Failure

5.8 B2 Brake Band Piston Assembly Damage

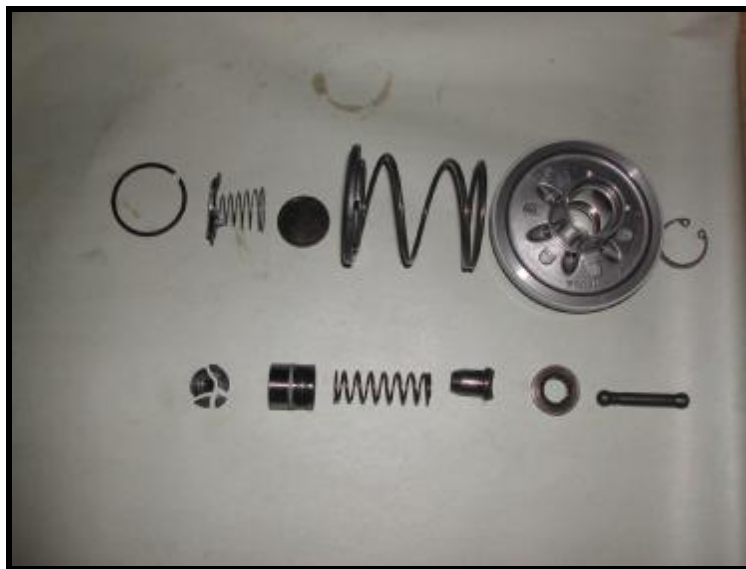
As can be seen from the picture below the inner B2 Piston crown had fractured into four pieces. It fractured circumferentially around the inside diameter of the piston. The thimble piece (no part number or name given or located in PET5) had the large diameter flange fractured off just under the flange. The inside of the cylinder liner located in the Brake Band Piston Assembly appears to be a press fit (steel cylinder liner in this case) showed a slight seizure mark about one third the circumference of the bore approximately at mid length where the piston appeared to have canted and seized. The hypothesis of the the contributing events, that led to the failure of the B2 Piston will be discussed later in this report.

B2 Piston Assembly damage

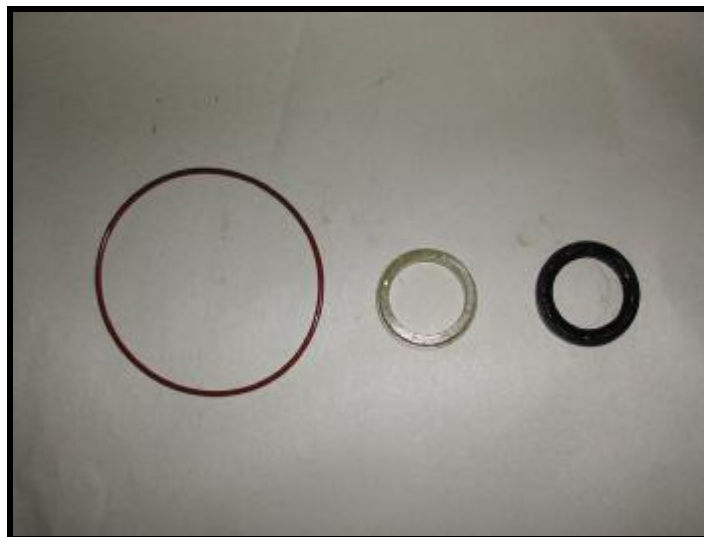
B2 Brake Band Piston Cover “O” ring, Piston Assembly Bush and lip seal

It was decided to renew the B2 Brake Band Piston Assembly, as a total replacement unit, to renew the Cover Plate O-ring seal as well as the lip seal item 7, part number 006 997 734 7, as shown in PET5 illustration number 307-55. To renew the seal it necessitated driving the bush and seal out from the inside the transmission case.

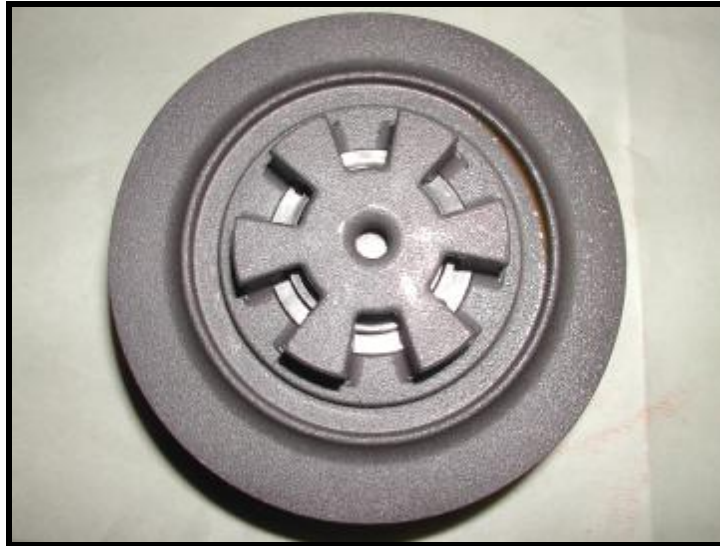
B2 Piston Old model Piston Assembly appears to be cast iron

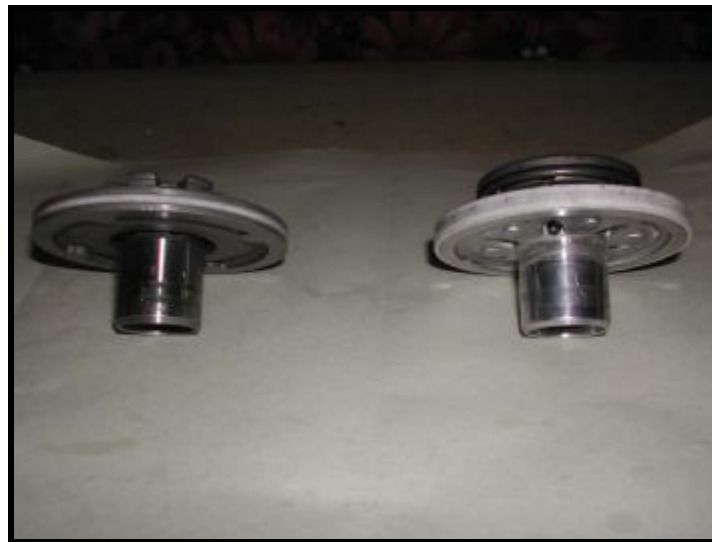
Old B2 Piston Assembly on LHS & Modified B2Piston Assembly on RHS

The old model B2 Brake Band Piston Assembly appears to be a cast iron assembly and it can be noted that the plastic type sealing ring is very similar to a piston ring (rectangular cross section). It was reported that the Brake band Piston Assembly was redesigned in

It will be noted from the photograph above that the B2 Brake Band Piston Assembly as removed from the vehicle had the more robust aluminum assembly, it was fitted with the “T” seal ring, however, it still had the steel cylinder liner fitted for the thrust pin actuating piston.

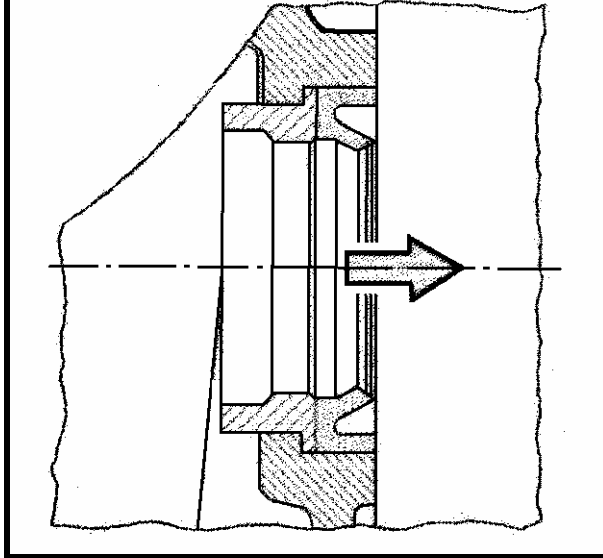
PET5 illustration 307-55 shows an incorrect location of items 6 & 7, the bush (Part Number 126 277 085 0) is installed after item 7 sealing ring (Part Number 006 997 734 7) when in fact it is the opposite as shown in the WSM Page 37-153 where the illustration below clearly shows the bush is installed first and the sealing ring in the top of the bush with the lip seal facing towards the B2 Piston Assembly Cover. This is because the pressure within the B2 Piston cylinder is approximately 90psi when the B2 Brake is applied. If this seal is installed with the lip seal toward the internals of the transmission the ATF could bypass the lip seal and the Piston could fail to activate the B2 Brake Band, which could cause the same failure of no forward motion in any of the forward gears.

Sketch of location of bush and lip seal facing outwards towards piston cover

Note: Insert guide ring
and drive in seal ring
right way round, seal lip
(arrowed) facing towards
the piston cover

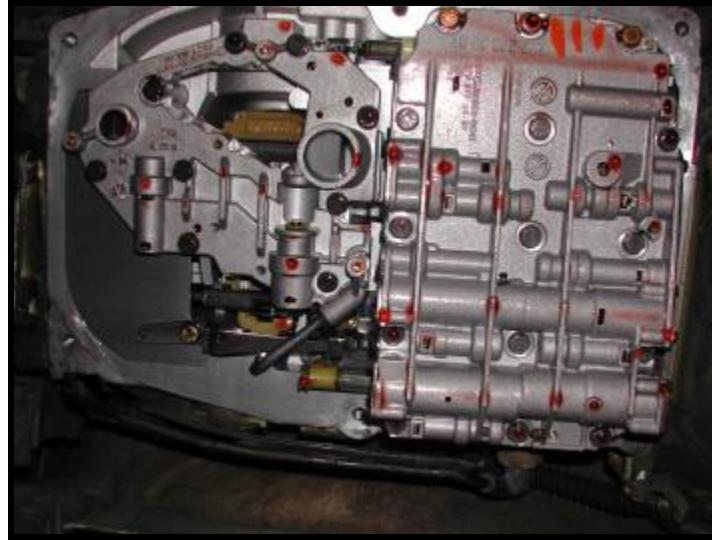
*View of internals of AT with Pan and Filter Removed.
On lower LHS space between centre is the oil pipe, detent quadrant leaf spring and
Range (Gear) Selection Valve with Slide Head can be seen*

On removal of the oil pan there was some debris from the failed B2 small Piston crown laying in the bottom of the pan, however considering everything the pan was quite clean. The ATF removed was still in very good condition as the AT was serviced in August 2003 at 71,018 kilometres, which consisted of a filter change, gasket change, and a total ATF change. The good condition of the oil would indicate that there was no clutch slipping or overheating of the clutches or brakes within the transmission.
