# 1990 Porsche 928 S4 Auto B2 Brake Band Piston Failure

## 6.4 Lower Cover

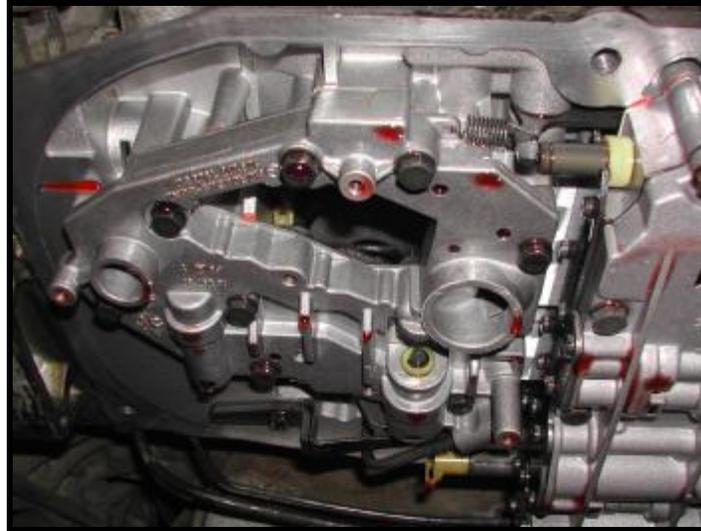
**Lower Cover showing Controlled Pressure Control Valve Piston and Lever in the top RHS foreground with spring loaded actuating lever, Range (Gear) Selector Valve in the lower RHS background with its plastic slide that fits on pin of the detent quadrant and the suction and delivery orifices from the oil filter**

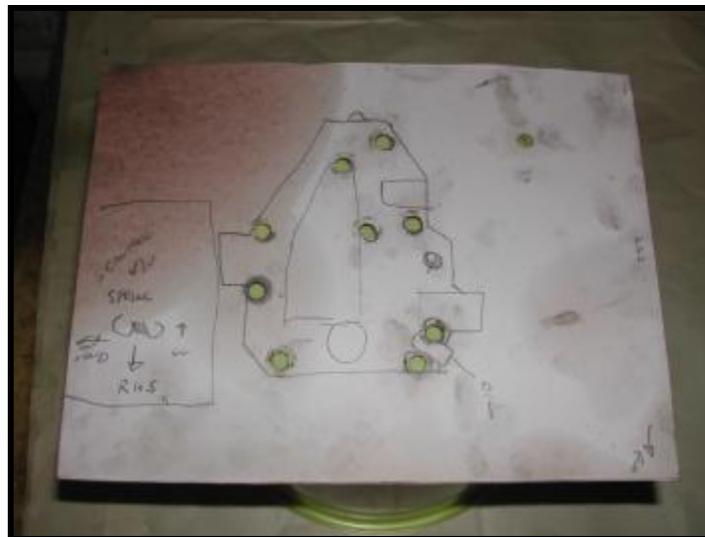
*Lower cover template retaining bolt holder*

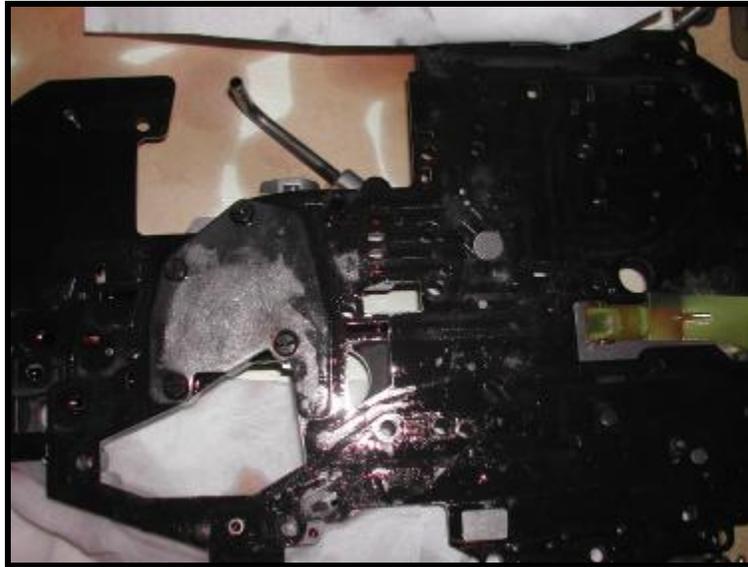
*Intermediate Plate with Lower Cover-Cover Plate (left of centre with Phillips-head screws) and Lubricating Oil Tube (centre top)  
Difficult to discern the various items as the gasket was very stained with ATF.  
RHS just off centre shows the plastic oil injector*
