DORSEY CARS NORTH AMERICA INC.

Technical Bulletin	Model 924S, 944, 944S, 944 Turbo	Group 1
	Subject: Oil Cooler/Oil Pressure Relief Valve Repair Guide	Part Identifier 1726/1740

Number
8904

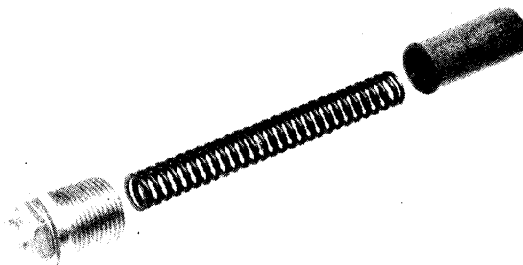
Figure 1

From start of production 1983, 944 cars came equipped with a spring and piston oil pressure relief valve (figure 1). This was used in all 944 and 944 Turbo up to the end of 1986 production. Also early 1987 924S used this system. In 1987 production of 944, 944S and 944 Turbo, a new type one-piece oil pressure relief valve PN 944 107 035 01 was installed (figure 2). Later production 1987 924S also received this valve. At around the same time a new type one-piece pressure relief valve, PN 944 107 035 11 was introduced as a retrofit to repair earlier engines from 1983 to 1986 along with the early 924S. With this, the old type spring and piston was discontinued as a spare part.

**Up to and including 1986 Model Year original equipment.
Three piece oil pressure relief valve.**

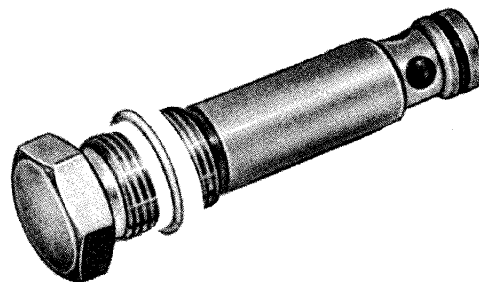
Figure 2

**From July 1986 (1987 Model year).
One piece oil pressure relief valve.**

1987 engines from production date July 1986, received pressure relief valve PN 944 107 035 01. This valve was not anti-corrosion treated. The engine numbers are as follows:

1987 engines from production date October 1986, the oil pressure relief valve PN 944 107 035 01 received an anti-corrosion treatment. Installation in production began with the following engine numbers:

When repairs are made to engines which fall between the above mentioned engine numbers, the oil pressure relief valve must be replaced with pressure relief valve PN 944 107 035 01.

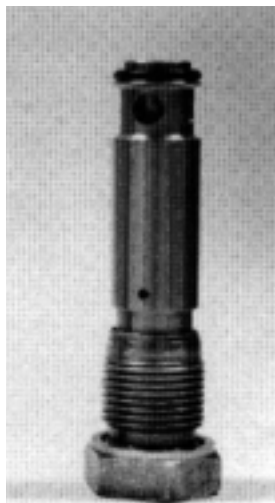
Fig. A

Figure A Valve

- 1. Valve 944 107 035 11
- 2. O-Ring 944 107 935 11
- 3. Seal Ring N 043 815 3

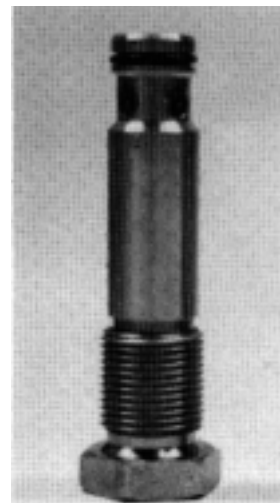
Fig. B

Figure B Valve

- 1. Valve 944 107 035 01
- 2. O-Ring 944 107 935 01
- 3. Seal Ring N 043 815 3

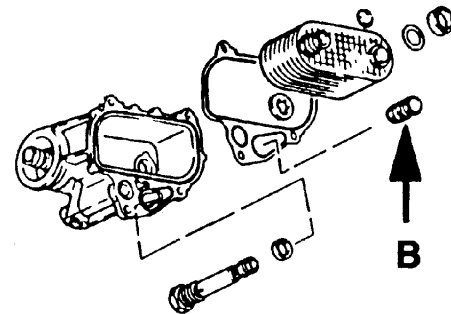
NOTE: Special tool 9215 is only used in engines having a steel sleeve installed in the oil pressure relief valve passage (1983-1986). It is important that the sleeve (arrow B below) be firmly installed in the crankcase. If loose, the oil cooler housing must be removed and the sleeve secured with loctite 648 or 638. Drive the sleeve to stop with special tool 9215. Consult the 944 Workshop Manual Vol. I, page 17-22 for additional instruction.

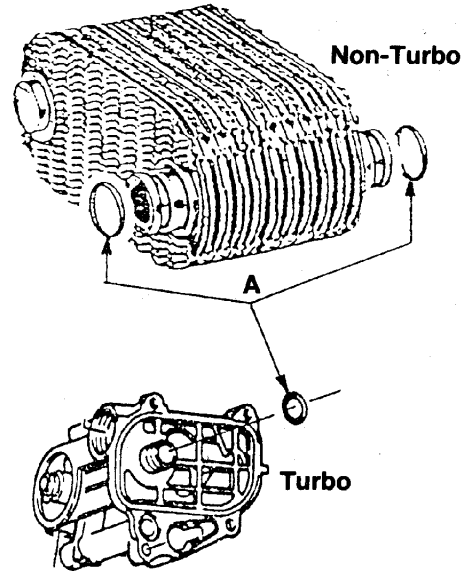
Figure 1

A - original design
B - new design

The sealing O-rings (A, figure 1) located on the oil cooler of normally aspirated cars and on the connecting pipe of the oil thermostat housing of Turbo cars, have been changed. The new version O-ring is now green in color (formerly red). When repairing, use **ONLY** the new version green O-rings PN 999 707 043 40.

Please note that the O-ring "A" in Fig. 1, is also installed in 944 Turbo cars. There are two O-rings on a short connecting pipe in the same place as they are found on normally aspirated cars.

When repairing earlier cars, the new type housing, plastic washer, and adjusting shims must be used.

To determine if the oil cooler housing is the latest version, and to help prevent needless housing replacement, inspect as shown.
