1989 Porsche 911 Carrera 4 Coupe AWD F6-3600cc 3.6L SOHC

Cylinder Heads - Refacing Information

Refacing Cylinder Heads with Use of Tool 9526

This bulletin replaces Technical Bulletin Group 1, Number 9202, Book I, pages 13-16.

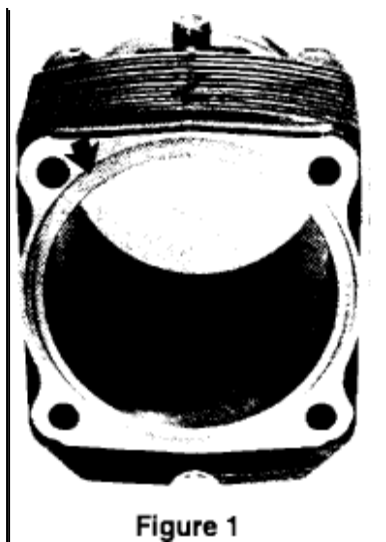
Figure 1

IMPORTANT: Replacement [piston](#) and cylinder sets have a groove to accommodate a seal between the cylinder head and cylinder mating surface (Figure 1). Effective immediately, only the steel sealing ring, Part Number 964 104 115 20 is to be used during repairs. This information also applies to engines produced after the above mentioned engine numbers.

When installing the cylinder head to the cylinder, the steel sealing ring must be fully installed in the groove of the cylinder. Sparingly use light grease to hold the ring in the cylinder during installation.
