Noise Symptom - Creaking Noise From Rear End Area: Checking coil springs on rear axle (SY 37/19)

Vehicle Type: 911 GT3 Gen. II (991)

Model Year: 2018

Subject: Coil springs on rear axle

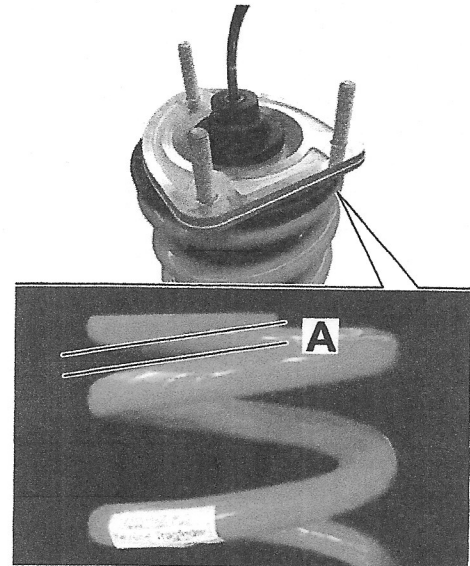
Coil spring on rear axle

Cause: The end of the spring may be touching the closest coil and this can make the noise.

2.1 Visually check whether the coils were touching — you may see signs of paint abrasion on the coils (⇒ *Coil spring on rear axle -Markings A-*).

- 2.2 If the coils were touching, replace old coil springs on the rear axle with new coil springs with shrink-fit hose, see ⇒ *Workshop Manual '427137 Disassembling and assembling rear spring strut'*.
