Noise Symptom - Creaking Noise From Rear End Area: Checking coil springs on rear axle (SY 37/19)

Vehicle Type: 911 GT3 Gen. II (991)

Subject: Coil springs on rear axle

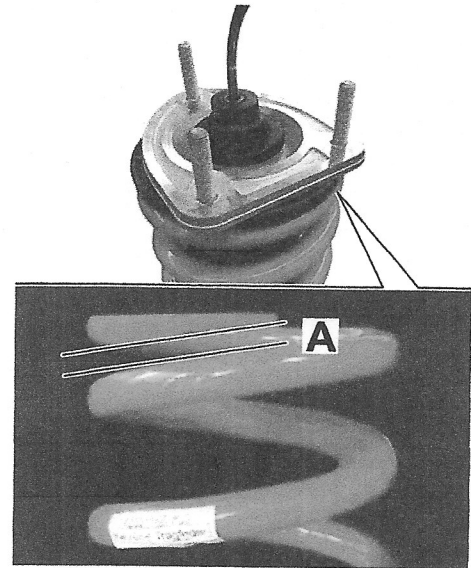
Coil spring on rear axle

Cause: The end of the spring may be touching the closest coil and this can make the noise.

2.1 Visually check whether the coils were touching — you may see signs of paint abrasion on the coils (⇒ *Coil spring on rear axle -Markings A-*).

- 2.2 If the coils were touching, replace old coil springs on the rear axle with new coil springs with shrink-fit hose, see ⇒ *Workshop Manual '427137 Disassembling and assembling rear spring strut'*.
