Eliminating Symptoms - Engine: Reworking Coolant Pipe (Loss of coolant at the coolant pipe/SY1416)

Model Lines: Sports Cars (981/991)

Model Year: **As of 2014 up to 2016**

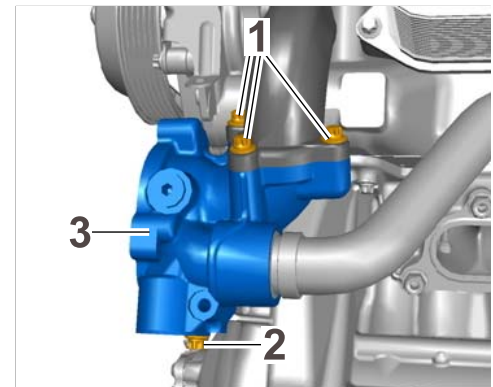
Coolant pipe on coolant regulator housing

Cause: Component tolerances between the coolant pipe flange and distributor housing can cause leaks.

- 2 Unscrew screws ⇒ *Coolant pipe on coolant regulator housing -1-* on the coolant regulator housing
⇒ *Coolant pipe on coolant regulator housing -3-*.
