Noise Symptom - Buzzing Noises From the Door Panel Area: Replacing Covers on Power Windows Mechanism With New Type of Covers (SY 73/20)

Model Line: **911 Carrera (992)**

Model Year: **As of 2020**

Subject: **Covers for power windows mechanism**

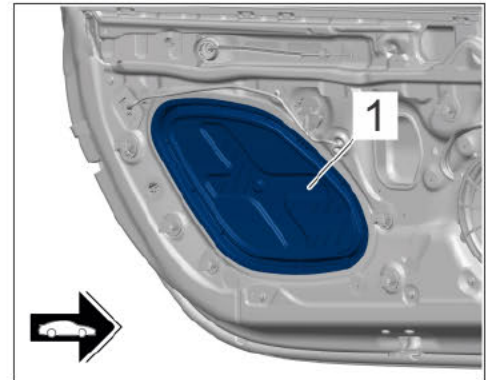
Cover for power windows mechanism

Symptom: Buzzing noises can be heard from the door panel area during sound output.

Cause: The covers for the power windows mechanism may have been pressed too much during production and are therefore not installed securely enough in the basic door frame.

- 1 Unclip cover on power windows mechanism ⇒ *Cover for power windows mechanism -1-* using a suitable tool and replace it with a new type of cover.
