Technical Bulletin

Noises from the Targa Roof Area

Number
9606

Models Affected: **911 Targa, Model Year 1996**

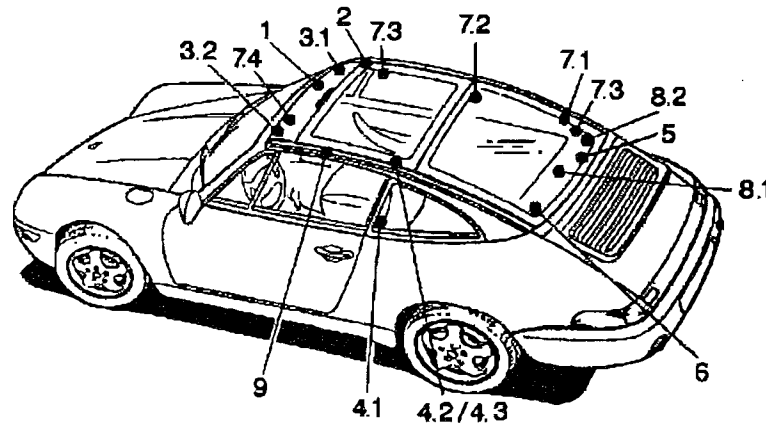
Possible areas where noises can occur include:

- 1 - Creaking in the area of the wind deflector.
- 2 - Creaking at the left and right sides of the sliding glass roof panel.
- 3 - Strong rattle noises in the area of the windshield frame (3.1 - 3.2).
- 4 - Rattle or creaking noises in the area of the "B" pillar, left and/or right sides (4.1, 4.2, 4.3).
- 5 - Creaking noises in the area around the rear window.
- 6 - Creaking noises in the area where the inside rear cover panel and rear window meet.
- 7 - Crackling or rattle noises from the area of the inner roof trim panels, left and right and the windshield frame cover (7.1, 7.2, 7.3, 7.4).
- 8 - Crackling or rattling noises from the rear inside wall trim panel (8.1, 8.2).
- 9 - Creaking noises in the area of the roof rail trim strips, left and right sides.

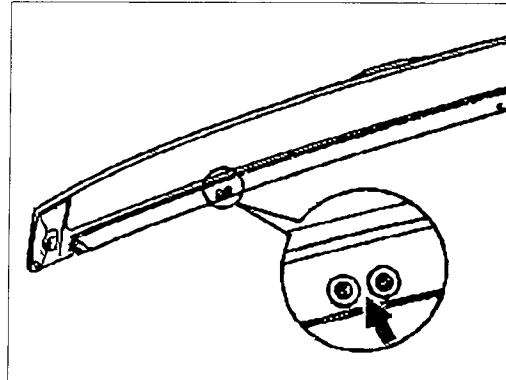
Figure 1

Area #1 Creaking noises from the wind deflector.

- Loose threaded inserts in the wind deflector hinge.

- If the threaded inserts (arrow in Figure 1) in the wind deflector hinge are loose, the wind deflector, part number 993 562 904 00, and the attaching bolts, part number 993 562 577 00, will need to be replaced. Tighten the attaching bolts to 5.5 Nm (4 ftlbs).

Note: Prior to removing the bolts, heat the bolt heads with a soldering gun to soften the Loctite.

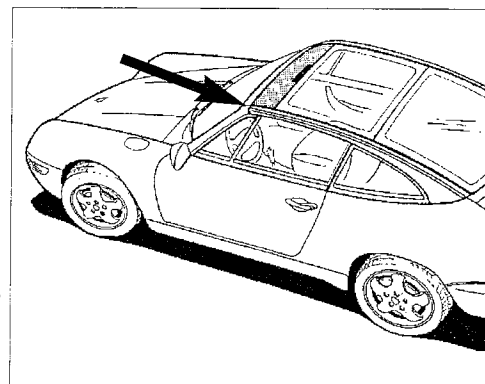
Figure 3

Area #2 Creaking or rattle noise from the sides of the glass sliding roof.

The side seals are sticking together (Figure 3).

- The side seal profile is "U" shaped and the upper and lower part of the seal are touching and sticking together. Pull off the front edge of the side seal and locate the opening at the end of the seal. Use a suitable wire coated with Vaseline to lubricate the inside of the seal along its entire length.

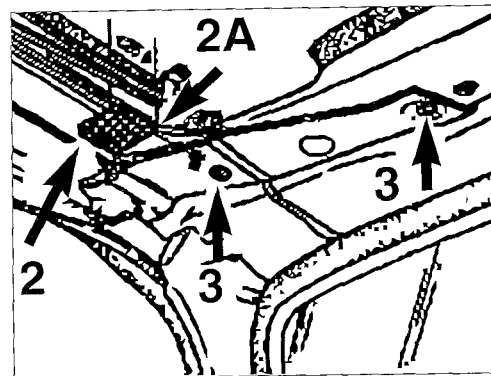
Figure 4

Area #3 Strong crackling noise from the front windshield frame area.

- The windshield frame / Targa top mounting bolts are loose and or the Targa roof assembly is installed under tension.

Repair: 3.1 - Shorten the corner plate bracket in the area of the bearing block holes (arrow 2, Figure 4).

- Remove the allen head screws (arrow 2, Figure 4).
- Remove the area indicated by crosshatch at area 2 in Figure 4.
- Proceed by inserting a screwdriver between the corner plate and the guide and bend the crosshatched area away from the guide 3 to 4 mm.
- To prevent damaging the guide, insert a 40 mm x 50 mm, 2 mm thick sheet metal plate between the guide and corner plate.
- Cut off the hatch-marked part at a length of 25 mm (arrow 2A, Figure 4).

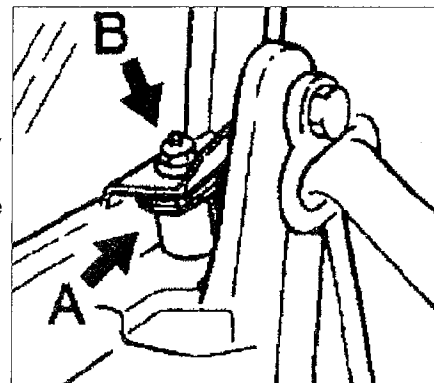
Figure 7

Area #4 Rattles or creaks in the area of the lower "B" pillar / roof, left and right.

- The distance spacer (A in Figure 7) may be loose or incorrectly positioned.
- The rubber stop for the guide pin of the glass roof latch may be missing.
- Lack of lubrication for the guide bushing on the rear axle plates.

Repair 4.1 Loose or incorrectly positioned distance spacer.

- Loosen the M6 nut (B in Figure 7) and check the position of the distance spacer. Afterward, re-torque the M6 nut to 9.7 Nm (7 Ftlbs).

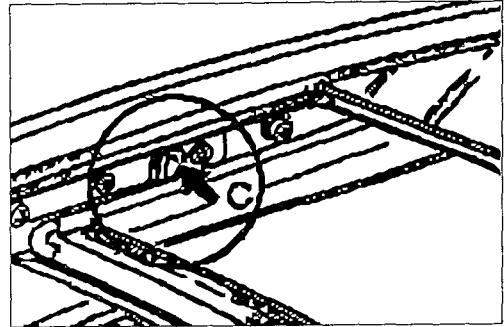
Figure 8

Repair 4.2: Missing rubber stop for the guide pin of the glass roof latch, left and right sides.

- Open the glass roof completely and check if the rubber stop, part number 993 562 810 00 for the guide pin of the glass roof is installed (arrow, Figure 8). The rubber stop is approximately 50 mm in front of the rear window on the guide tracks and is only accessible when the roof is fully open.

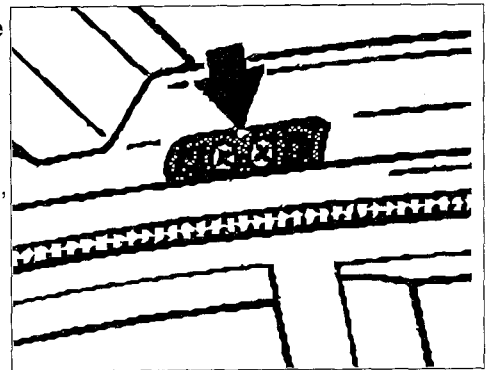
Figure 10

Repair 4.3: Lack of lubrication for the guide bushing on the rear axle plates.

- Remove the rear axle plate (arrow, Figure 10) with the glass roof closed.
- Lubricate the guide bushing of the axle plate with a stiff grease, part number 999 917 751 00.
- Reinstall the axle plates and adjust the height of the glass roof to the roof trim pieces. Torque the axle plate screws to 5.5 + 0.5 Nm (4 Ft lbs).

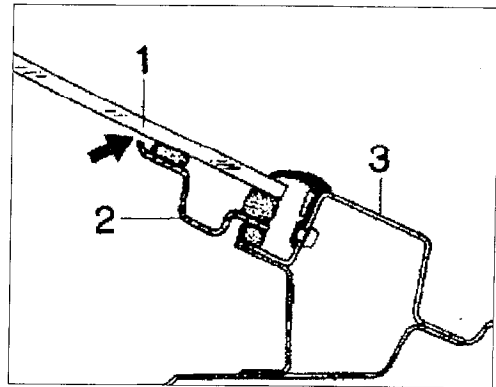
Figure 11

Area #5: Creaking noises from around the rear window.

- The rear window mounting frame (2 in Figure 11) touches the rear glass.

- Check for clearance using a 2.0mm feeler gauge (arrow in Figure 11).

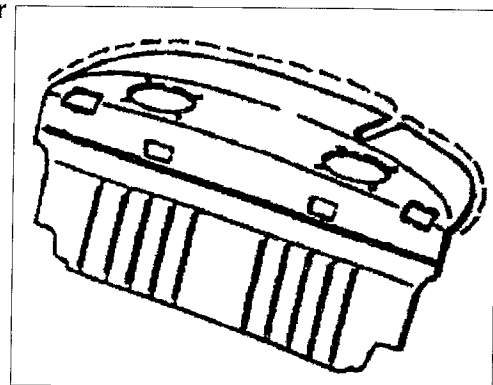
Figure 13

Area #6 Noise in the area of the rear wall trim panel near the rear glass, C pillar covers and side covers.

- The edge of the rear wall trim panel touches the rear glass.

- Install a length of felt material, part number 993 555 545 00 onto the edge of the rear wall trim panel (Figure 13). As of Oct. 12, 1995, vehicles with leather covered rear wall trim panels have the felt strip installed in production form VIN: 99 5 TS 38 5091.

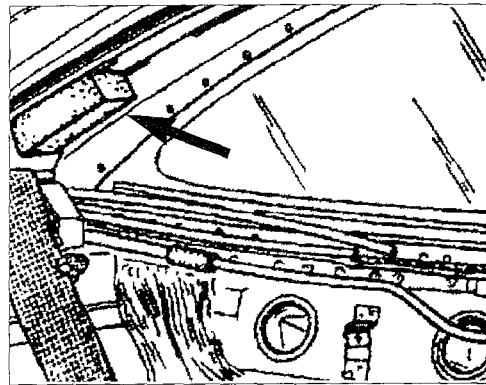
Figure 14

Area #7 Crackling or rattle noises in the area of the left or right inner roof rail trim panels.

Repair 7.1: The roof trim panel touches the metal roof frame.

- Glue foam pieces (arrow in Figure 14) part number 993 556 245 00 to the inside of the roof rail trim panels at the location shown in figure 12.

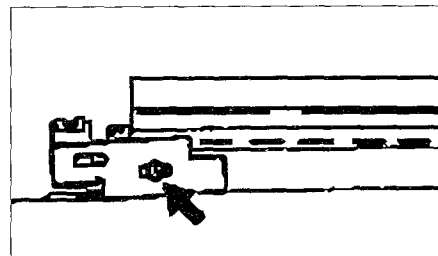
Figure 15

Repair 7.2: The center securing supports for the roof trim panels left and right sides are loose.

- Secure loose rivets (arrow in Figure 15) by using pliers to squeeze the rivet heads. Make certain not to damage the roof trim panel.

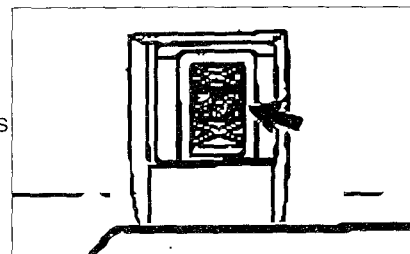
Figure 16

Repair 7.3: Play on the front and/or rear securing parts, left and right sides.

- With the roof rail trim panels removed, glue felt or foam pieces, approximately 12mm X 10mm and 5mm thick in the indentations of the securing part (arrow, Figure 16). The glued in part must be approximately 1mm taller than the securing part indentation.

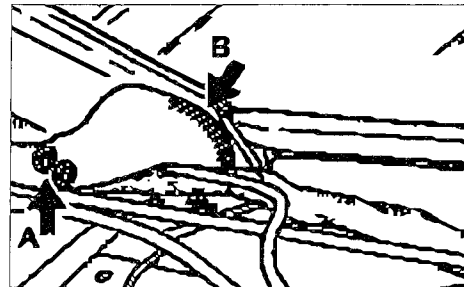
Figure 17

Repair 8.2: Rear wall trim panel rattles on the roof rail trim panels, left and right sides.

- When the rear wall trim panel is removed, remove the covers for the roof rail trim panels (arrow A, Figure 17).
- Install a foam or felt strip, approximately 50mm X 10mm, 2 to 3 mm thick on the top edge of the cover for the roof rail trim panel pointing toward the guide rail (arrow B, Figure 17).

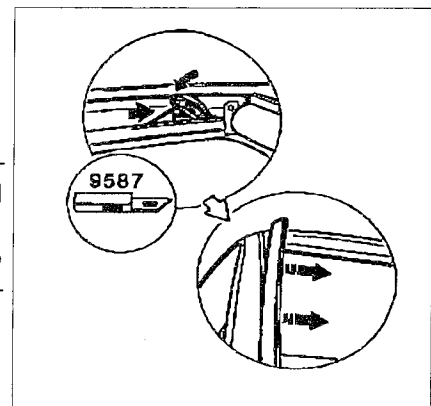
Figure 19

Repair #9: Crackling noises in area of the roof rail trim strips.

- The roof rail cover strips are installed under tension. The roof rail trim strip will require replacement.

- Open the sliding roof completely.
- Position the fold-up lever for the wind deflector to the rear using special tool 9587 (See Figure 18).
- Use the appropriate 9587 tool (left or right) for the side of the vehicle being repaired (Figure 19). Insert the tool into the guide rail channel behind the cable driver. Use a screwdriver to push the tool 9587 into the cable driver which will allow the cable driver to move forward. This will cause the fold-up lever to move down toward the rear. Leave the tool in place while repairs are being made.

Caution: Do not close the glass roof while the tool 9587 is installed.
