Noises at the Windshield and Rear Window

Vehicle Type: **911 Carrera (996)**

Model Year: **As of 1999 (X)**

Concern: **Noises at the windshield and rear window.**

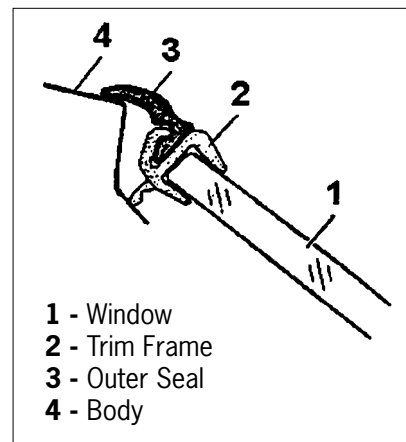
Figure 1

Information: Rattling noises can occur if the trim frame around the windshield and/or rear window becomes loose. The bonding of the trim frame around the windshield (and the rear window on the Coupe) was improved in production, as of November 19, 1998, and from Vehicle Identification Numbers: (VINs)
