## Porsche Plastic Body Repair

ONE 993 TURBO OWNER FOUND HIS PLASTIC TAIL WARPING FROM EXCESSIVE HEAT AND CAME UP WITH A SIMPLE FIX — ONE THAT MIGHT INTEREST 964 AND 993 OWNERS WITH WARPED FRONT BUMPERS, TOO  
STORY AND PHOTOS BY GARY WOLFGANG

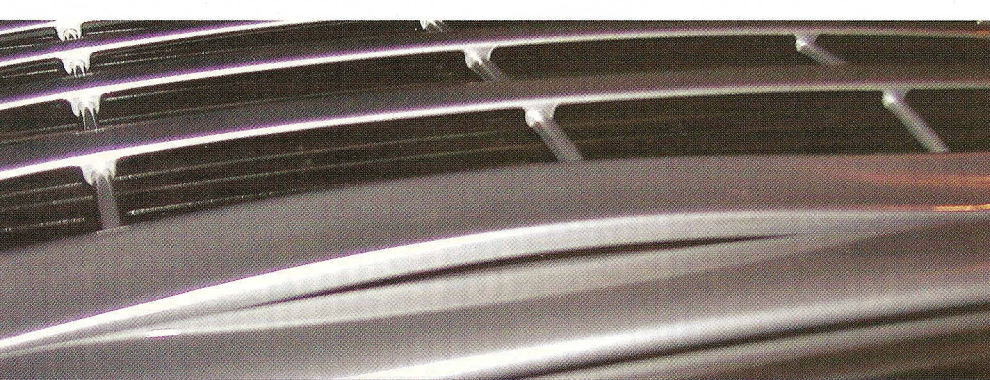
Heat soak after shutdown can take its toll on the 993 Turbo's rear grill, which is located above the intercooler. After a real workout, it might be a good idea to raise the engine lid...

But, in my seventh year of 993 Turbo ownership, I began to notice bulging in the leading edge of my tail's grill insert between the three hold-down pin points. In time, the deformity worsened and was visible even when the engine was cold. On close inspection, one could see that the grill had expanded in length, causing upward bulging in areas where there were no attachment pins to hold it down. The heat-warped grill was still flexible, however, and finger pressure on the bulged areas corrected the deformity. But, since the grill was elongated, holding down the bulges created a tighter fit at the corners.

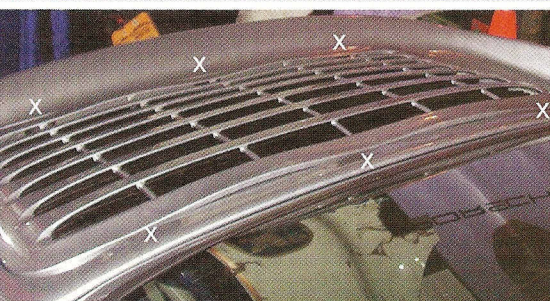
X marks the spot, or in this case, each of the hold-down pins for the grill section

left and right sides. The leading edge is then pulled upward, unsnapping three hold-down pins. The trailing edge of the grill is then unclipped from its three holding points. The grill structure can now be removed and cleaned. Removal of the grill allows identification of three leading-edge anchor holes and the two side-bolt anchor holes.

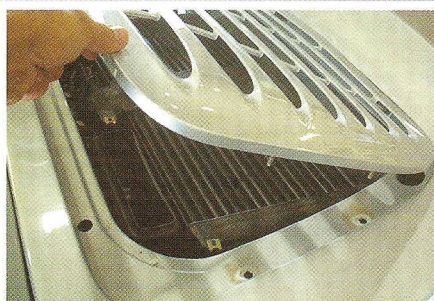
Two additional hold-down points are located on each side of the grill

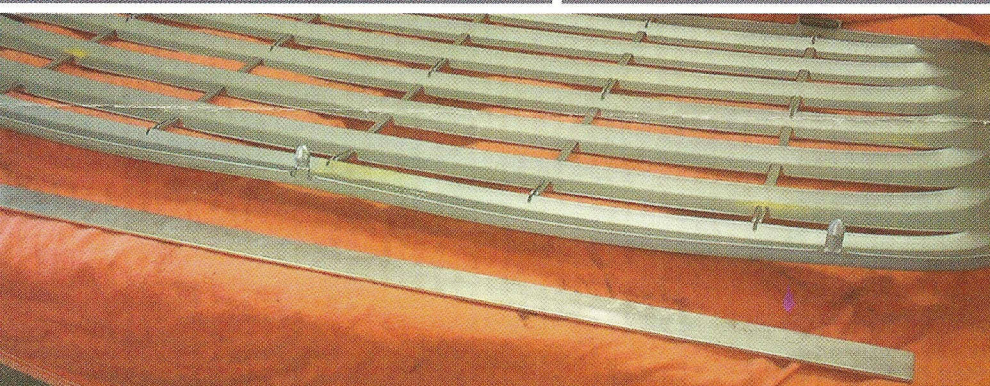
The strip of aluminum we chose to strengthen our grill was a 0.25-inch thick bar that is 1.0-inch wide and 28 inches long, seen here laying next to the grill

A strip of aluminum stock — 0.25-inch thick, 1.0-inch wide, and 28 inches long — was readied for application. 0.25-inch holes were drilled into the aluminum stock to allow for intrusion of the cement. Polyurethane cement — Speed Grip by Norton — was applied to the underside of the leading edge of the grill. The aluminum was clamped to the grill and allowed to set. The cemented strip actually elongates the leading edge of the grill, causing minor upward bulging of the corners. A T-shaped panel rivet pin was also cemented to the underside of each corner with polyurethane cement.

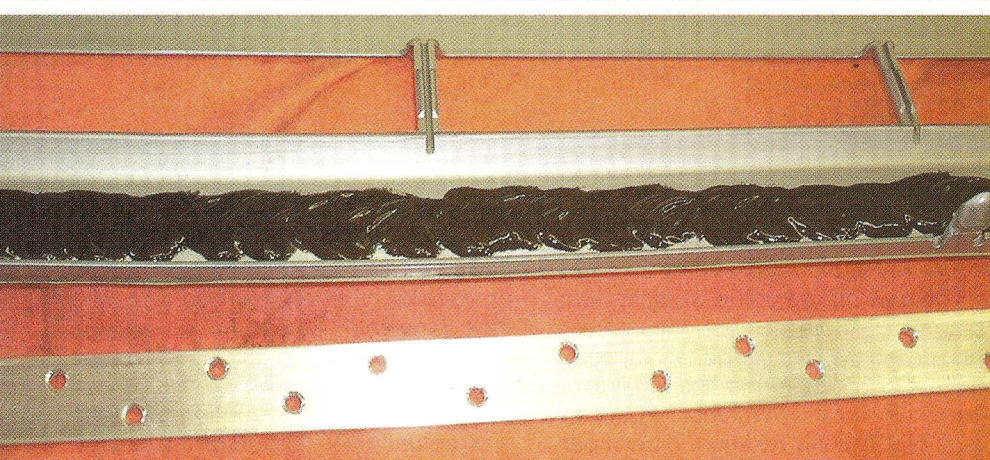
We drilled a lot of holes down the aluminum strip's length to allow the epoxy to get an additional hold on the strip, then spread the epoxy down the "bed" of the grill

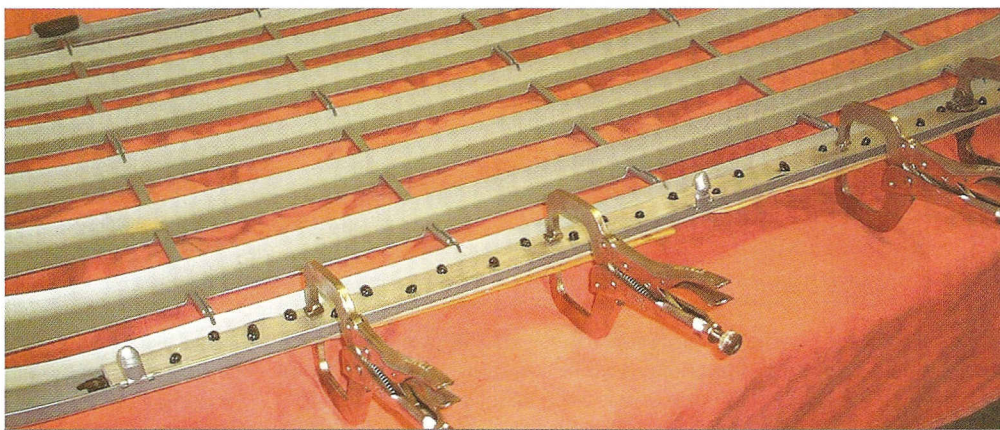
You can see the epoxy protruding out of the holes in the aluminum strip. Simple Vice-Grip clamps make curing easy, but be sure to protect the paint on the other side of the clamps!

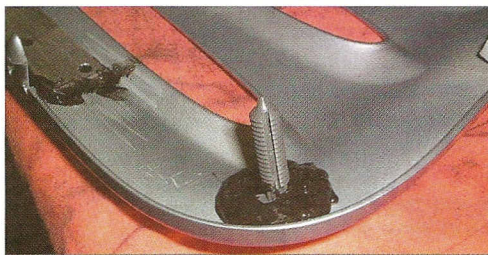
New holding pin cemented in the corner of the grill's underside leading edge...

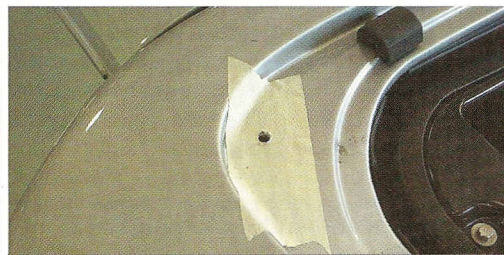
...while a matching hole was drilled in the spoiler. Tape protects the paint for drilling

Inserting the grill temporarily allowed marking on masking tape for a careful location of two corner anchorage holes, which still needed to be drilled.

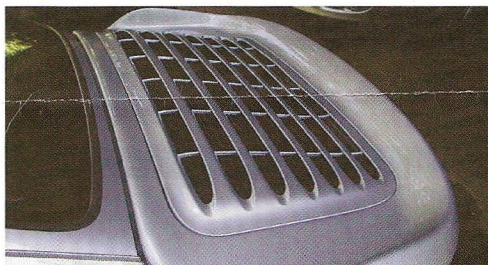
From this angle, the repaired spoiler looks just about perfect...

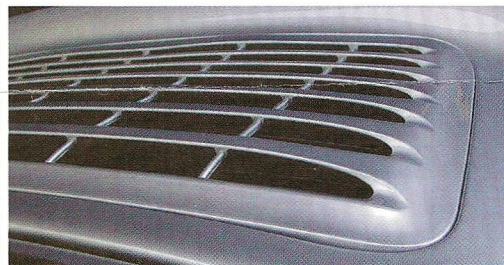
Replacement of the grill is a reversal of the disassembly process. The posterior edge clips are engaged, the three hold-down clips are snapped together, and the newly installed corner clips are attached. The two side bolts are fastened on each side and their vinyl plugs are then replaced. The resultant grill fit and alignment is quite acceptable — although it's still not perfect. The corners remain slightly elevated and the seam width on each side is a tight fit.

...though a closer look gives the game away. But it's more than good enough!
