Put the convertible top in service mode. Refer to the great Pelican Parts guide, and follow disassembly up to Figure 5 of Ref. [1].

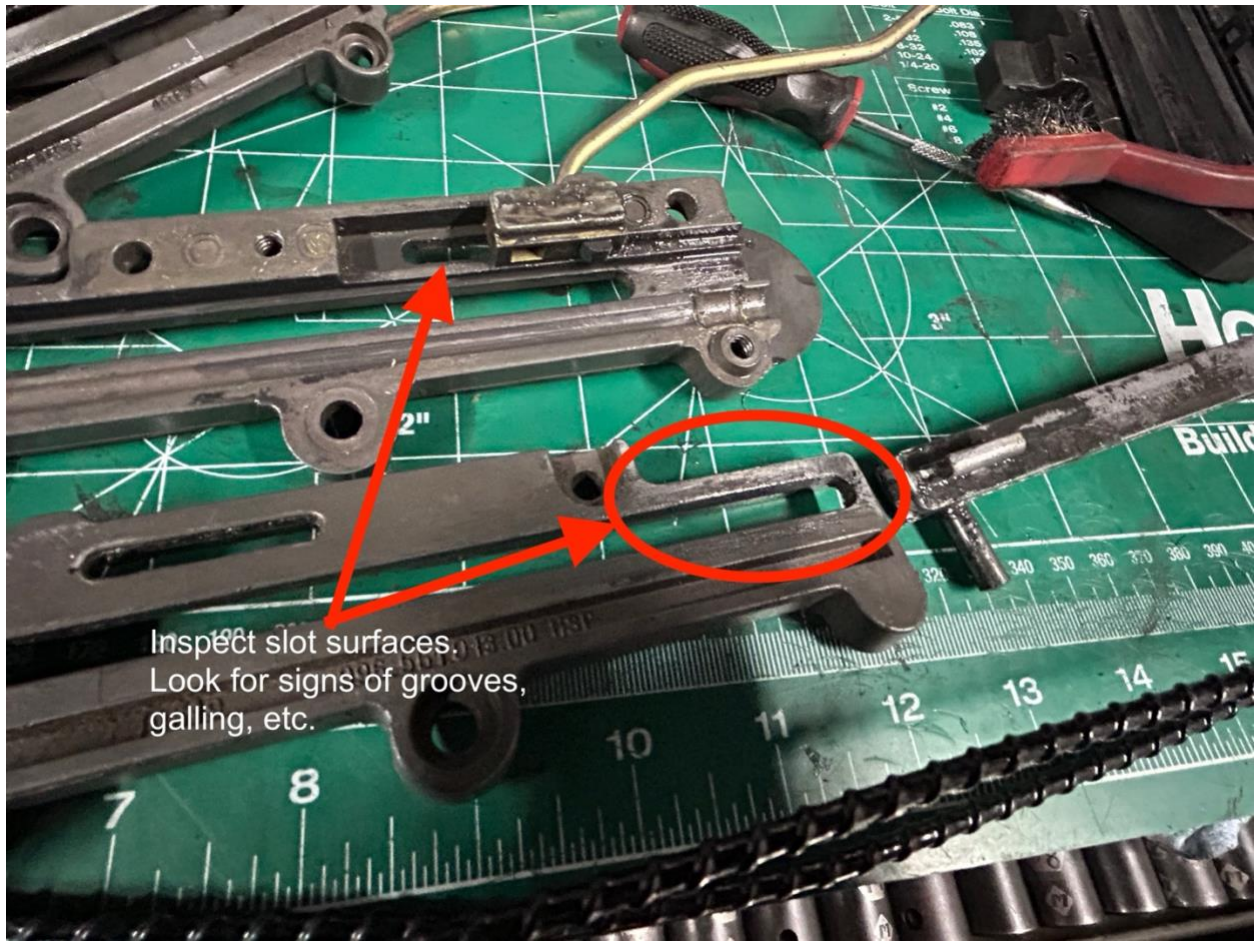
Inspect slot surfaces.
Look for signs of grooves,
galling, etc.

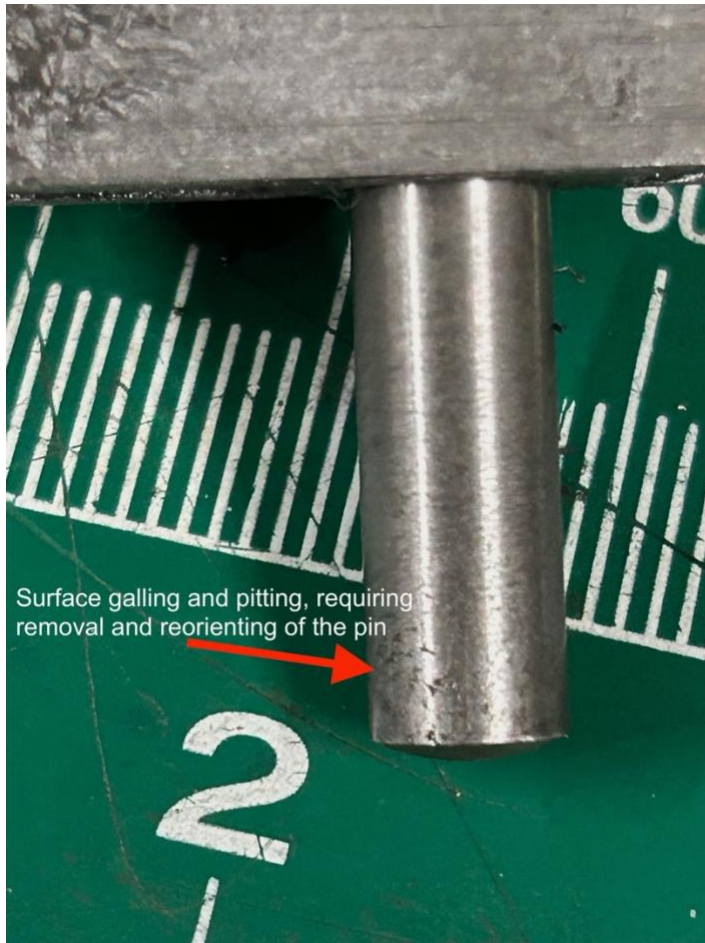
Surface galling and pitting, requiring removal and reorienting of the pin

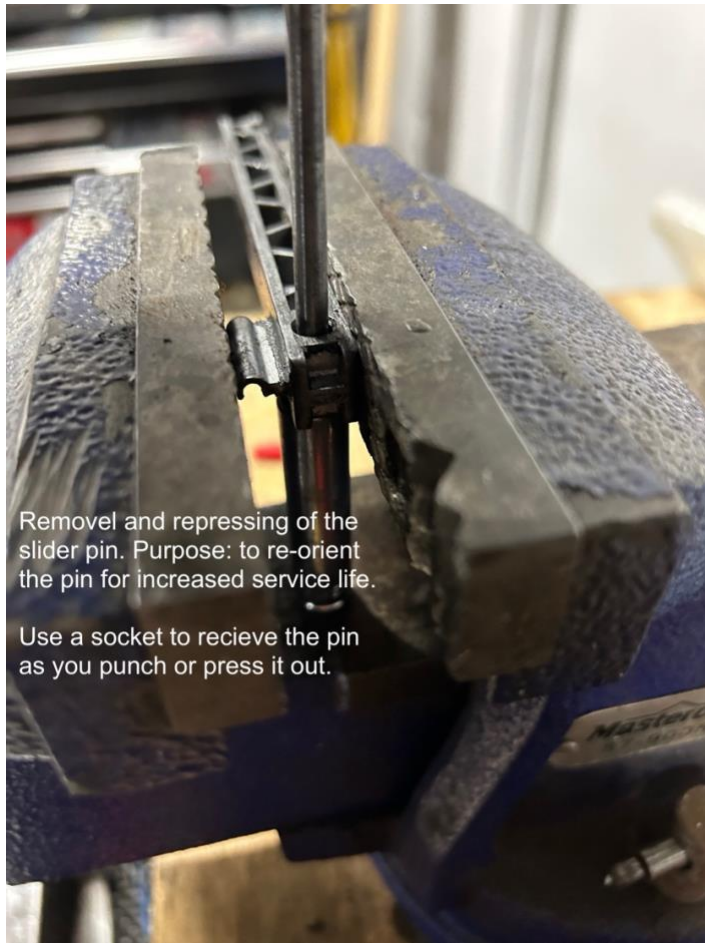
Worn pin, re-install in a different orientation.

Removal and repressing of the slider pin. Purpose: to re-orient the pin for increased service life.

Use a socket to receive the pin as you punch or press it out.

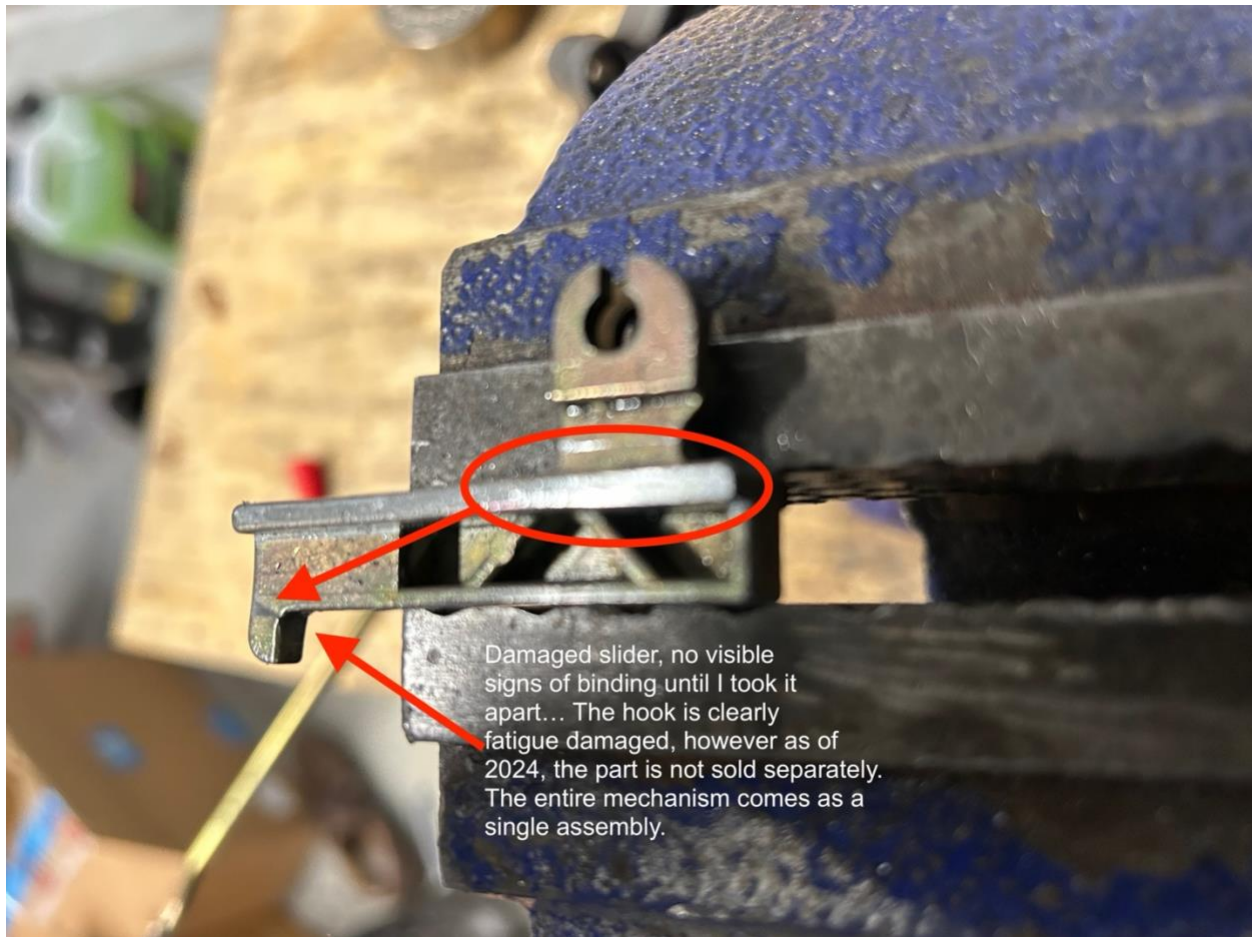
Slider in the central drive mechanism which controls the rear lock/latch.
