Barry Hart, Technical Director, Hartech Automotive

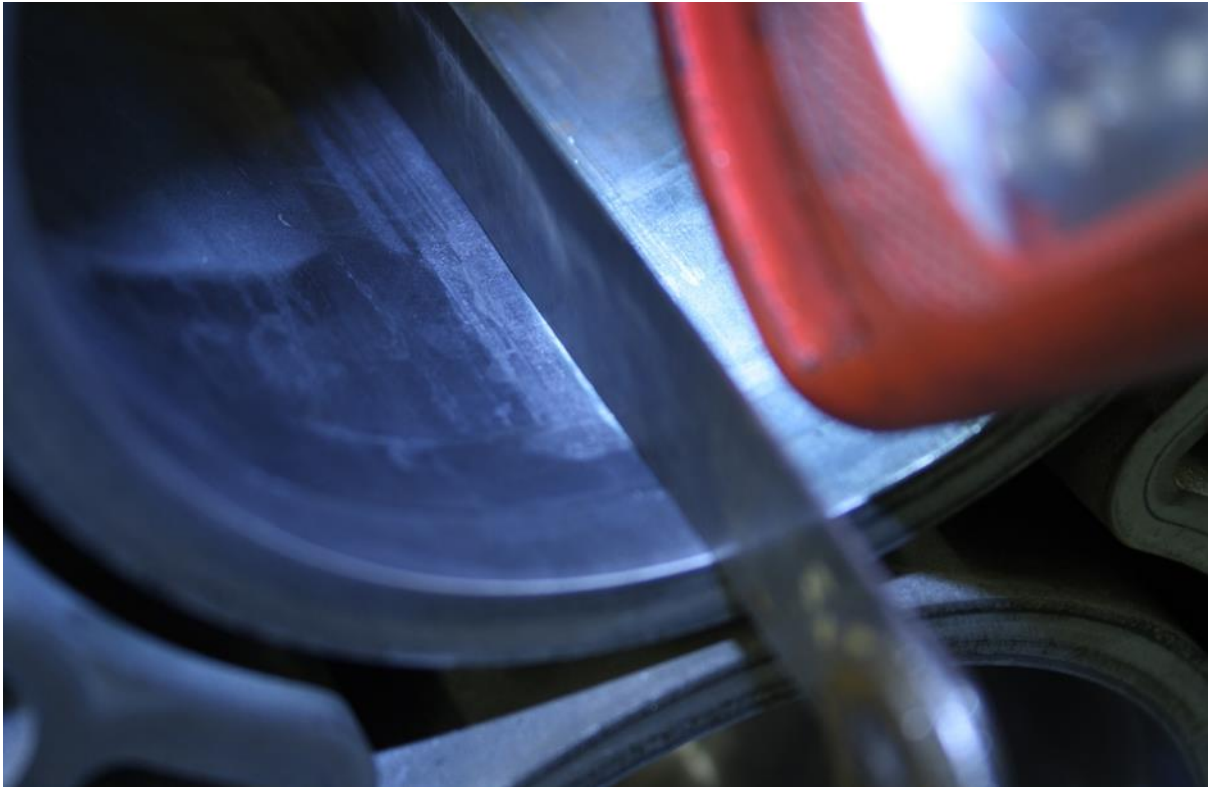
- (15) So is it (a) the rougher silicon exposed by hydraulic erosion or (b) released particles – that initiate bore scoring?
- (16) During our research we found evidence of erosion.

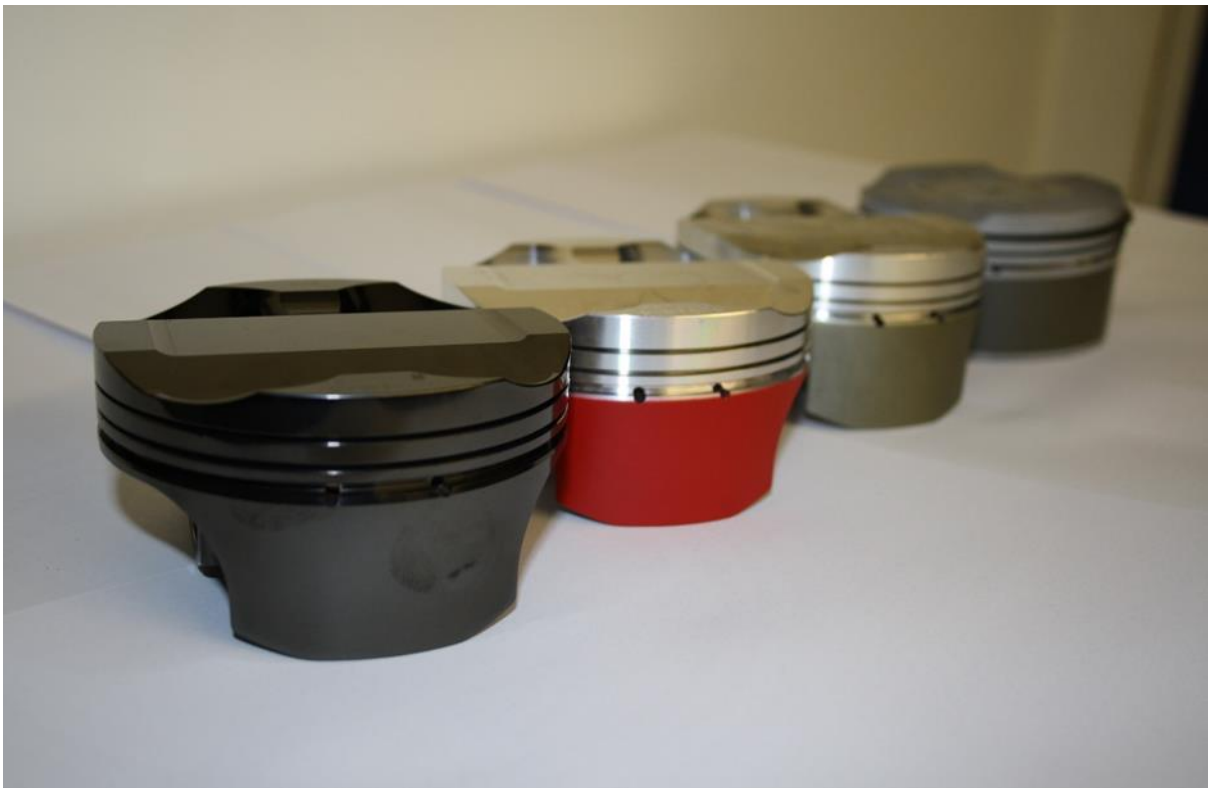
(17) We also tested different piston coatings in the same engines.

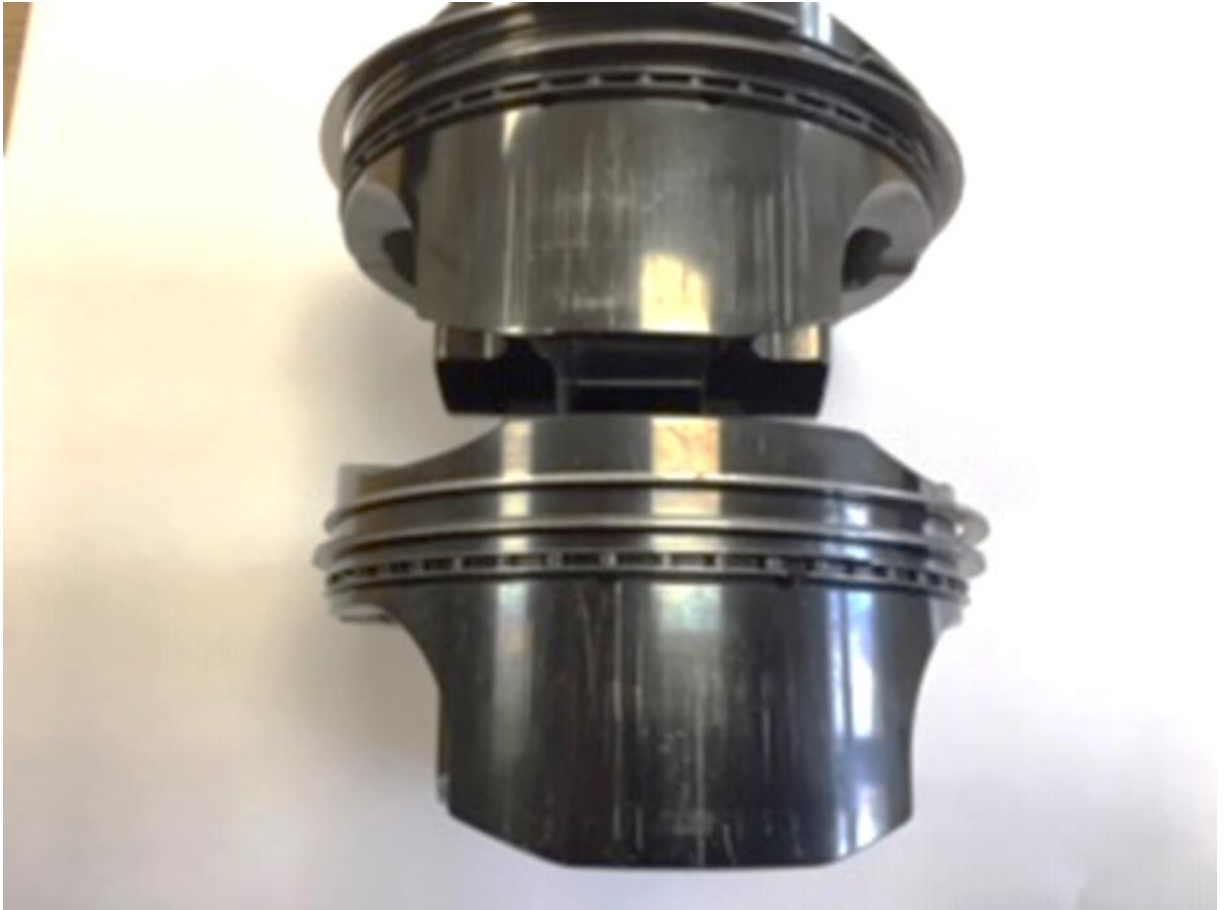
(18) The piston we had coated in **“Diamond Like Coating”** revealed the answer because the very thin coating on most of the thrust face was still

shiny (untouched by the bore) while in several other places very thin vertical lines had been scored into it – the result (we believe) that could only be caused by loose silicon particle release.

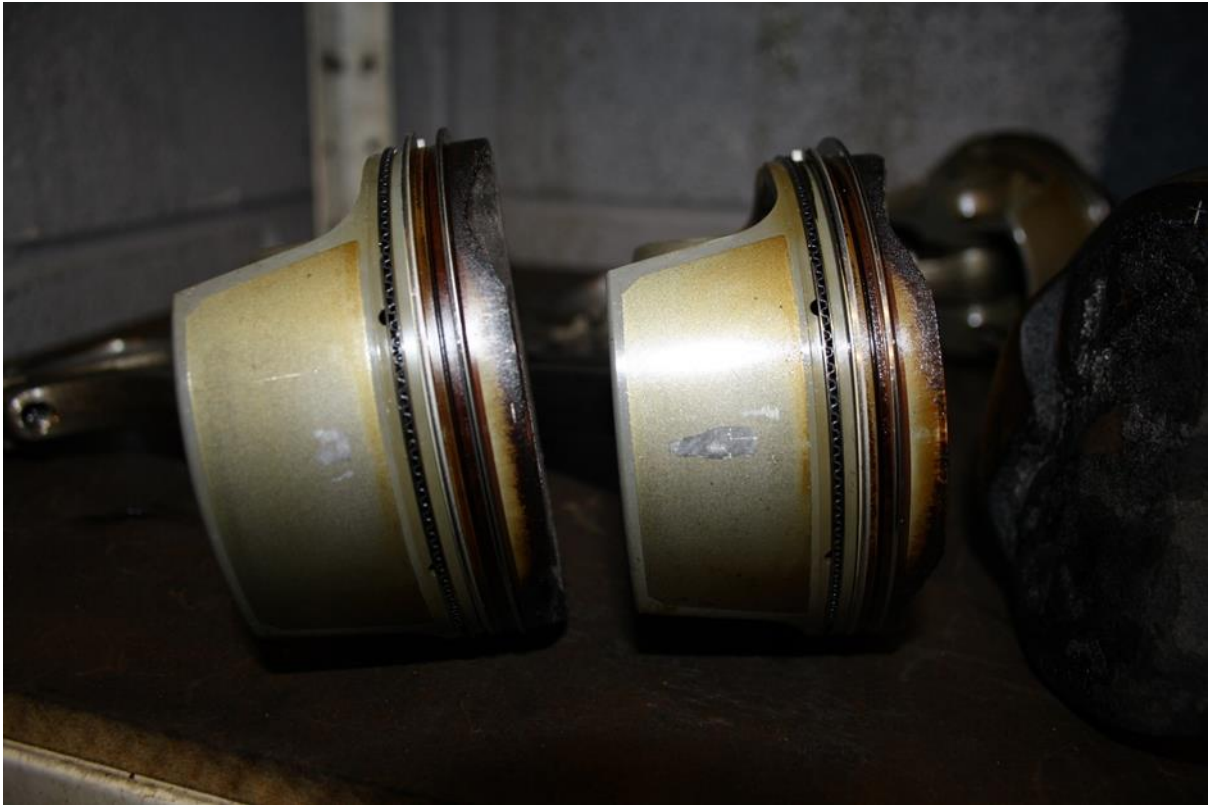
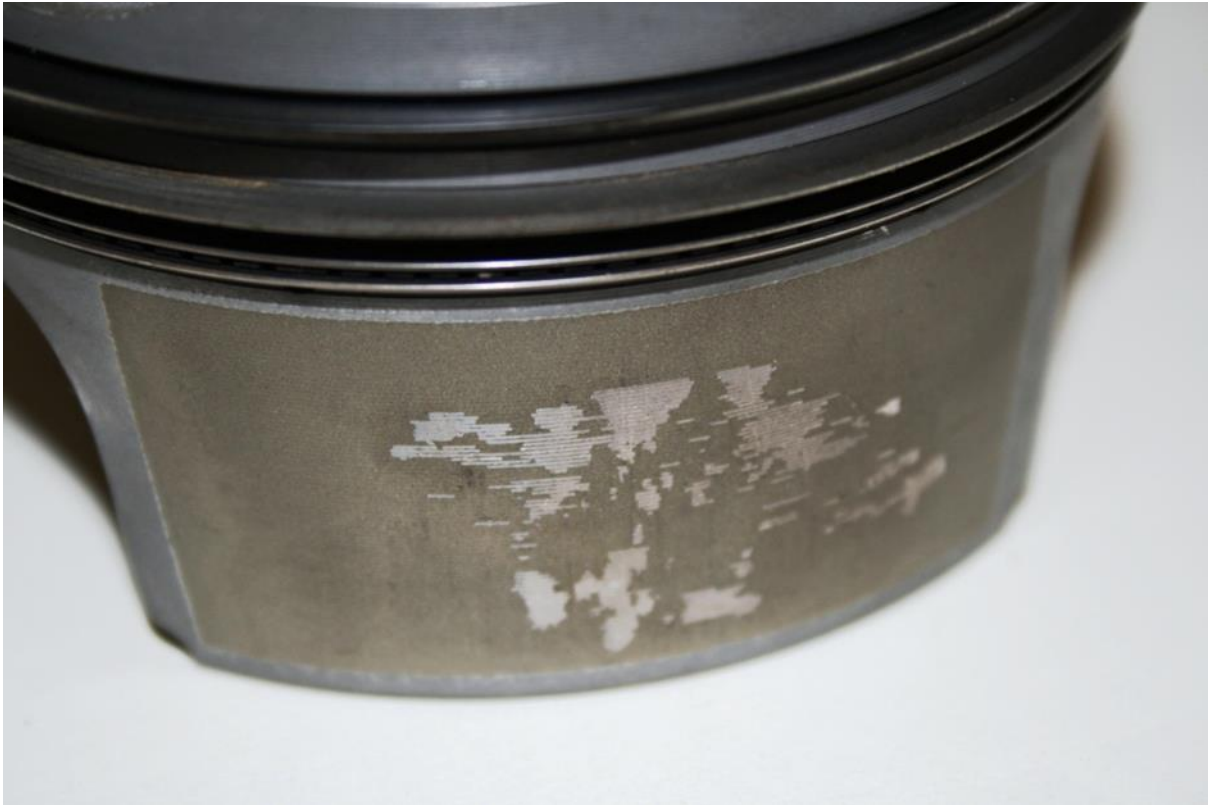
(21) So how good is that coating? Some pictures showing evidence the first 2 typical of a particle plucking out some coating.

If it was silicon still bonded to the bore that plucked out the coating then the loss would extend up and down the piston at this stage while these pictures demonstrate the temporary nature of the particle release.

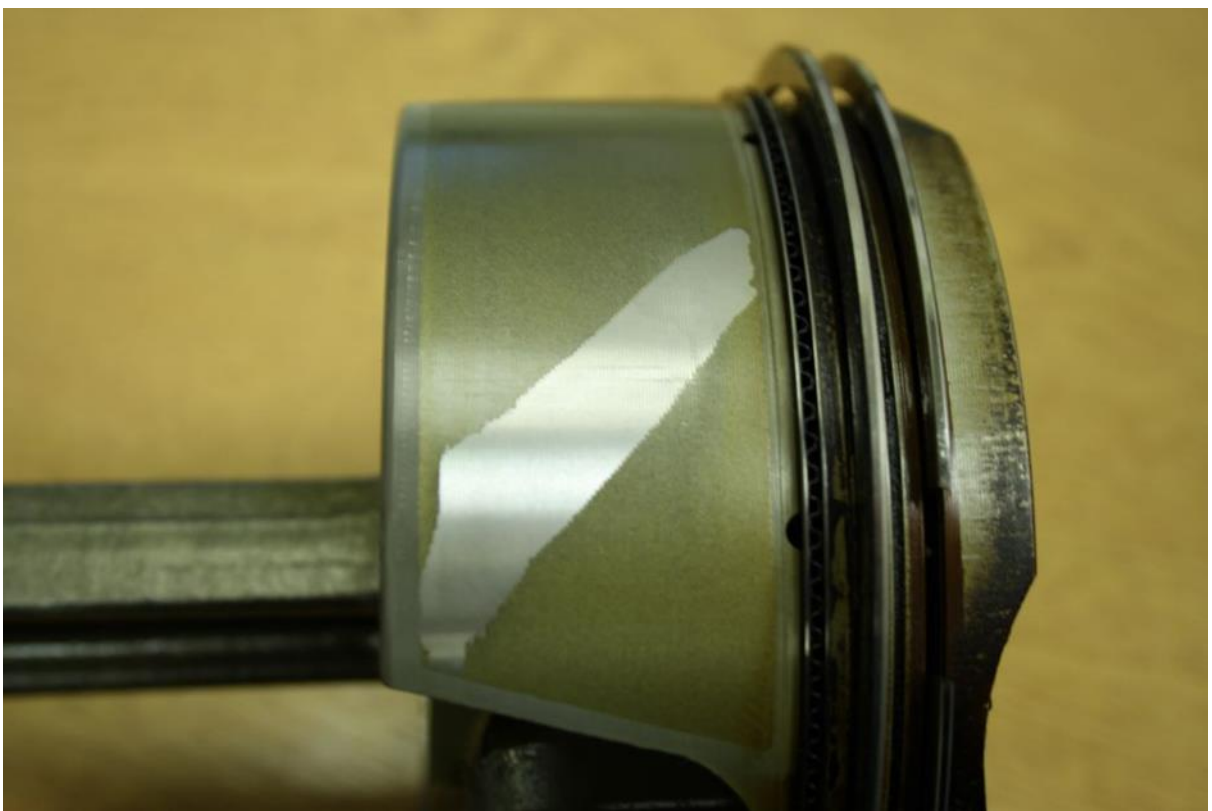
The next picture shows poor coating bonding.

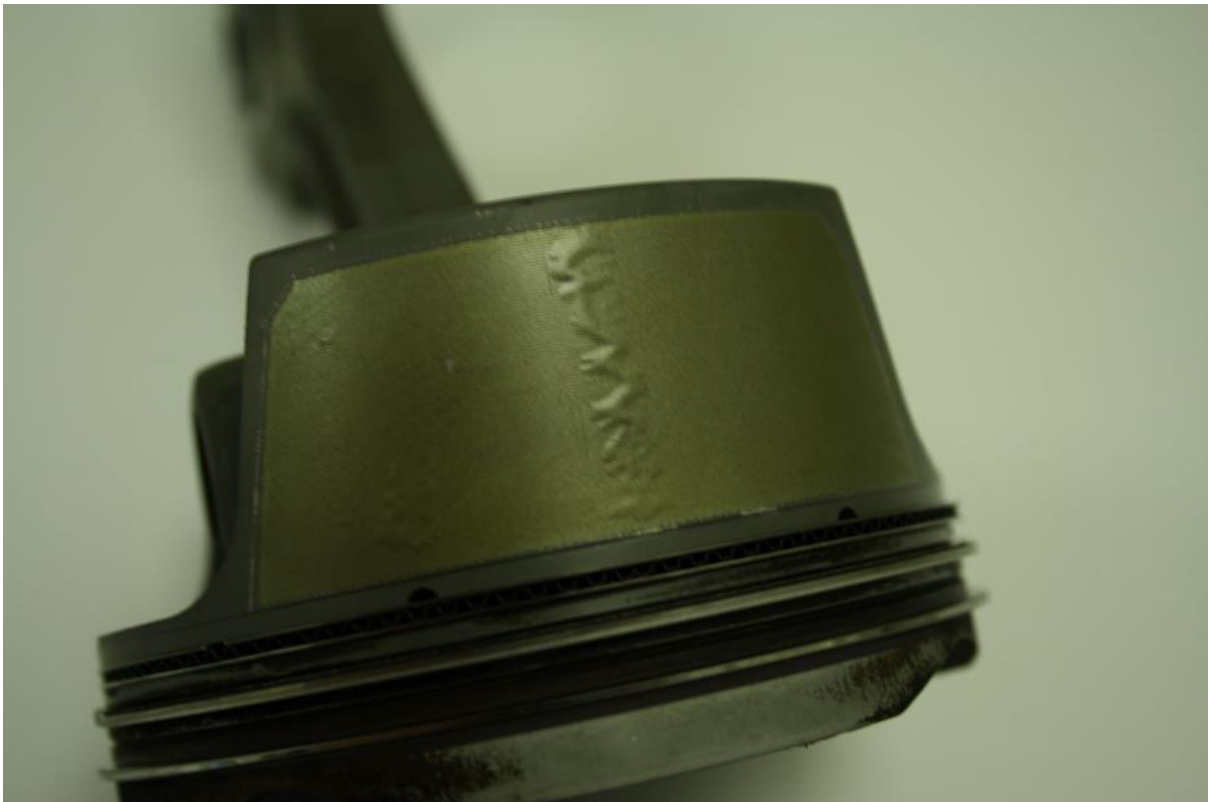
The last is by far the best showing how despite still being in tact with adjacent coating it has bubbled away from the piston – but still running OK against the

bore. If it was the rough surface of the bore causing scoring them that would have picked off this area of bubbles but instead the thrust loads have squeezed the piston against the bore and the bubbles have been squashed to move up and down with the piston. However – if a small piece of silicon became free and dug into the bubble – it is easy to imagine it plucking that portion free of the piston.

This proves to us that the bore surface is smooth enough to run without scoring the lining as long as it is intact and the oil film is present - but equally makes it obvious what would happen if a small piece flowed free and penetrated to one of those bubbles!

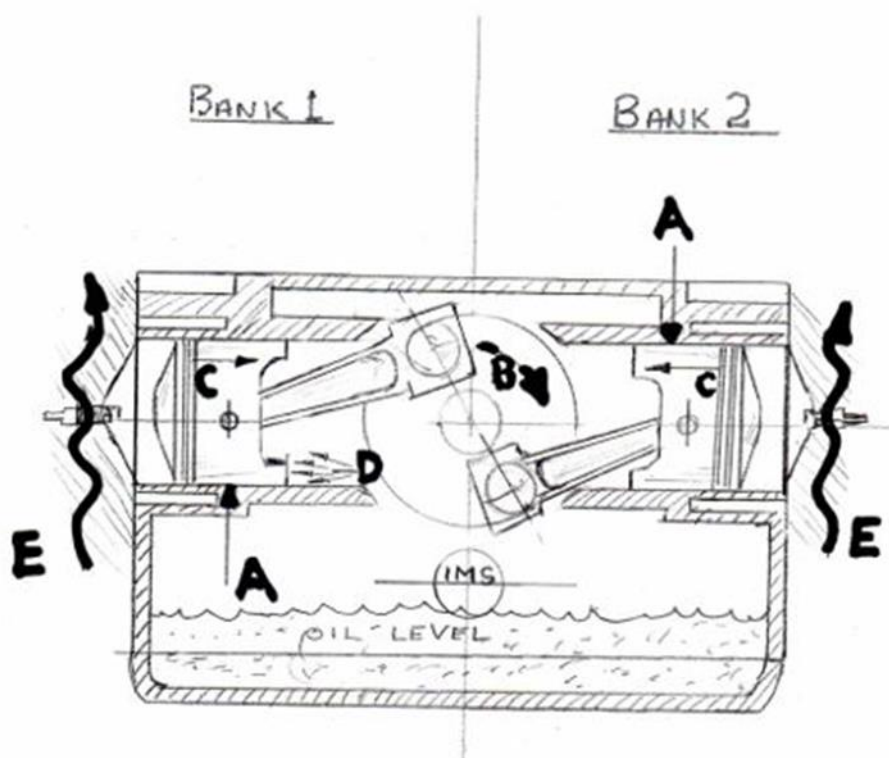
- (22) IF the resistance to scoring related to the oil film thickness then anything that made the oil on the top of bank 2 thinner than on the bottom of bank 1 would explain its inability to keep the piston and bore far enough apart to allow the released particles to float away in the gap the oil film creates for longer and that would be caused if the temperature was higher there on bank 2.
- (23) So - to find out we fitted temperature sensor inside the engines which revealed just that and it explained why because the coolant enters

the bottom of both blocks and rises to exit at the top (see picture above E). As it does so its temperature rises and the top of bank 2 (A) is the thrust face which is at the bottom of bank 1 (so the oil will always be thicker on bank 1 thrust face than bank 2 and the oil film at the same torque will always be squeezed thinner in bank 2 allowing any released particles to penetrate the piston coating on bank 2 sooner (which will also be hotter and unlike iron – will be softer with temperature rises).

- (25) This also meant that a thicker viscosity of oil would also help (especially as cars age).
- (26) As a result of these findings we advised all to use thicker oils and avoid high power take off in second in Tiptronic (to try and delay scoring) and made a 184 page report (explaining all the above in far more detail) freely available but nothing that we understand will ever eliminate it.
