**Noises in the Rear Seat Well**

Vehicle Type: **911 Turbo (996)**

Model Year: **MY 2001 (1)**

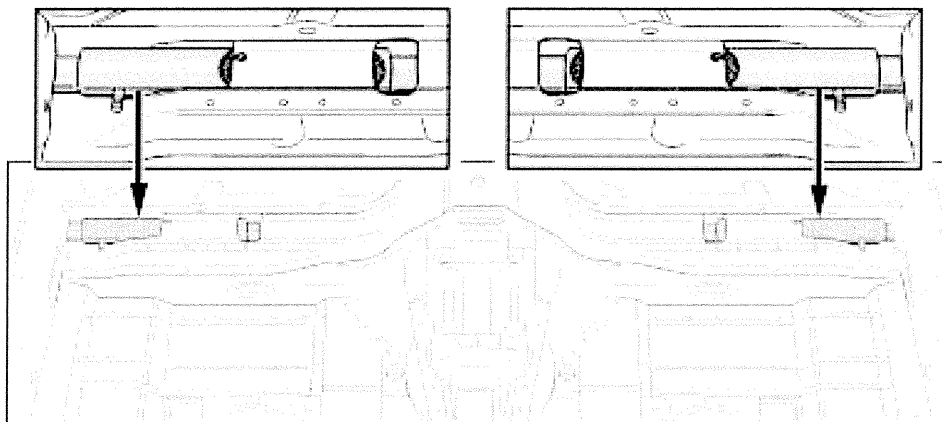
**Figure 1**

Concern: **Noises in the rear seat well area due to relative movements of the transverse reinforcement tube.**

Information: An additional transverse reinforcement tube has been installed in the rear seat well area. See figure 1. During driving the relative movement of the reinforcement tube may come into contact with the rear seat well panel. This condition may result in audible "clinking" type noises.

To eliminate the noise, felt tape has been installed in new vehicles between the reinforcement tube and the rear seat well panel. The felt tape was installed in production on May 14, 2001 from the following VIN:

If a customer complains of "clinking noises in the rear seat well area", felt tape can be installed on vehicles that fall within the VIN range indicated above.

Parts:	<b>Part Number</b>	<b>Description</b>
	999 551 140 40	Felt tape (45 x 35 x 5mm). Up to 4 pieces of felt tape may be required.
