PKD Transmission Diagnosis: Symptoms and Repair Procedures (35/09)

Vehicle Type:	Boxster (987)/Boxster S (987) Cayman/Cayman S
Model Year:	As of 2009
Equipment:	Porsche Doppelkupplung (PDK) – I-no. 250
Concerns:	PDK transmission/control unit for PDK transmission
Information:	Procedure and repair measures in the event of complaints relating to PDK: <ul style="list-style-type: none"> • Gearbox emergency operation/other warning messages • Fault memory entries in the fault memory of the PDK control unit • Leaks on the PDK transmission • Complaints relating to comfort • Complaints relating to noises

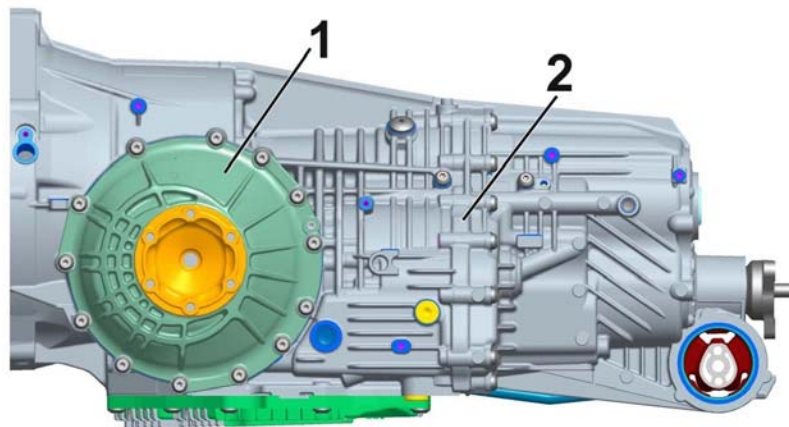
Figure 1

Item	Designation	Possible cause(s)	Remedial action
1	Leaks in the short halfshaft flange/differential area ⇒ <i>Figure 1 -Pos. 1-</i> FES5: 3922L – Sealing ring for halfshaft flange, left	Sealing ring for short halfshaft flange damaged	Replace sealing ring ⇒ <i>Workshop Manual '392219 Removing and installing sealing ring for short halfshaft flange'</i>
		Housing cover seal damaged	Replace PDK transmission ⇒ <i>Workshop Manual '373419 Removing and installing Porsche Doppelkupplung (PDK)'</i>
		Housing screws loose	
2	Leaks at the threaded joint between rear part of housing and clutch housing ⇒ <i>Figure 1 -Pos. 2-</i> FES5: 37343 - Gear housing seal	Seal damaged	Replace PDK transmission ⇒ <i>Workshop Manual '373419 Removing and installing Porsche Doppelkupplung (PDK)'</i>
		Housing screws loose

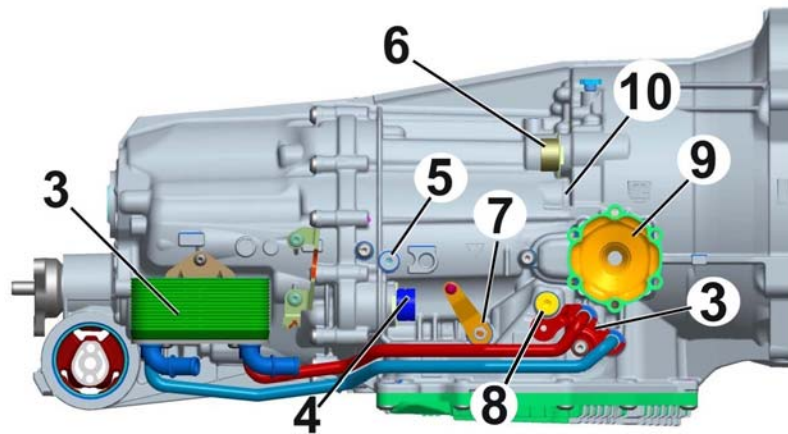
Figure 2

3	Leaks in the oil cooler area or around the oil lines for the oil cooler ⇒ <i>Figure 2 -Pos. 3-</i> FES5: 3862R - ATF line for oil cooler, return FES5: 3862V - ATF line for oil cooler, supply FES5: 38600 - ATF cooler	Retaining brackets for oil lines loose/O-rings on oil lines for oil cooler damaged.	Replace retaining brackets or O-rings on the oil lines for the oil cooler ⇒ <i>Workshop Manual '386219 Removing and installing lines for ATF cooler'</i> .
		Oil line damaged	Replace oil line for the oil cooler ⇒ <i>Workshop Manual '386219 Removing and installing lines for ATF cooler'</i> .
		Oil cooler leaking	Replace oil cooler ⇒ <i>Workshop Manual '386019 Removing and installing ATF cooler'</i>
4	Leaks at the sensor connector (16-pin) ⇒ <i>Figure 2 -Pos. 4-</i> FES5: 37344 - Porsche Doppelkupplung (PDK) connector	O-ring damaged	Replace PDK transmission ⇒ <i>Workshop Manual '373419 Removing and installing Porsche Doppelkupplung (PDK)'</i>

Connector leaking	
5	Oil leak from bleeder screw ⇒ <i>Figure 2 -Pos. 5-</i> FES5: 3734A - Hydraulic-oil inspection plug	Radial shaft seal on mounting for drive shaft 1/drive shaft 2 damaged	Replace PDK transmission ⇒ <i>Workshop Manual '373419 Removing and installing Porsche Doppelkupplung (PDK)'</i>
6	Leaks at the sensor connector (20-pin) ⇒ <i>Figure 2 -Pos. 6-</i> FES5: 37344 - Porsche Doppelkupplung (PDK) connector	O-ring damaged	Replace PDK transmission ⇒ <i>Workshop Manual '373419 Removing and installing Porsche Doppelkupplung (PDK)'</i>
		Connector leaking	
7	Leak around the parking lock ⇒ <i>Figure 2 -Pos. 7-</i> FES5: 37330 - Selector-shaft sealing ring	O-ring damaged	Replace O-ring ⇒ <i>Workshop Manual '373319 Removing and installing sealing ring for parking lock shaft'</i>

8	<p>Leak close to the oil filler screw for clutch fluid ⇒ <i>Figure 2 -Pos. 8-</i></p> <p>FES5: 3734C - PDK transmission filler screw</p> <p>FES5: 3734D - PDK transmission drain plug</p>	<p>Replace oil filler screw for clutch fluid and sealing ring</p>	<p>Replace oil filler screw and sealing ring, correct oil level ⇒ <i>Workshop Manual '370235 Checking and topping up ATF (clutch fluid)'</i></p>
9	<p>Leak in the flanged shaft/long halfshaft flange area ⇒ <i>Figure 2 -Pos. 9-</i></p> <p>FES5: 3922R - Sealing ring for halfshaft flange, right</p>	<p>Radial shaft seal damaged Halfshaft flange seal damaged Housing screw on halfshaft flange loose</p>	<p>Replace PDK transmission ⇒ <i>Workshop Manual '373419 Removing and installing Porsche Doppelkupplung (PDK)'</i></p>
10	<p>Oil leak from inspection bore (centring plate) ⇒ <i>Figure 2 -Pos. 10-</i></p> <p>FES5: 37348 - Inspection bore on centring plate</p>	<p>Radial shaft seal on drive shaft 2 – centring plate damaged</p>	<p>Replace PDK transmission ⇒ <i>Workshop Manual '373419 Removing and installing Porsche Doppelkupplung (PDK)'</i></p>

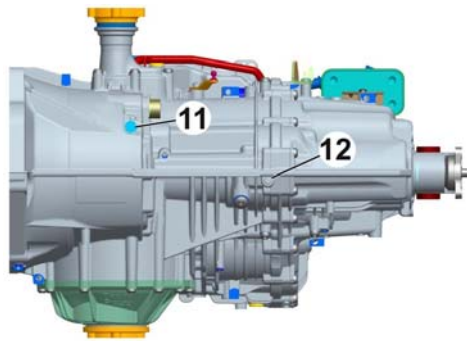
Figure 3

11	Oil leak from the hydraulic space bleeder ⇒ <i>Figure 3</i> -Pos. 11- FES5: 3747H - Hydraulic space bleeder	Oil over-filled	<p>Check clutch fluid level and transmission oil level ⇒ <i>Workshop Manual '370235 Checking and topping up ATF (clutch fluid)'</i> and ⇒ <i>Workshop Manual '399035 Checking and topping up oil for final drive (with transmission oil)'</i></p> <p>If the clutch fluid level is too high and the transmission oil level is OK, correct the clutch fluid level as required.</p> <p>If the clutch fluid level is too high and the transmission oil level is too low (>= 500 ml), check the PDK transmission for leaks (e.g. around the oil filler screw or oil drain plug for transmission oil) and repair it.</p> <p>If no leaks are found, replace the PDK transmission ⇒ <i>Workshop Manual '373419 Removing and installing Porsche Doppelkupplung (PDK)'</i></p>
		Not enough anti-foam additive in clutch fluid	<p>Check clutch fluid level and transmission oil level ⇒ <i>Workshop Manual '370235 Checking and topping up ATF (clutch fluid)'</i> and ⇒ <i>Workshop Manual '399035 Checking and topping up oil for final drive (with transmission oil)'</i>.</p> <p>If both oil levels are OK, change the clutch fluid. Follow the instructions on the container (shake, stir) ⇒ <i>Workshop Manual</i></p>

12	<p>Oil leak from the gearwheel set space bleeder ⇒ <i>Figure 3 -Pos. 12-</i></p> <p>FES5: 3734R - Gear housing bleeder</p>	Oil over-filled	<p>'370255 Changing ATF (clutch fluid)'.</p> <p>Check clutch fluid level and transmission oil level ⇒ <i>Workshop Manual '370235 Checking and topping up ATF (clutch fluid)'</i> and ⇒ <i>Workshop Manual '399035 Checking and topping up oil for final drive (with transmission oil)'</i></p> <p>If the clutch fluid level is OK and the transmission oil level is too high, correct the transmission oil level as required.</p> <p>If the clutch fluid level is too low and the transmission oil level is too high (>= 500 ml), check the PDK transmission for leaks (e.g. around the oil filler screw or oil drain plug for clutch fluid) and repair it.</p> <p>If no leaks are found, replace the PDK transmission ⇒ <i>Workshop Manual '373419 Removing and installing Porsche Doppelkupplung (PDK)'</i></p>

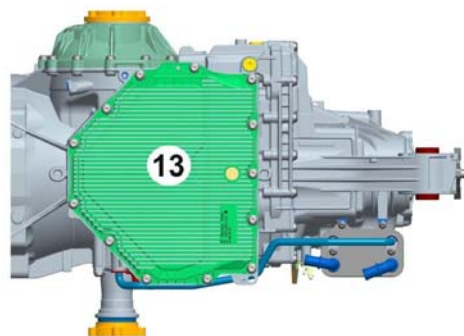
Figure 4

13	Leak around the oil pan/oil drain plug ⇒ <i>Figure 4</i> -Pos. 13- FES5: 37550 – ATF pan FES5: 37560 – Seal for ATF pan	Information	
		Traces of oil around the oil pan seal must only be classified as a “leak” if droplets are clearly visible . A suspected leak can be caused by an ATF check or ATF top-up carried out earlier. To check this, refer to the vehicle documents or the vehicle history. In this case, only clean around the oil pan seal. For more information, see also ⇒ <i>Technical Information '373400 Leak around the ATF oil pan on PDK transmission (35/11)'</i>	
		Traces of oil after opening the hydraulic space	Clean the oil pan
		Fastening screws on oil pan loose/oil pan seal damaged	Replace oil pan and fastening screws ⇒ <i>Workshop Manual '375519 Removing and installing ATF pan'</i>
		Oil drain plug for clutch fluid loose or leaking	Replace oil drain plug, correct oil level ⇒ <i>Workshop Manual '370235 Checking and topping up ATF (clutch fluid)'</i>

Oil drain plug for gearwheel set oil loose or leaking	Replace oil drain plug, correct oil level ⇒ <i>Workshop Manual '399035 Checking and topping up oil for final drive (with transmission oil)'</i>

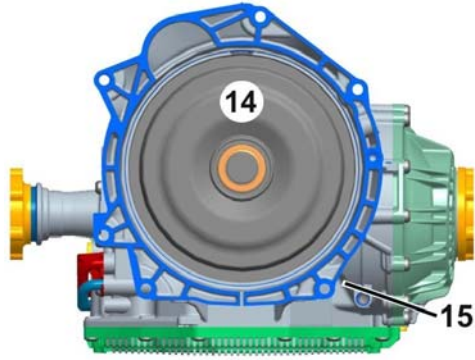
14	Leak around the clutch bell-housing ⇒ <i>Figure 5</i> -Pos. 14- FES5: 37530 - Seal for transmission housing	Apparent preservative grease leak	Check whether the leaking fluid is preservative grease or oil. If residual grease is leaking out, no further measures are required.
		Engine leaking	Find and repair leaks on the engine.
		Radial shaft seal on coupling hub damaged	Replace radial shaft seal ⇒ <i>Workshop Manual '386919 Removing and installing radial shaft seal on Porsche Doppelkupplung (PDK)'</i>
		O-ring on clutch cover damaged	Replace PDK transmission ⇒ <i>Workshop Manual '373419 Removing and installing Porsche Doppelkupplung (PDK)'</i>
15	Oil leak from inspection bore for differential ⇒ <i>Figure 5</i> -Pos. 15- FES5: 37349 - Inspection bore for differential	Radial shaft seal on differential damaged	Replace PDK transmission ⇒ <i>Workshop Manual '373419 Removing and installing Porsche Doppelkupplung (PDK)'</i>

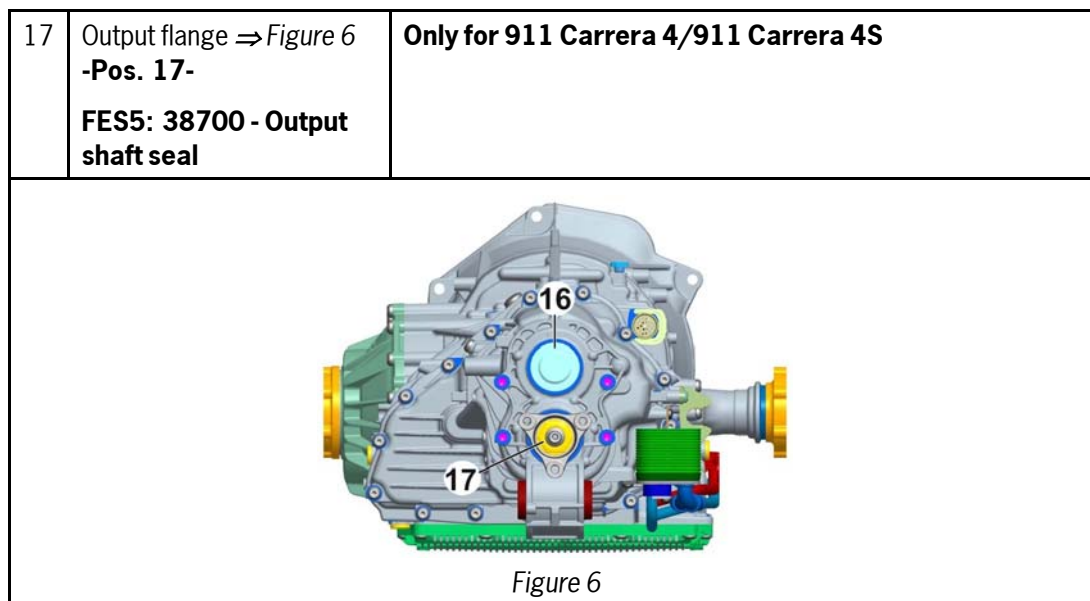
<p><i>Figure 5</i></p>			
16	Leak in the assembly cover area ⇒ <i>Figure 6</i> -Pos. 16-	Assembly cover damaged	Replace assembly cover ⇒ <i>Workshop Manual '375019 Removing and installing assembly cover'</i>
