TEST REPORT

Report Number 201620251 – Revision 4 (Updated grain flow analysis)

Material Identity
Aluminum Wheel

Wheel
RTM

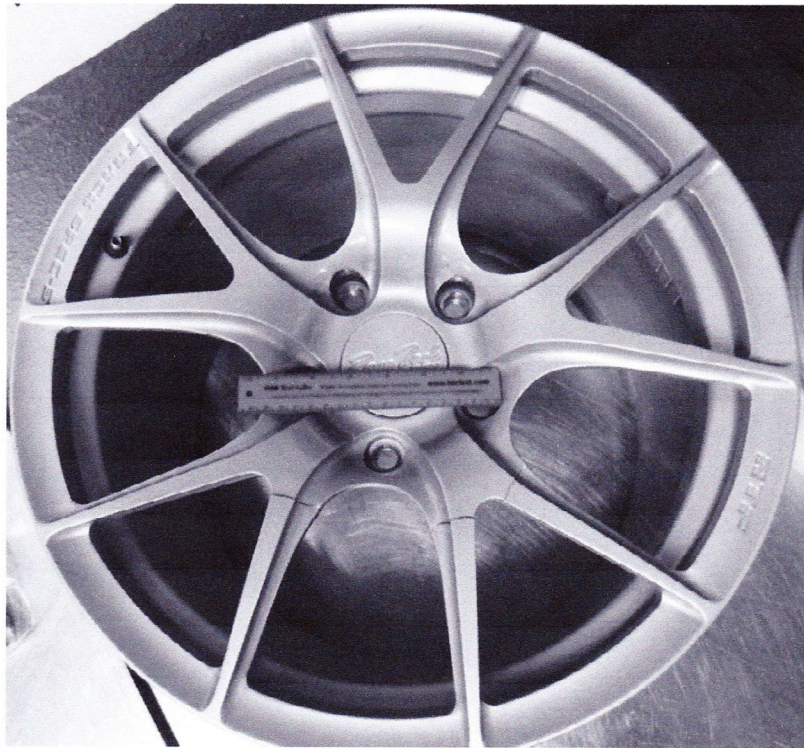
Gary
Everest's
Wheel
with 3
broken
spokes

Figure 1: Macro photograph showing as received **Fractured Sample**.

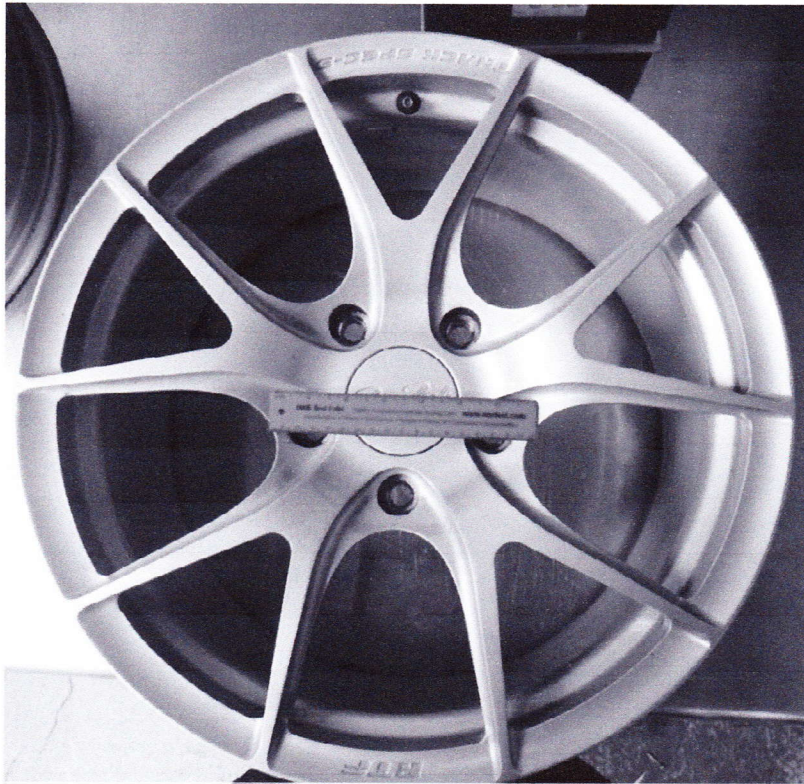
Figure 2: Macro photograph showing as received **Non-Fractured Sample**.

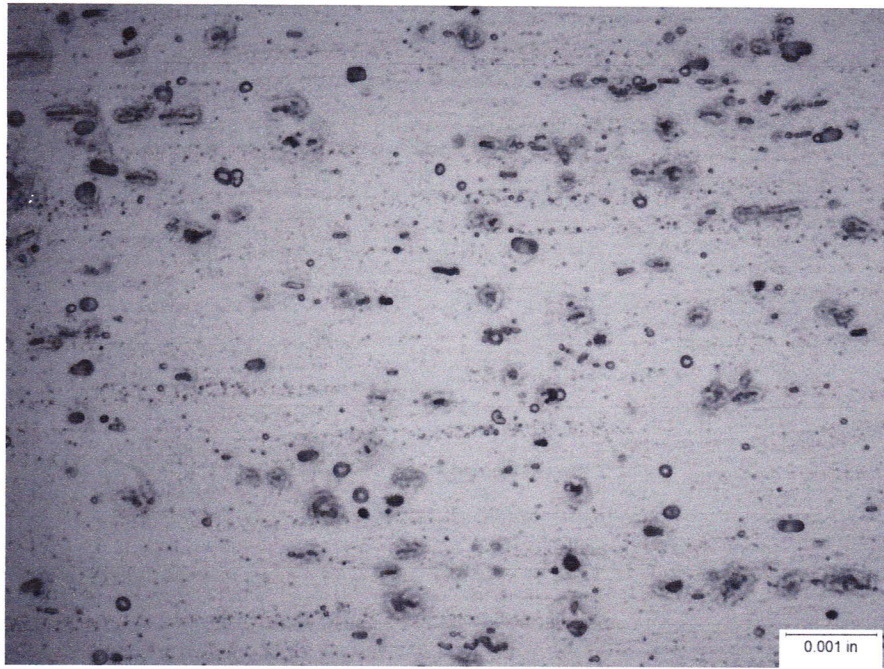
A section from the Rear Wheel was mounted, metallographically prepared, etched using Weck's and examined at 500X magnification. The microstructure shows particles of MgSi in a matrix of aluminum solid solution. No grains were observed.

Manganese
and silicon
particles
in metal

Normal
for
6061

Figure 3: Representative photomicrograph of Rear Wheel (20251-MET) taken at the core. Weck's. Original magnification 500X.

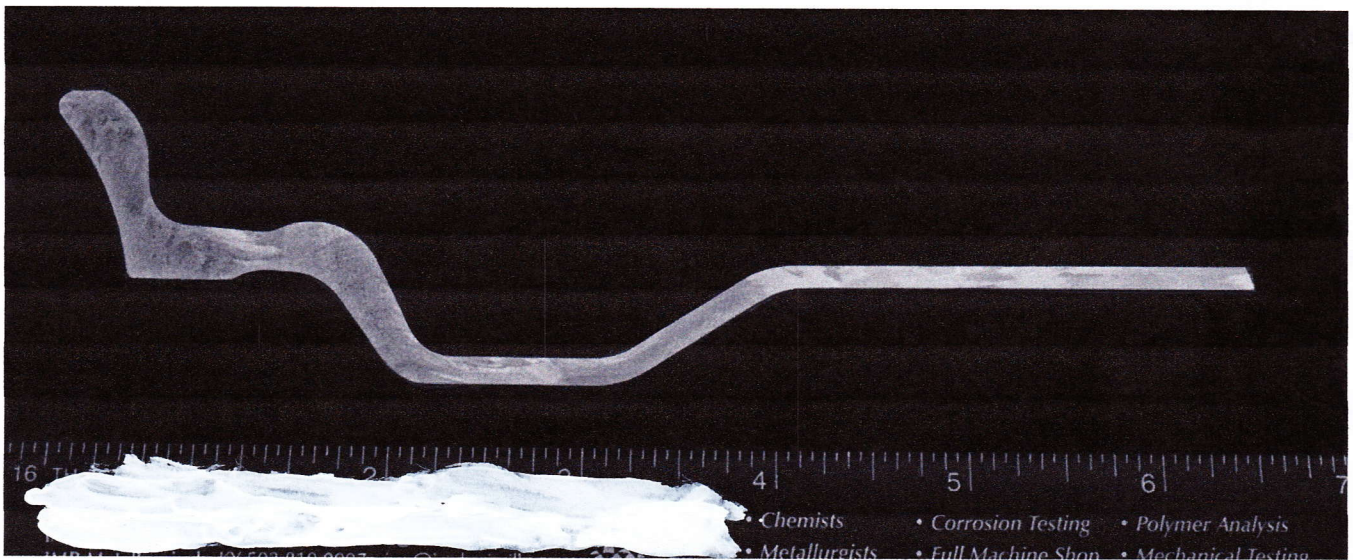
"Grain flow" appears in all forged monoblock wheels

The sample was metallographically prepared and etched using Kroll's. No grain flow was observed. No reentrant grain flow was observed. The lack of grain flow is normally observed in cast metals. The part appears to have been machined after casting and shows no signs of forging.

Figure 4: Macro photograph showing grain flow. Kroll's.

^
lack of
