W902 - Reworking Adjustment Mechanism for Variable Turbine Geometry (VTG) (Workshop Campaign)

Vehicle Type: **911 Turbo (997)/911 GT2 (997)**

Model Year: **As of 2007 up to 2009**

Concerns: **Adjustment mechanism for Variable Turbine Geometry (VTG).**

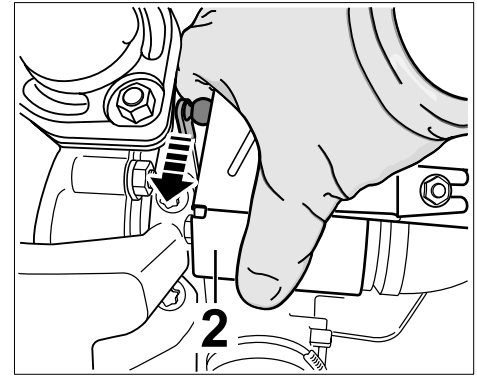
To do this, press the actuating rod at the bottom ball joint down firmly as far as possible with your fingers as shown in ⇒ Figure 4 (⇒ Figure 4 -arrow-). Support your hand on the heat shield (⇒ Figure 4 -item 2-) using your thumb while doing this. Then let go of the actuating rod.

The movement of the adjustment mechanism is OK if the actuating rod can be pressed down and goes back to its original position again when you let it go.

On the turbocharger on the left in direction of travel, the amount of force required for moving the adjustment mechanism down is found to be considerably higher than on the right side of the vehicle due to kinematics and restricted access.

However, this is **not** an indication of a stiff adjustment mechanism.

2.4 **If**, contrary to expectations, the actuating rod in the adjustment mechanism on one or both turbochargers **cannot** be moved or does **not** go back to its original position when you let it go, the affected turbochargers must be replaced ⇒ *Workshop Manual '213019 Removing and installing turbocharger'*.
