**W902 - Reworking Adjustment Mechanism for Variable Turbine Geometry (VTG) (Workshop Campaign)**

Vehicle Type: **911 Turbo (997)/911 GT2 (997)**

Model Year: **As of 2007 up to 2009**

Concerns: **Adjustment mechanism for Variable Turbine Geometry (VTG).**

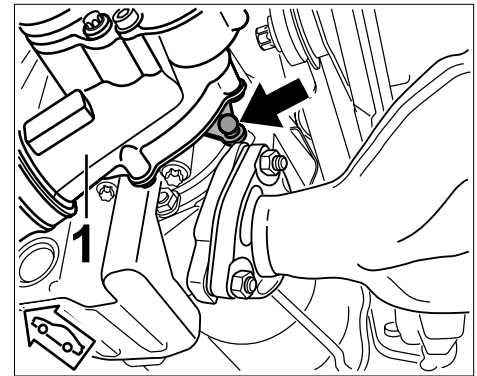
Figure 1

- 2.1 On the turbocharger on the **right** in direction of travel (⇒ *Figure 1 -item 1-*), check that the adjustment mechanism (⇒ *Figure 1 -arrow-*) can be moved freely.

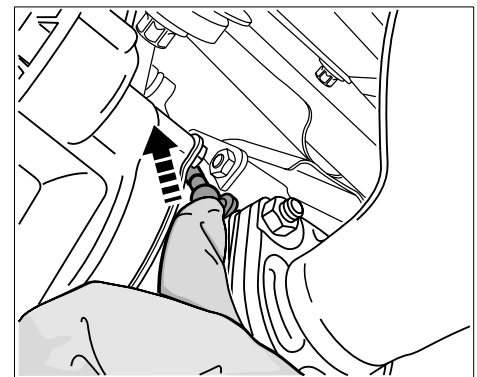
Figure 2

To do this, press the actuating rod in the adjustment mechanism at the bottom ball joint up as far as possible with your finger as shown in ⇒ *Figure 2* (⇒ *Figure 2 -arrow-*). Then let go of the actuating rod.

The movement of the adjustment mechanism is OK if the actuating rod can be pressed up and goes back to its original position again when you let it go.

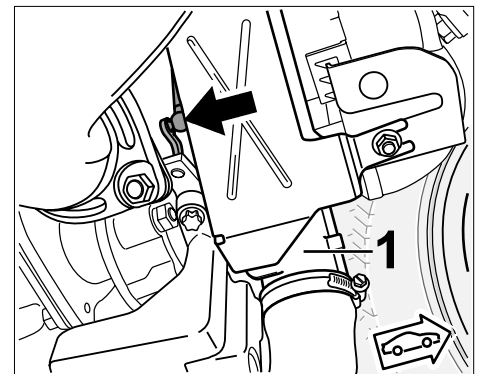
Figure 3

- 2.2 On the turbocharger on the **left** in direction of travel (⇒ *Figure 3 -item 1-*), check that the adjustment mechanism (⇒ *Figure 3 -arrow-*) can be moved freely.

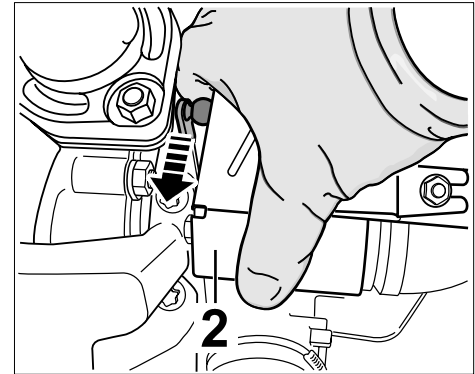
To do this, press the actuating rod at the bottom ball joint down firmly as far as possible with your fingers as shown in ⇒ Figure 4 (⇒ Figure 4 -arrow-). Support your hand on the heat shield (⇒ Figure 4 -item 2-) using your thumb while doing this. Then let go of the actuating rod.

The movement of the adjustment mechanism is OK if the actuating rod can be pressed down and goes back to its original position again when you let it go.
