Auto Assets Inspection Report

Customer:	Evan Adwar	License:	
Vehicle:	2007 Porsche 911 Turbo, 5-Speed Automatic, RWD, 3.6L H6 DOHC 24V TURBO	VIN:	WP0AD29917S783317
Inspection date:	12/22/2020	Odometer:	31,948 miles
Repair Order:	62088	Last Visit:	12/22/2020

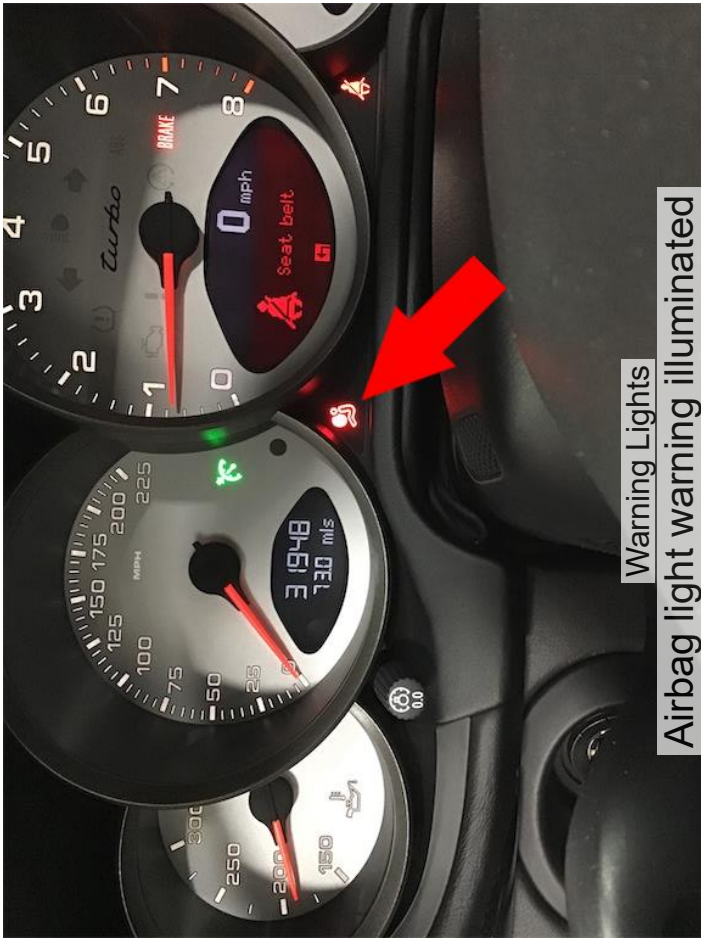
Road Test	Observation	Recommended Action
Warning Lights	Air Bag <i>Notes:</i> Air Bag Light is present and will not clear	Diagnostic Check
Clutch Engagement	Not Applicable <i>Notes:</i> Clutch is very stiff on start up. Assume clutch accumulator failure. Replace accumulator.	Repair
Engine Performance	Shakes <i>Notes:</i> Slight rpm drop and harshness on start up. Ignition coils old style and starting to crack.	Diagnostic Check
Under Hood	Observation	Recommended Action
Engine Coolant	Low <i>Notes:</i> Coolant low. Note that there was still a lot of pressure in system even after 1.5 hours of sitting. Top up and monitor.	Adjust Level
Drive Belts	Glazed <i>Notes:</i> Drive belt aged and glazed. Replace	Replace
Radiator	Packed With Debris <i>Notes:</i> LF radiator packed with debris. Note that a coolant smell was detected from the front	Radiator Cleaning

Warning Lights
Airbag light warning illuminated

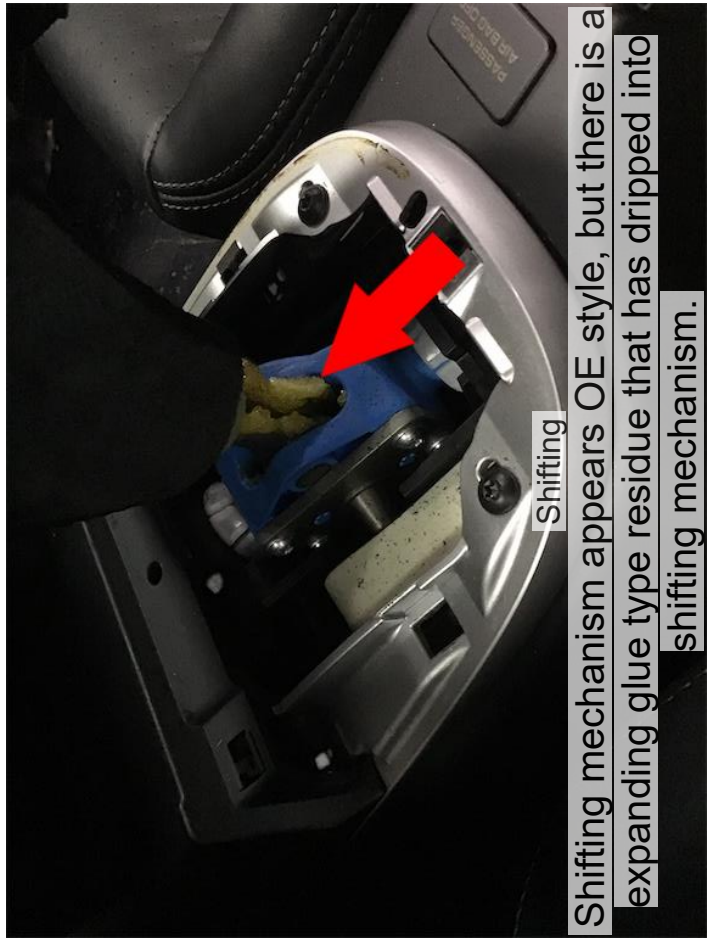
Road Test	Observation	Recommended Action
Shifting	Delay <i>Notes:</i> 2nd gear is difficult to engage. Shifting mechanism appears OE. Shifting mechanism appears OE style, but there is a expanding glue type residue that has dripped into shifting mechanism.	Note For Future Follow Up
In Car	Observation	Recommended Action
Air Conditioning/Heater	<i>Notes:</i> Popping noise from dash on initial start up	
Under Hood	Observation	Recommended Action
Power Steering Fluid	Low <i>Notes:</i> Power steering fluid is slightly low, level needs to be adjusted	Adjust Level

Shifting
Shifting mechanism appears OE style, but there is a expanding glue type residue that has dripped into shifting mechanism.

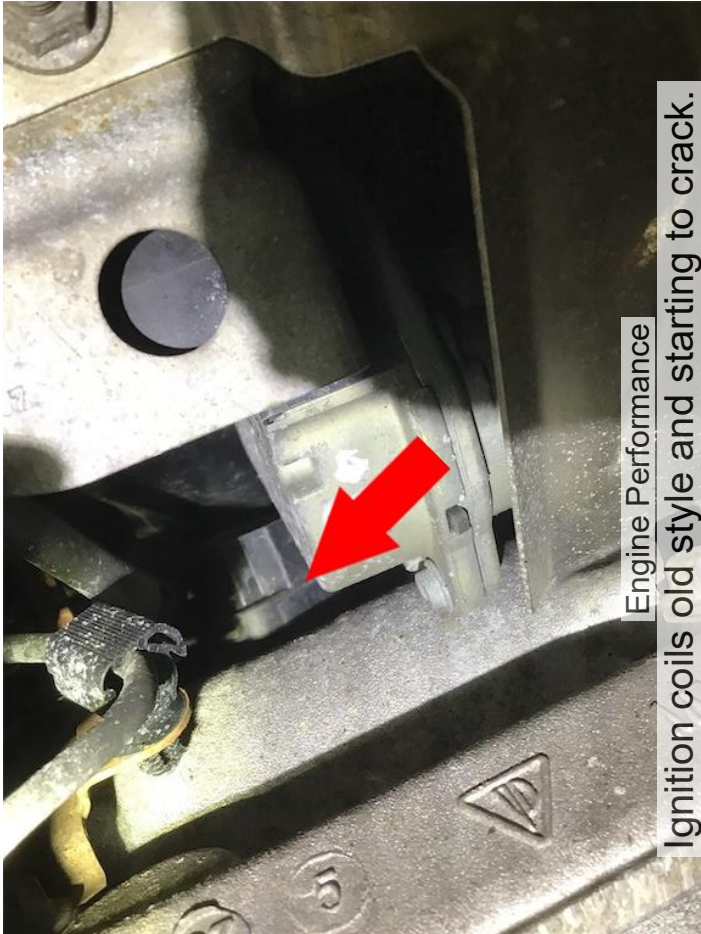
Engine Performance
Ignition coils old style and starting to crack.

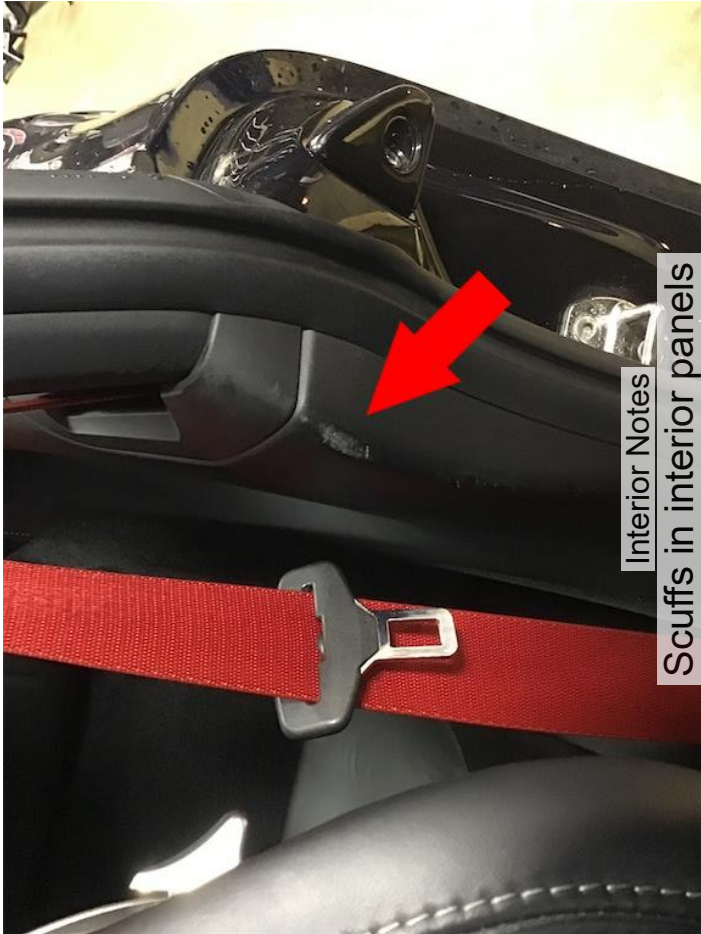
Interior Notes
Scuffs in interior panels

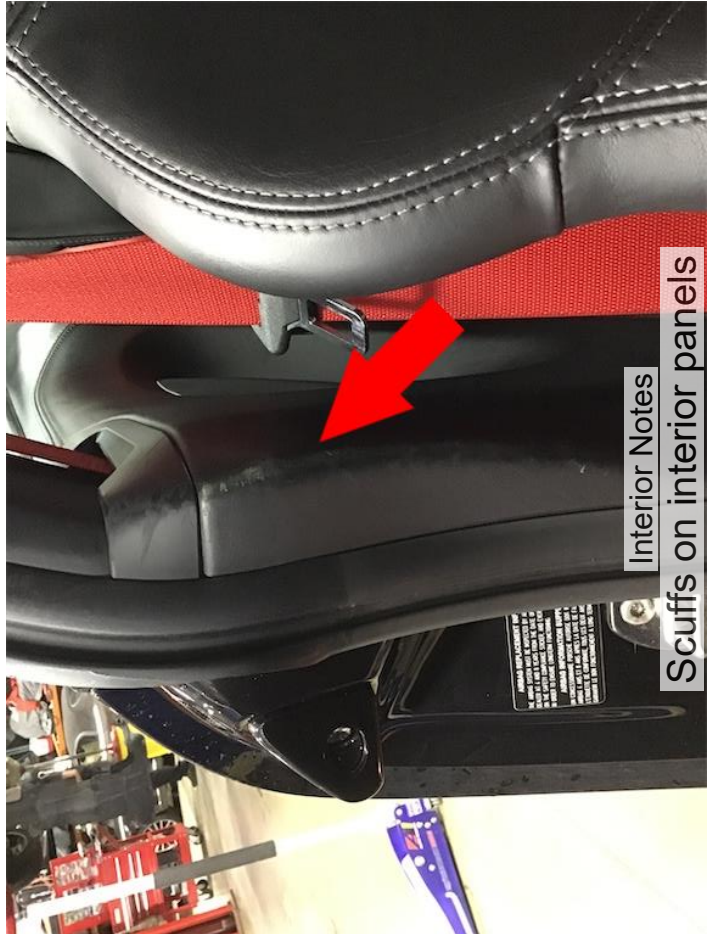
Interior Notes
Scuffs on interior panels

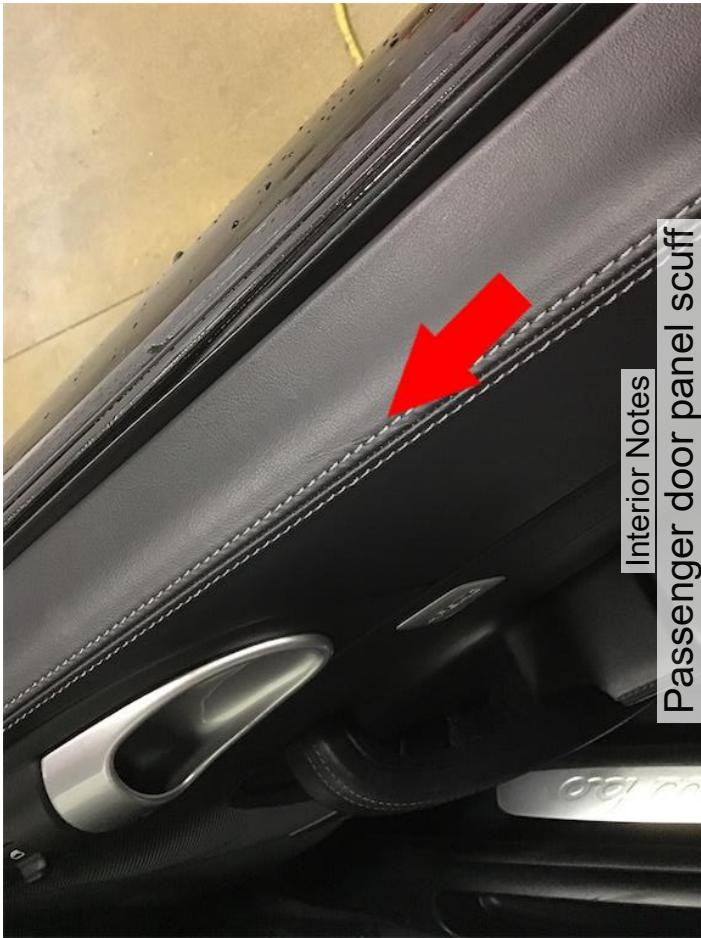
Interior Notes
Passenger door panel scuff

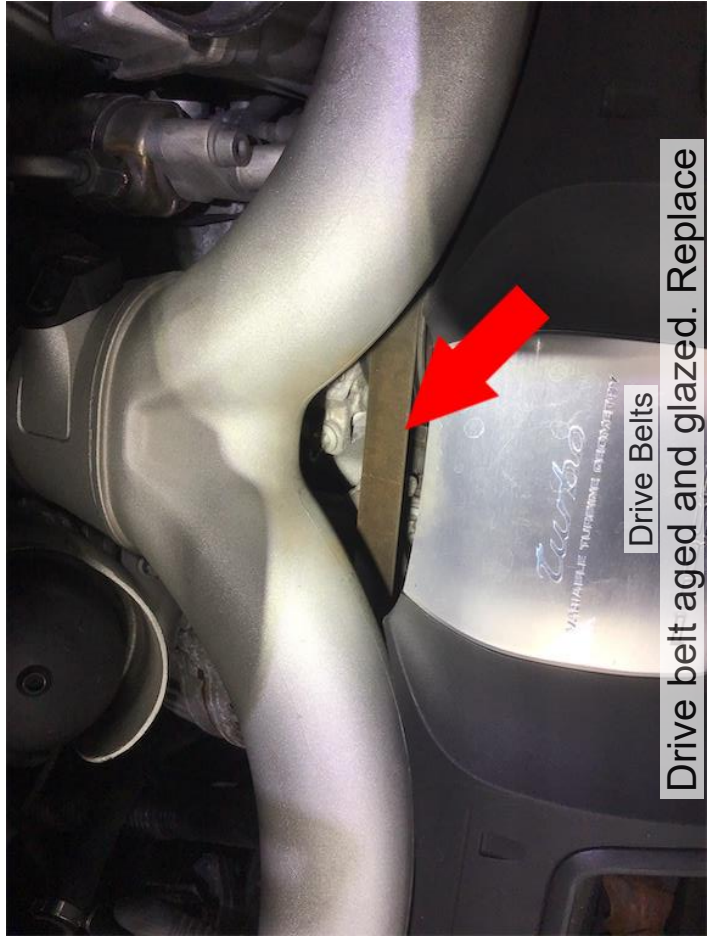
Drive Belts

Drive belt aged and glazed. Replace.

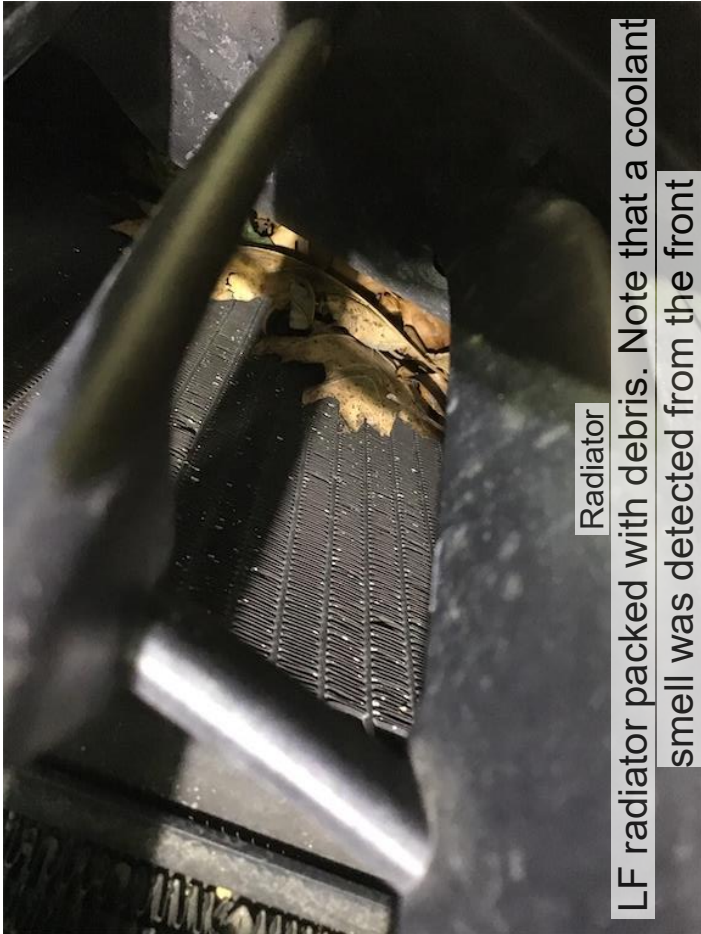
Radiator

LF radiator packed with debris. Note that a coolant smell was detected from the front

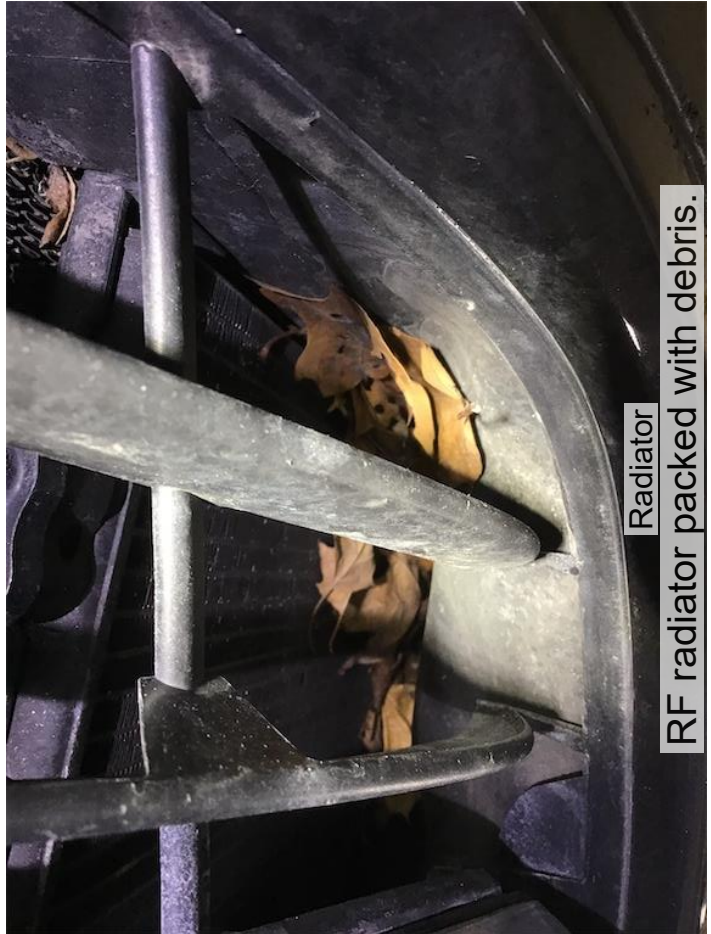
Radiator

RF radiator packed with debris.

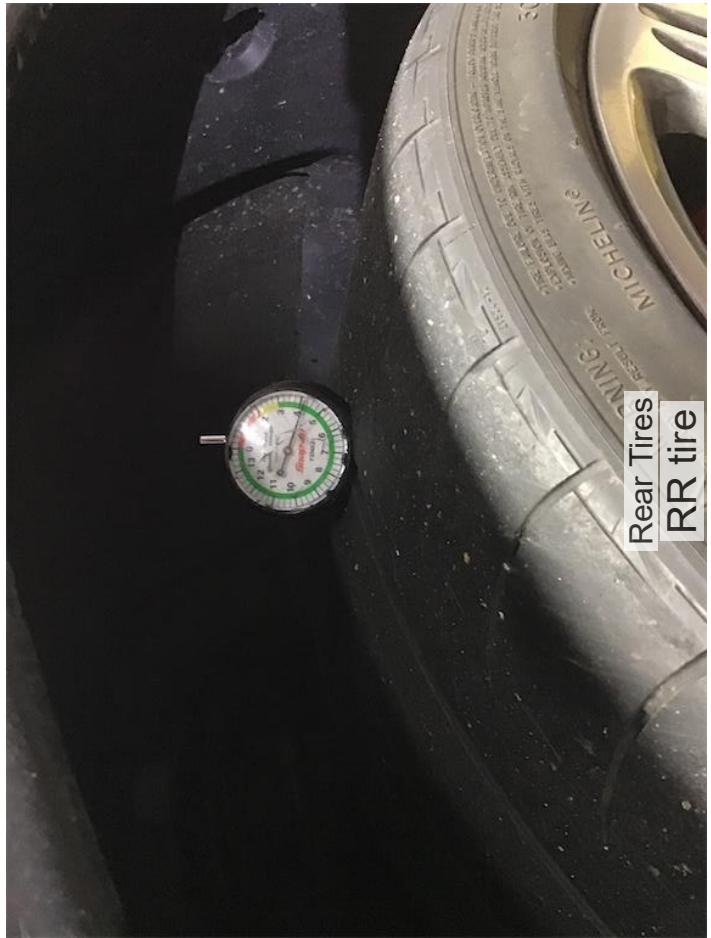
Rear Tires
RR tire

Rear Tires
RR tire made in 2013

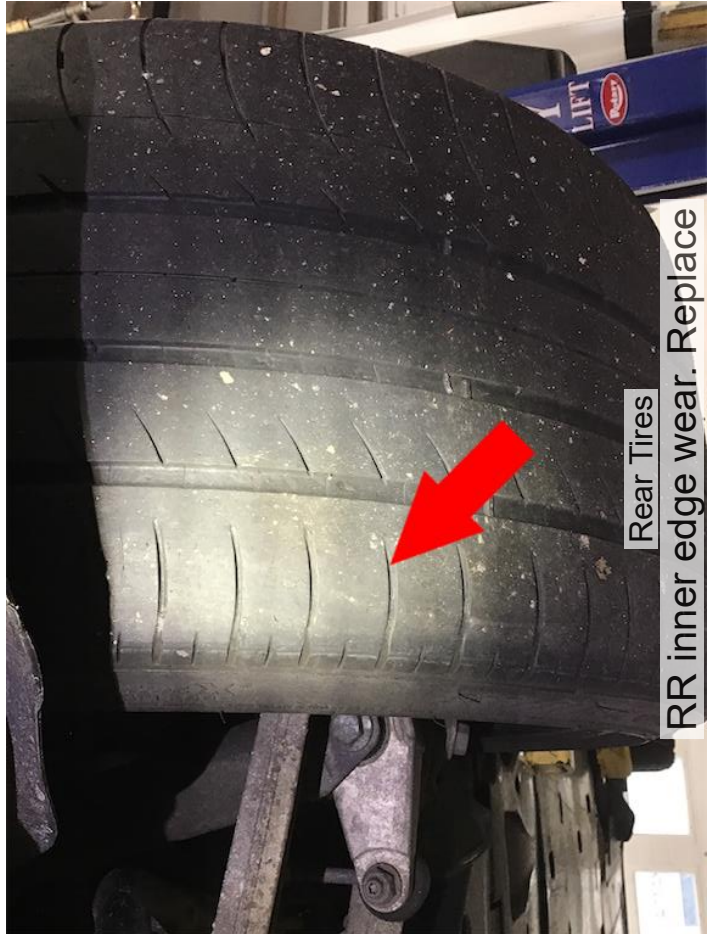
Rear Tires
RR inner edge wear. Replace

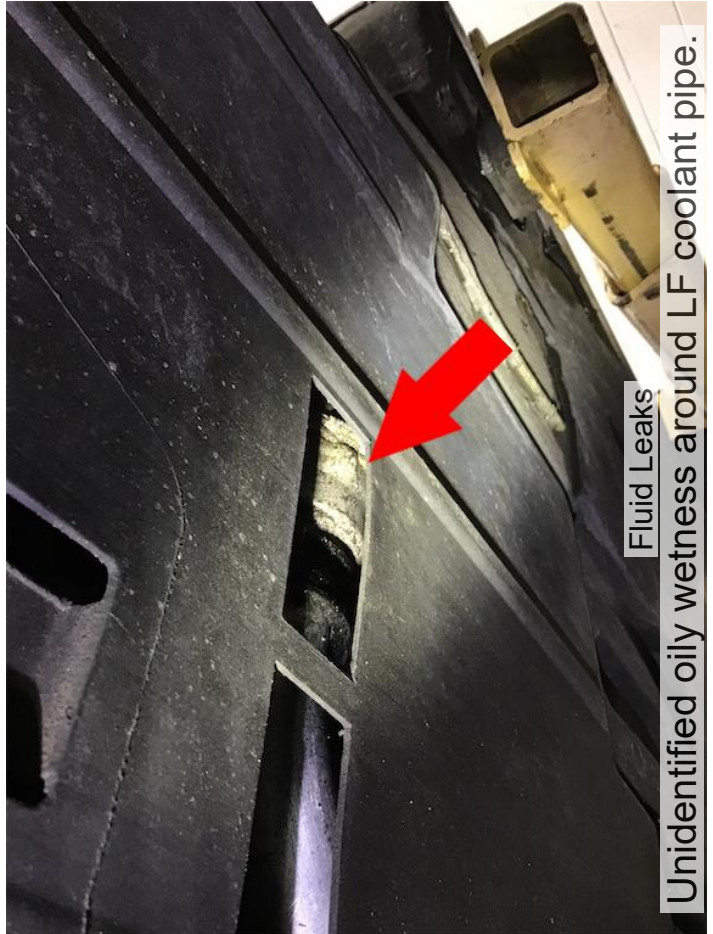
Fluid Leaks	<p>Other</p> <p><i>Notes:</i> Unidentified oily wetness around LF coolant pipe. Underbody of the car will need cleaned down in order to pinpoint the source of the leak</p>	<p>Diagnose</p>

Fluid Leaks
Unidentified oily wetness around LF coolant pipe.
