Noise Symptom/Jerking - Clicking Noise/Rough-Running Engine/Jerking Under Load With Respect to Transfer Case: Programming all-wheel drive control unit/checking transfer case (SY 84/17)

Model Year: **As of 2011 up to 2017**

Vehicle Type: **Cayenne (VR6 - 92A)/Cayenne S (92A)/Cayenne GTS (92A)/Cayenne Turbo (92A)/Cayenne Turbo S (92A)**

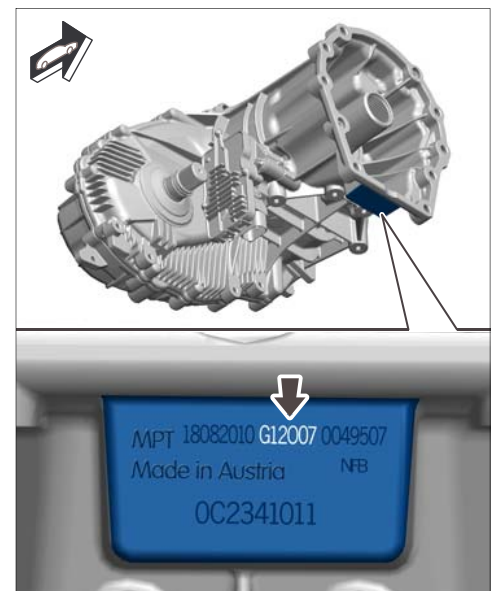
Classification data for transfer case

- If the transfer case with servo motor (control unit) is replaced, there is no need to reload data (classification data).
- This data is already contained in the control unit for servo motor and transmission bundle replacement.
- Classification data can be read out of the control unit using the PIWIS Tester (see "Actual values" tab)
- If only the servo motor is replaced, the classification data must be re-written into the control unit.
- Classification data can be found on the transfer case housing.
