**Noise Symptom - Rattling Noises from Engine Compartment (SY 120/19)**

Vehicle Types: **Panamera (971)/Panamera 4 (971)/Panamera 4S (971)/Panamera 4 E-Hybrid (971)/Panamera 4 Sport Turismo (971)/Panamera 4S Sport Turismo (971)/Panamera 4 E-Hybrid Sport Turismo (971)**

Model Year: **As of 2017 up to 2019**

Subject: **High-pressure pump or balance shaft bracing wheel**

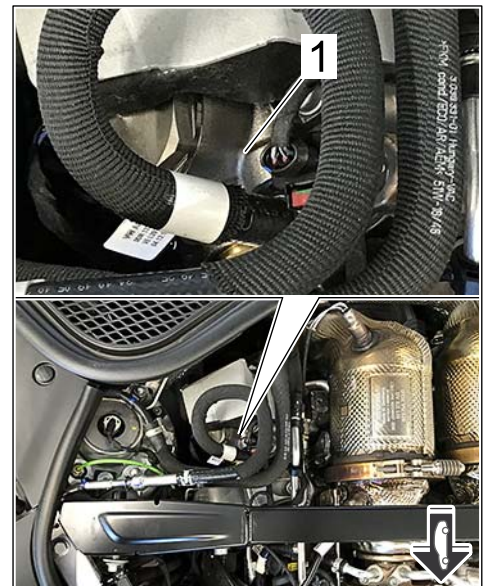
*Contact point on high-pressure pump*

If you can clearly hear the rattling noise at ⇒ *Contact point on high-pressure pump -1-*, stop the engine and continue with Step 3.

- 3 Replace high-pressure pump, see ⇒ *Workshop Manual '246319 Removing and installing high-pressure pump (V6 Turbo)'*
- 4 Replace balance shaft bracing wheel, see ⇒ *Workshop Manual '138019 Removing and installing balance shaft bracing wheel (V6 Turbo)'*

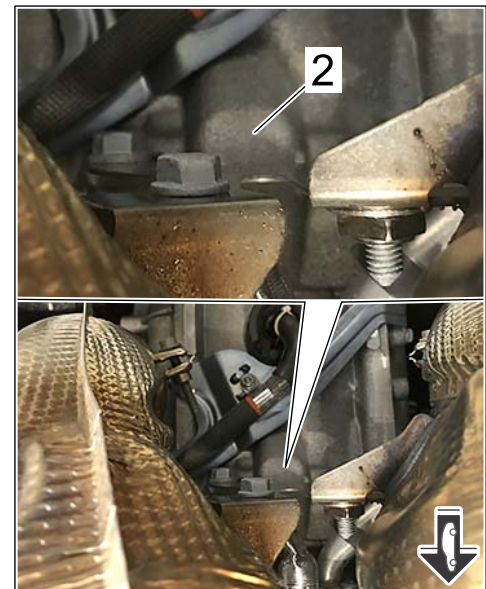
Contact point on engine housing

If you can clearly hear the rattling noise at ⇒ *Contact point on engine housing -2-*, stop the engine and continue with Step 4.
