Technical Report for Automotive Structural Failure

**Written by:
Global Technology Experts**

January 2, 2012

GTE was retained by Ms. Lisa Moore (owner) to inspect a 2012 Porsche Panamera (VIN number WP0AD2A71CL045354) that was significantly damaged while being towed onto a flatbed truck. A summary of the accident from supplied information is as follows:

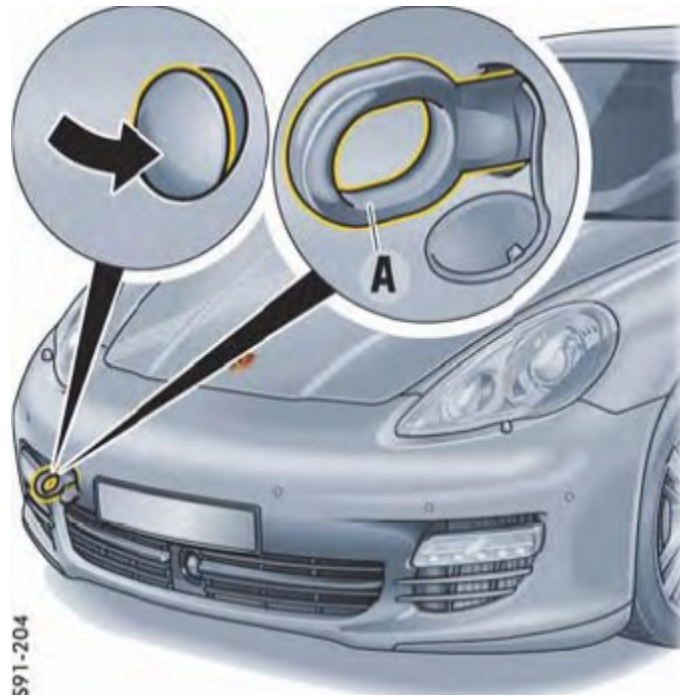
- B.** During front-end towing high multidirectional forces exist in the towing lug and the frame. The design of the Porsche Panamera allows for front end towing. A depiction from the owner’s manual can be seen below:

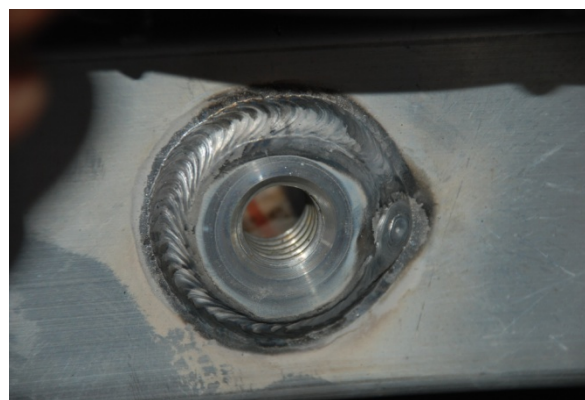
However, inspection of the tow plate indicated that the tow plate welds did not distort or fracture. It is our opinion that the complex state of stress involved in towing were transmitted to the compromised frame rails, which did fracture, causing the bumper assembly (and related front-end components) to catastrophically fail. Therefore, the weakest points in the system were the frame rail welds. A photograph showing that the weld holding towing plate was intact and did not sustain any damage can be seen below:

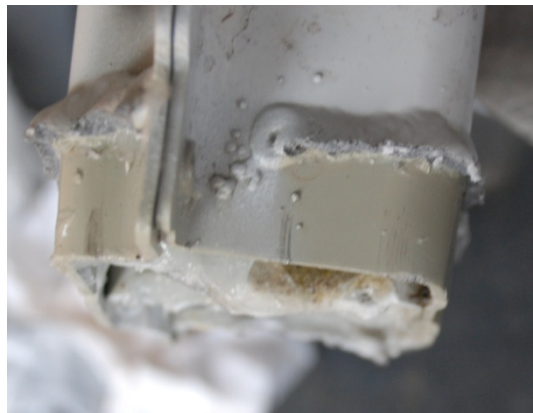
- C. From the supplied information, the welding process employed to join the bumper assembly flange to the frame rails is not known. However there are three ways that automobile companies routinely weld aluminum. The common methods are: Gas Tungsten Arc welding [Ref. 1], Laser welding [Ref. 2] and Delta Spot welding [Ref. 3] used in the Porsche Panamera. In aluminum welding of automotive components, base metal cleanliness is extremely essential. Base metal contamination was observed at the welded surface, as seen in the photograph below. Contamination affects the weld quality by reducing the strength of the weld. It causes incomplete or lack of fusion as impurities react with air to form oxides within the weld. The photograph below shows an example where the right frame rail appears to be painted adjacent to the weld.

- D. It appears that the welding and quality control standards were not maintained in the manufacturing of Panamera 2012 S Hybrid. The standards applicable to aluminum welding can be found in [ref. 5]. The base metal surface preparation deficiencies should be typically identified earlier in automotive manufacturer's aluminum welding quality control procedures. It is evident from inspection of a newer Porsche Panamera (loaner 2013 base model) that the weld quality seems to be much better. It appears that they might have improved the welding process as well as inspection protocol prior to the 2013 Panamera being manufactured.

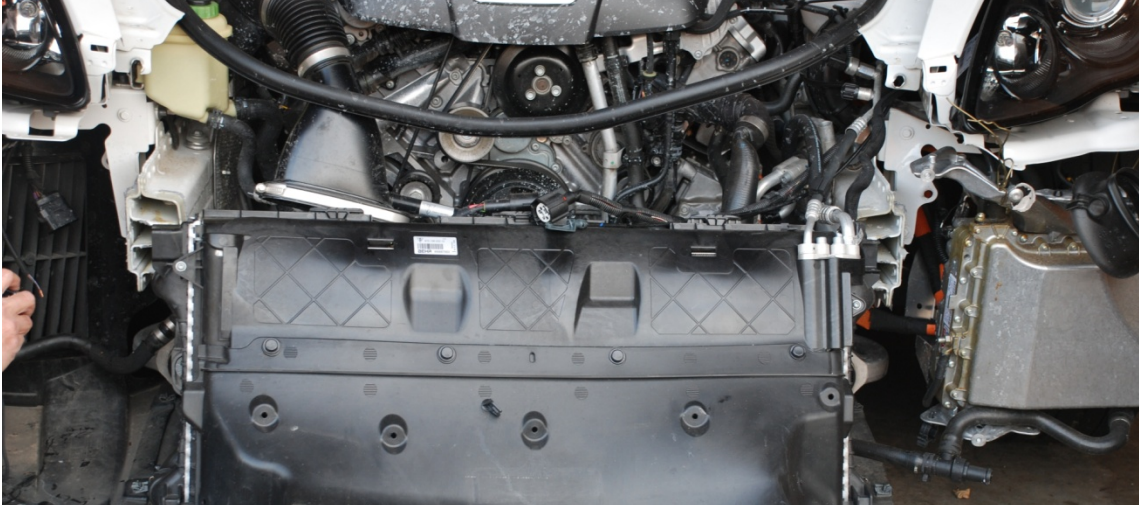
- E. The left frame rail was observed to be bent. This can be seen in the paragraph below. It is our opinion that the frame rail was not dimensionally straight during assembly and was not checked during quality control inspection. This could account for the fact that the vehicle was unsuccessfully aligned four times by Porsche dealerships. Wheel alignment affects the handling of the car, significantly reducing tire life and adversely affecting gas mileage. Vehicles that cannot be properly aligned to the manufacture's standards will be a hazard to drive as the operator may experience "over-steering" affects or hard steering. Technical information regarding vehicle alignment can be found in [Ref. 4] and research related to frame damage can be found in [Ref. 6].

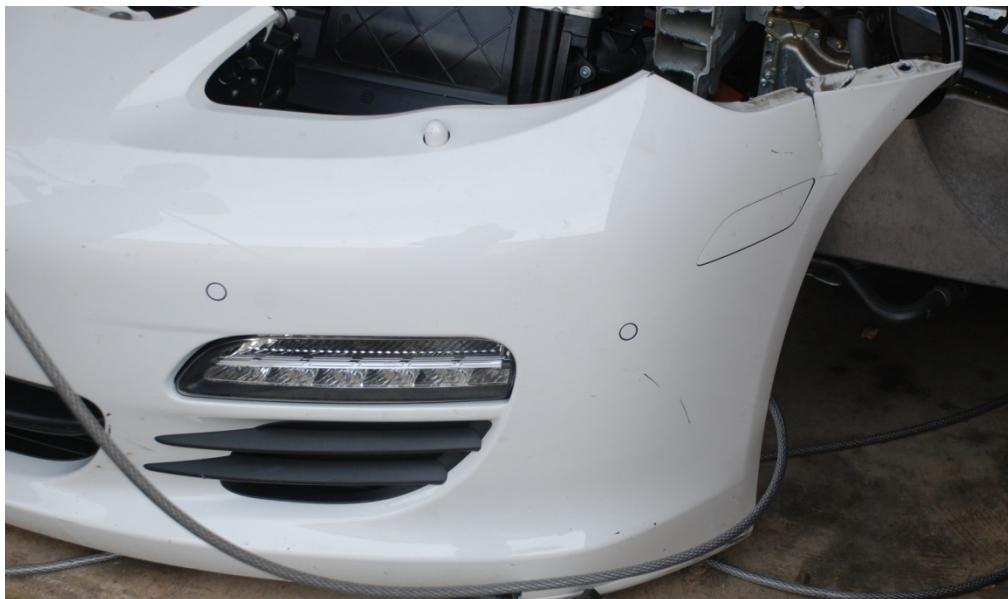
G. There is some evidence of replacement of front bumper skin as was observed in the inspection that the reflectors on the front bumper have been painted over. However, we did not observe any repair in the front structural components of the vehicle.

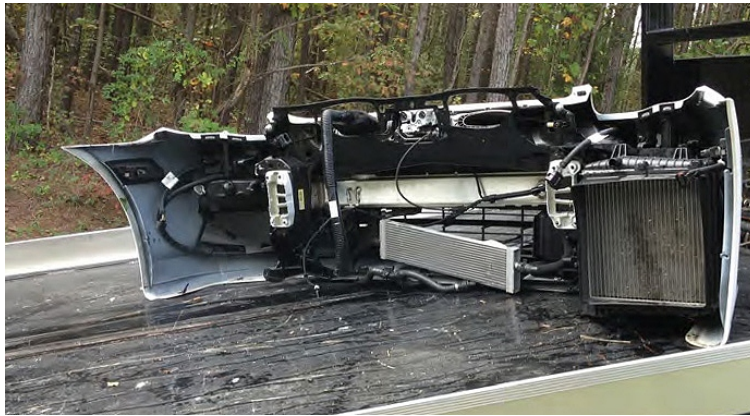
- A. The front end of the car separated from the remainder of the car at the right and left horizontal frame rails. This can be observed in the photo below:

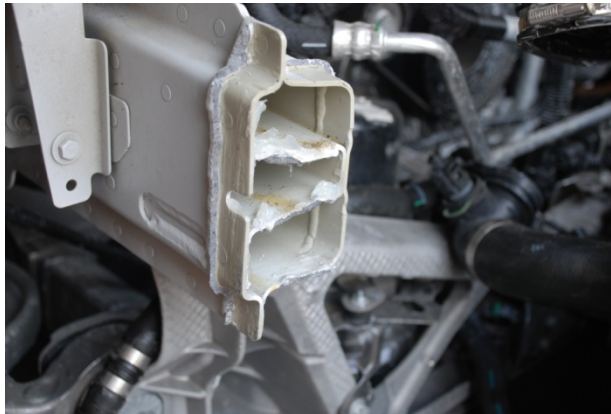
- B. It was observed that separation (on both sides) occurred in the area where the bumper assembly mounting flange is welded to the horizontal frame member. The failed right side rail can be observed in the photograph below:

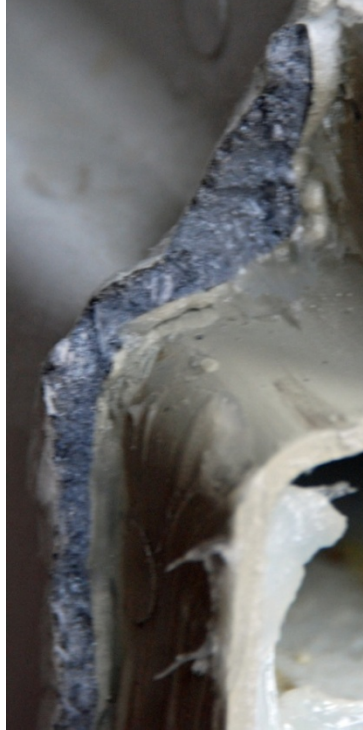
- C. It was observed that the welds failed in a brittle manner, exhibited porosity and had insufficient weld build-up. This can be seen (for the left-side weld) in the photo below:

(Note that a petroleum based product was applied to the failed weld surfaces to prevent surface oxidation)

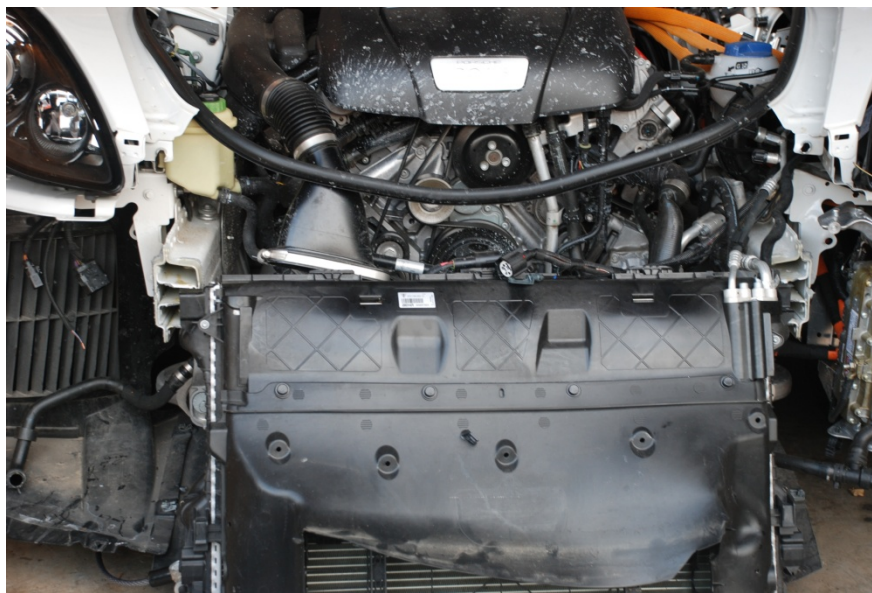
- D. It was observed that the right (passenger side) horizontal frame rail was bent. This can be observed in the photo below:
