“GT1” Engine Coolant Lines

The importance of water retention

BY TONY CALLAS AND TOM PRINE

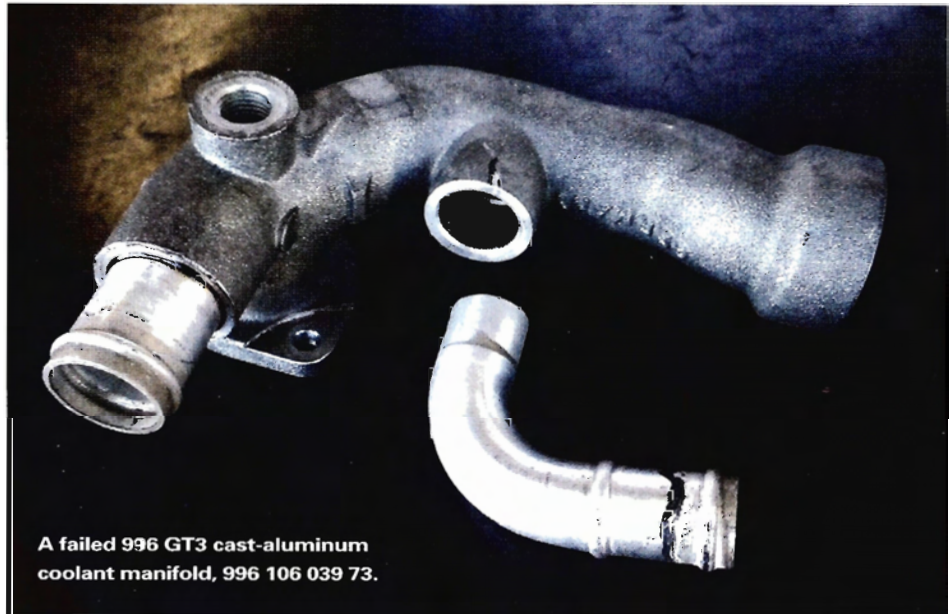
A failed 996 GT3 cast-aluminum coolant manifold, 996 106 039 73.

for all rubber hoses. The extruded aluminum pipe fits into the manifold and is held in place by glue or a bonding agent. The failure point is between the cast manifold and the extruded aluminum pipe, and is caused when the glue or bonding agent fails and allows the extruded aluminum pipe to separate from the cast manifold while the engine is running.

Option 1: TIG-weld the original extruded aluminum pipes into the cast aluminum manifolds. This may be your best option, as it provides a permanent repair. Prior to the TIG-welding process, the bonding agent should be removed from the parts. If this is a preventive repair, all extruded aluminum pipes must be removed from the manifolds. This involves using a MAP gas torch to heat the cast-aluminum manifold near — but not on — the connection point with the aluminum pipe until the bonding agent starts to ooze out of the connection. It is important that the heat being applied to the aluminum pipe is not excessive, as that could distort the pipe, rendering it useless.

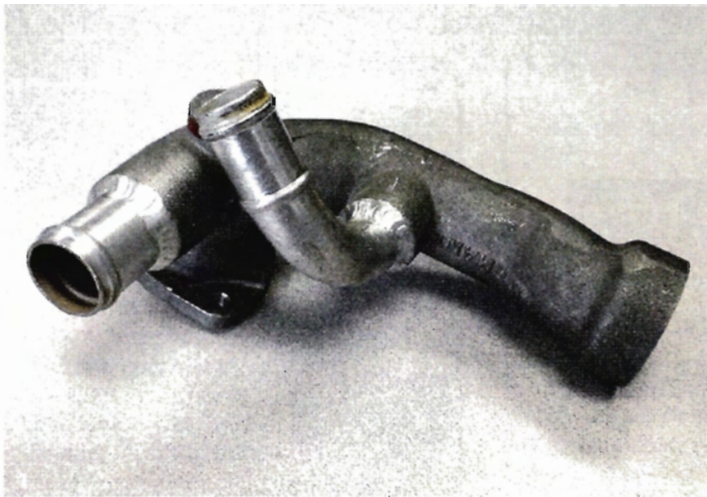
996 106 039 73 after TIG-welding both extruded aluminum pipes (1). 996 GT3 coolant manifold following TIG welding, which mounts below the power-steering pump (2); 997 part is very similar. 996 GT3 water-pump housing after TIG welding (3). GT3 oil filter/heat exchanger manifold (4); both pipes have been TIG-welded into cast manifold, allowing the coolant to circulate through the heat exchanger.

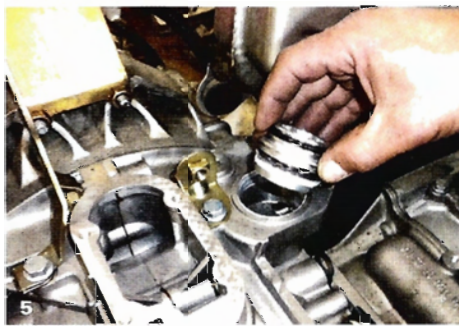
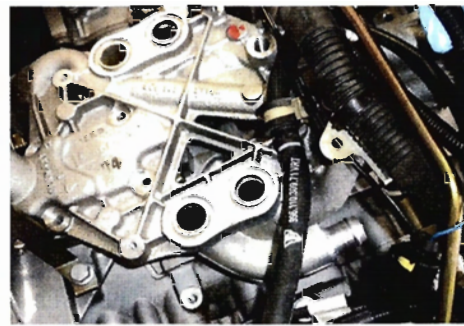
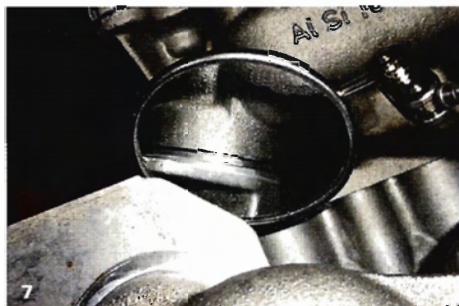
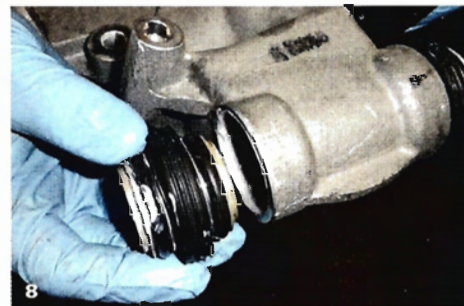
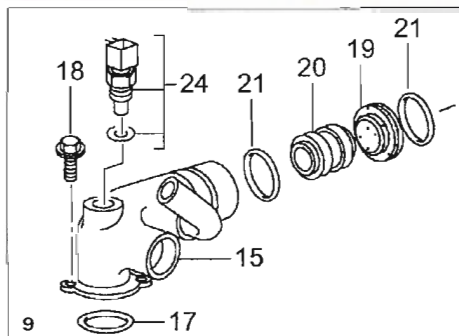
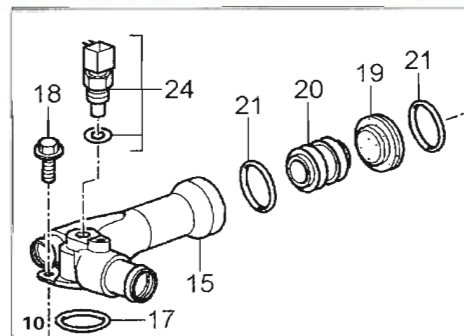
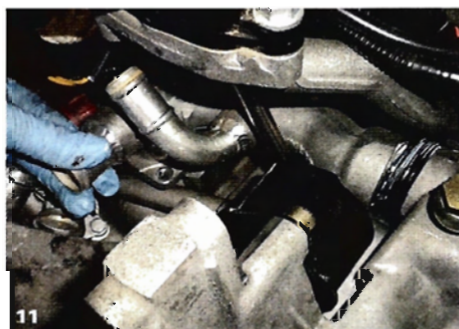
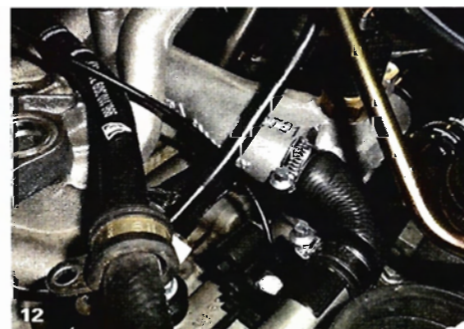
Preparing to reinstall heat exchanger manifold (5) with new O-rings and seals. Moving manifold into position (6) with top of engine apart for better access. Checking O-ring seal (7). Four O-rings (999 707 411 40) on top of engine are held in place by right and left cylinder head coolant manifolds (8). Parts breakdown for M96.70 driver's side coolant manifold (9) and 997 GT3 driver's side coolant manifold (10). 996 driver's side coolant manifold following TIG welding (11). View from back of 997 GT3 driver's side manifold (12); note addition of curved hose 997 106 233 72 and coolant pipe 997 106 252 90.

Interestingly, Porsche changed this part on M97.76 (GT3) engines to part number 997 106 039 90, which is of a different configuration and does away with the curved pipe altogether. The updated part is from the 997 GT3 and will fit all versions of the M96.70 engines in the 996 Turbo, GT2, and GT3. The same part on a 997 Turbo or 997 GT2 is different. The 997 GT3 part is a tight fit in the older cars and will also require the addition of part numbers 997 106 233 72 (hose) and 997 106 252 90 (coolant pipe). All other flanges, O-rings, and components are the same.
