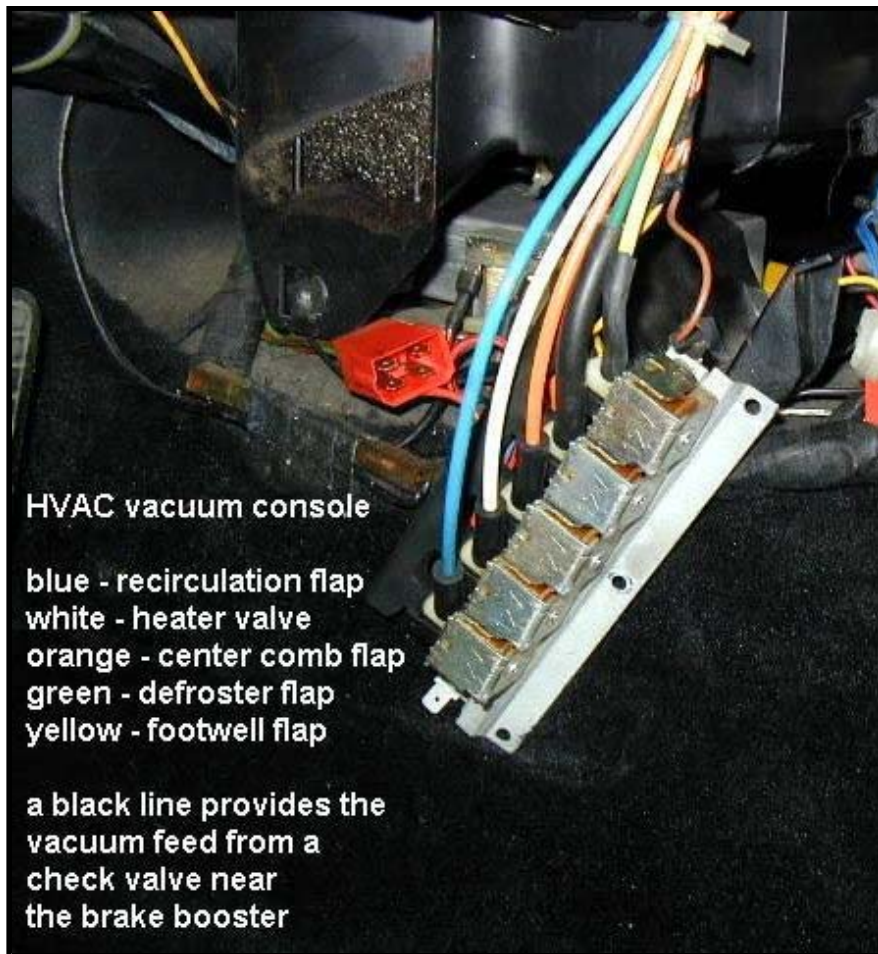
13. The most often-used actuators are the best candidates for failure. When testing the white line look under the hood at the heater valve arm for movement (be aware that the heater valve may function properly but the internal shutoff can warp allowing coolant flow). Two other common failures are the orange and blue lines.
14. The yellow line feeds the footwell flap (generally used to direct heat to the floor). This actuator is located behind the HVAC control head and removing the head should provide adequate access.
15. The comb flap actuator (orange line) sits above the footwell flap actuator and cannot be reached without removing the [center console](#). A procedure for removing the [center console](#) is [here](#).
