1990 Porsche 928 S4 Auto B2 Brake Band Piston Failure

5. *Disassembly*

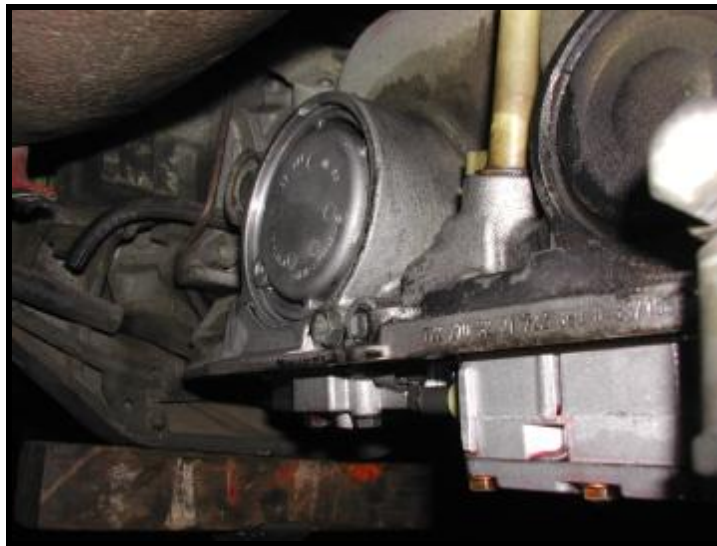
B2 Piston Assembly Cover Plate

4. The cover plate is held in position by a circlip and is held against the circlip by the spring loaded B2 Piston.
5. Inwards axial pressure applied to cover plate and circlip removed by using a small screwdriver. To assist in its removal the circlip was moved

circumferentially round in its recess until an end was within the gap in the retaining flange. The tang of the screwdriver was placed under the end of the circlip and it was worked out of its retaining groove.

6. Cover plate removed by the use of two small screwdrivers to lever the cover plate out. During removal the plate canted and jammed several times, which required it to be relocated square within the housing. It was not a difficult operation.

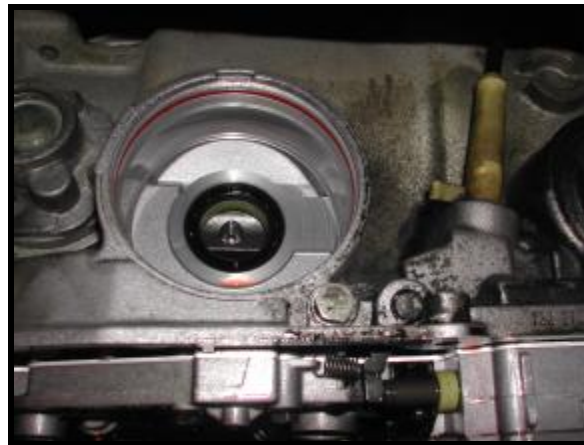
B2 Piston aperture showing black lip seal behind which is located the plastic guide bush. The location of the thrust pin into the brake band is also visible in the centre of the hole. Also visible is the cover O-ring seal (red)

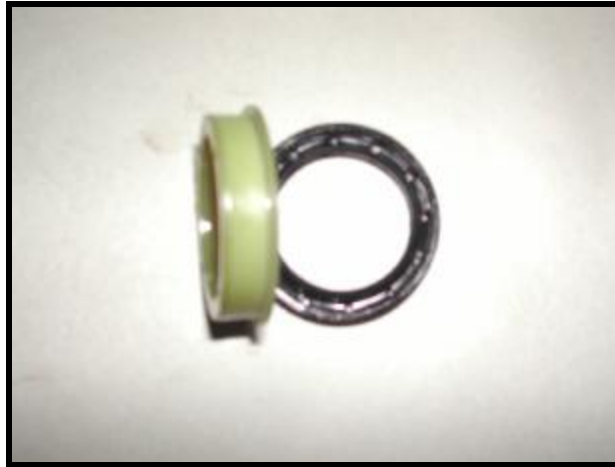
Bush and lip seal for B2 Brake Band Piston are located at the end of the bore in the aperture into the transmission as shown in the preceding photograph.

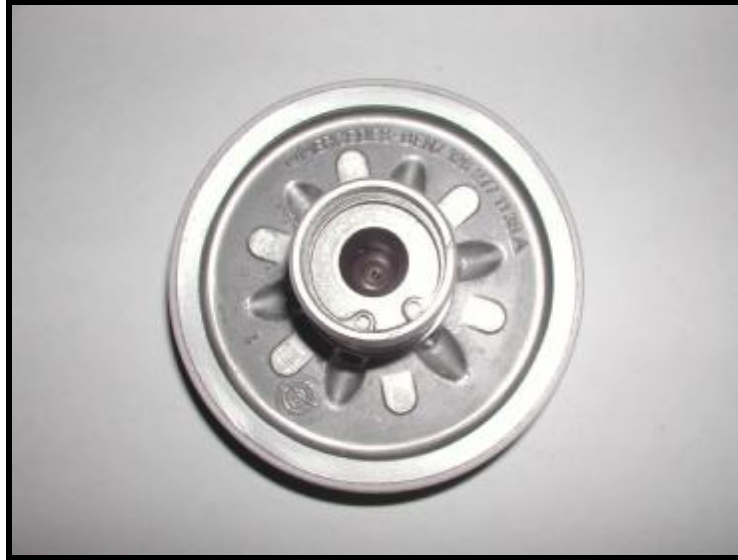
*B2 Brake Band Piston Assembly
With a view of thimble piece and retaining circlip*

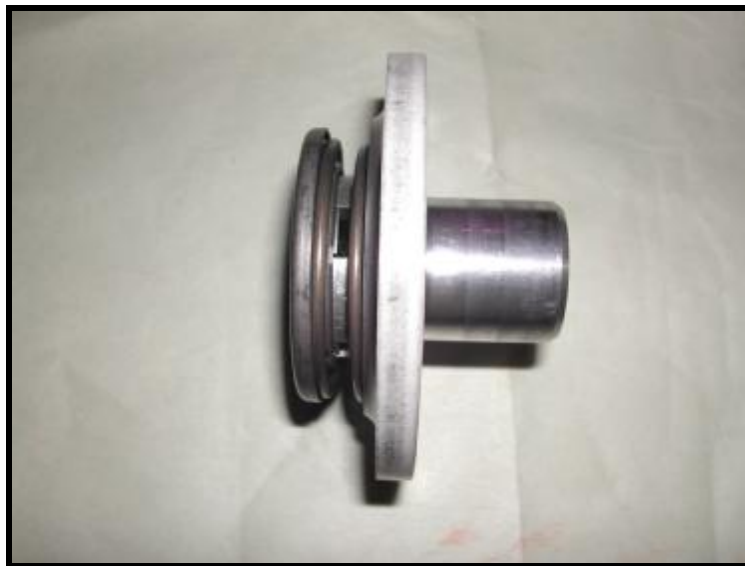
*B2 Brake Band Piston Assembly
with a view of retaining washer, spring, "T" plastic seal ring and OD of piston cylinder
where lip seal seals*

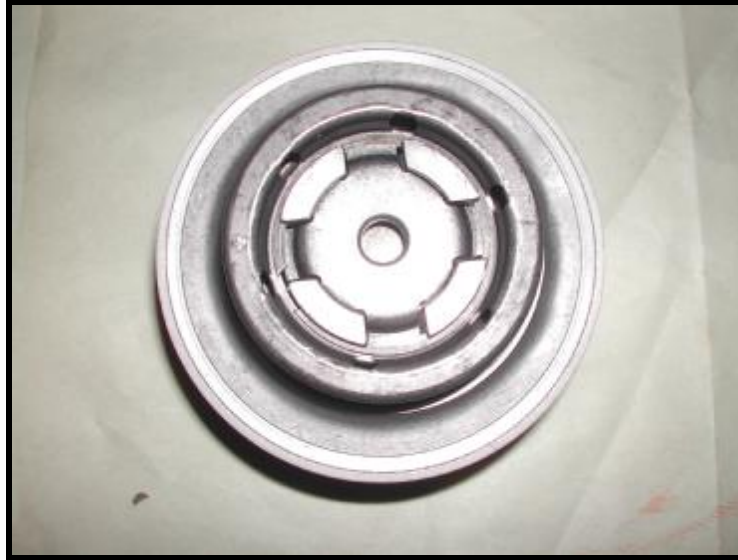
*B2 Brake Band Piston Assembly
with spring retaining ring, circlip and cruciform piece holding the conical spring and
non-return valve that can be seen through centre hole*

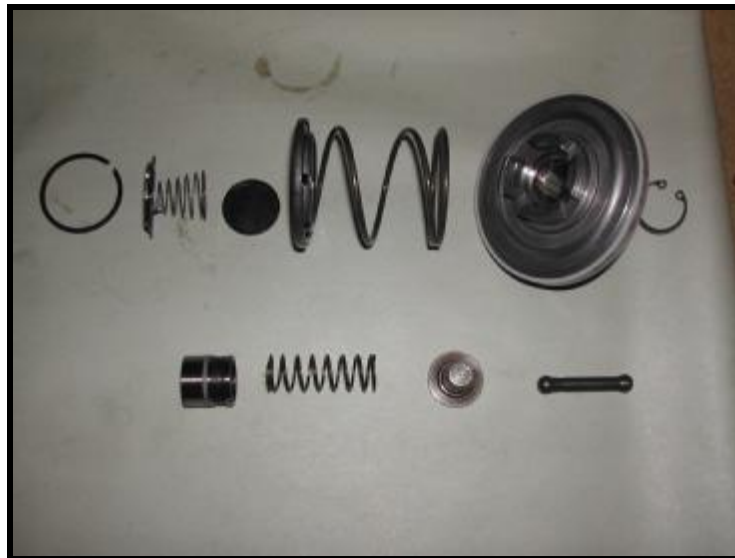
The B2 Piston Assembly disassembled

1. Circlip,
2. Conical spring,
3. Non return valve disc,
4. Spring and Retaining Ring,
5. B2 Piston Outer Assembly (brake band piston),
6. B2 Piston (inner piston),

7. Piston spring,
8. Thrust pin thimble piece,
9. Thrust Pin, and
10. Circlip.
