Technical Bulletin

Model
All 911
1994

Subject: Motor Vehicle Theft Law
Enforcement Act - Part Marking

Number
9301

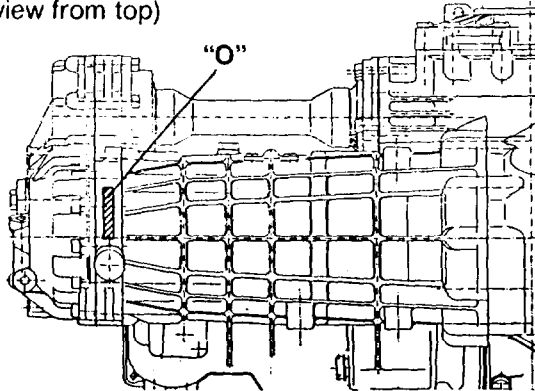
Tiptronic transmission original
(view from top)

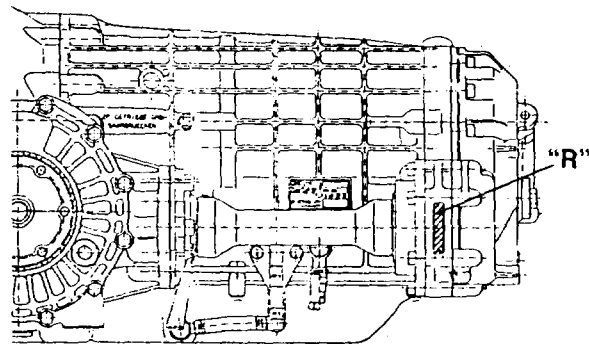
Tiptronic transmission replacement
(view from side)

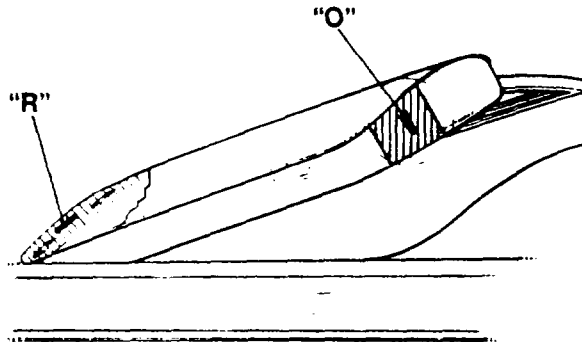
Door
(left and right)

(viewed from below)

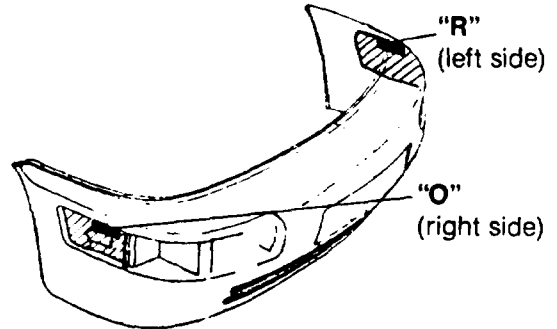
Front bumper

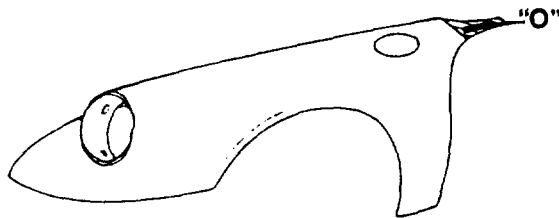
Fender front
(left and right)
Rear top inside fender seam

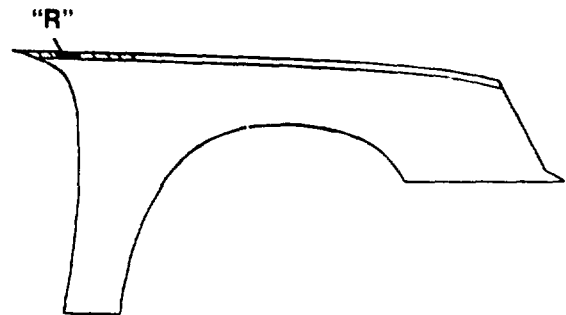
Fender front
(left and right)
Mounting flange rear inside

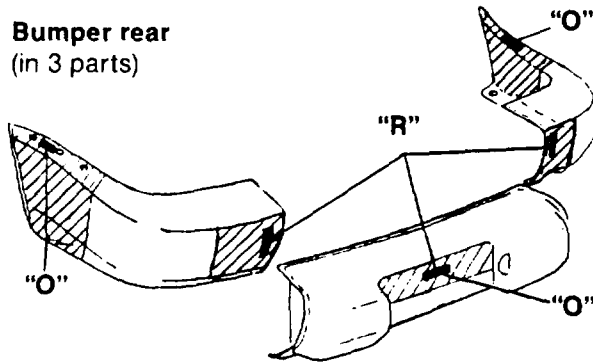
Bumper rear
(in 3 parts)

Note: On the center section of the rear bumper, the original I.D. marking is behind the license plate bracket. On the replacement part, it is on the inside behind the insulation piece.

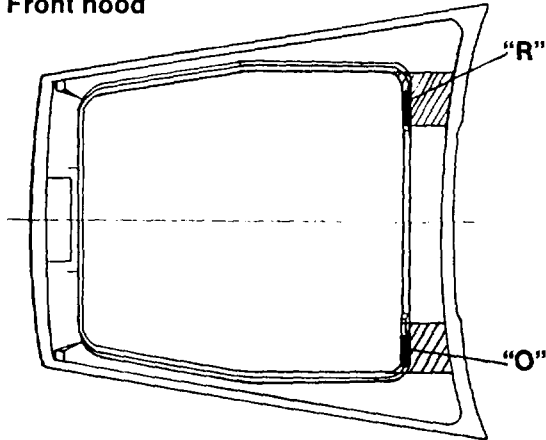
Front hood
