# Automobile Status Report

2017 Porsche 911

# Multi-Point Inspection Form

# Additional Service Recommendations

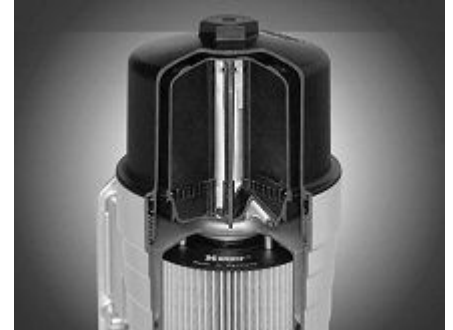
**Oil Separator Centrifuge: TIME INCLUDES 3.5 HOURS OF DIAGNOSIS. PLEASE QUOTE A NEW OIL SEPARATOR, OIL SEPARATOR O-RINGS, AND INTAKE MANIFOLD GASKETS ON BANK 2 (CYLS. 4-6, PASSENGER SIDE), THROTTLE BODY GASKET. OIL SEPARATOR HAS FAILED AND IS ALLOWING EXCESSIVE OIL INTO THE INTAKE TRACT CAUSING SMOKING AND EXCESSIVE OIL CONSUMPTION.**

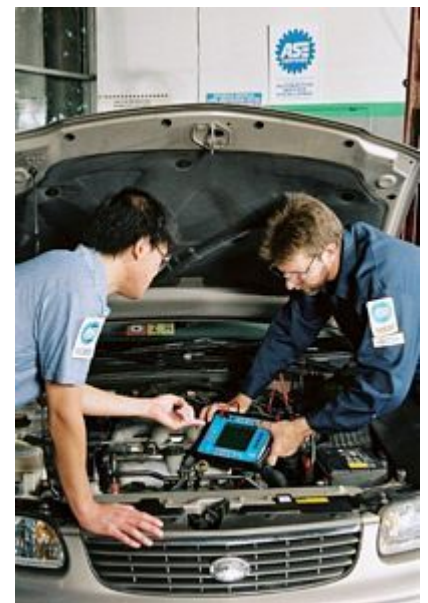
**Diagnostic: VACUUM LINE FOR ATF COOLER ACTUATOR IS DAMAGED. THE LINE CAN BE REPAIRED AND THE VACUUM SYSTEM TESTED FOR ADDITIONAL LEAKS.**

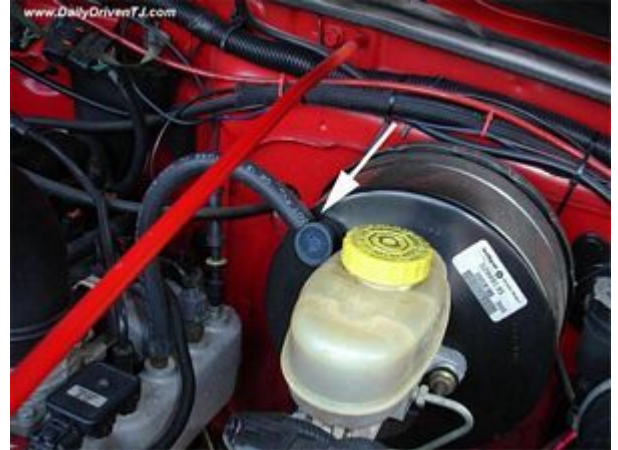
## Vacuum Line Replacement: ALL VACUUM LINES AND ELECTRIC CHANGEOVER VALVES NEED TO BE REPLACED DUE TO OIL CONAMINATION. SEE TECH
