993 Intake Oil Leak

BY STEVE GROSEKEMPER

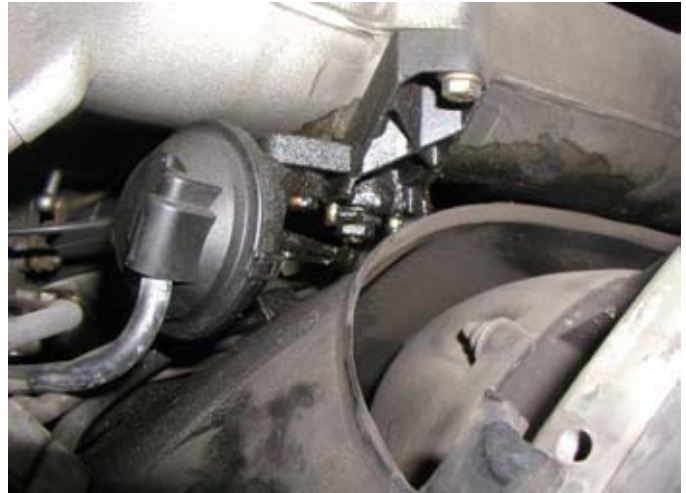
It pools right on top of the seal for the resonance flap and it leaks out onto the top of the motor (see image).

Leaking intake resonance flap with blower and ducting removed

As this item continues to leak, the oil cascades down the left side of the motor and eventually covers the case through-bolts with oil. That would be the disguising part of the oil leak.

Repair is not as difficult as it might seem. The flap is wedged between the intake manifold and the fan housing with about 5mm of clearance. The problem is the unit is about 75mm in height.

The trick is to separate the intake manifold from the port flange on the left side so it can be raised high enough to be able to slide the flap out the bottom of the intake manifold.

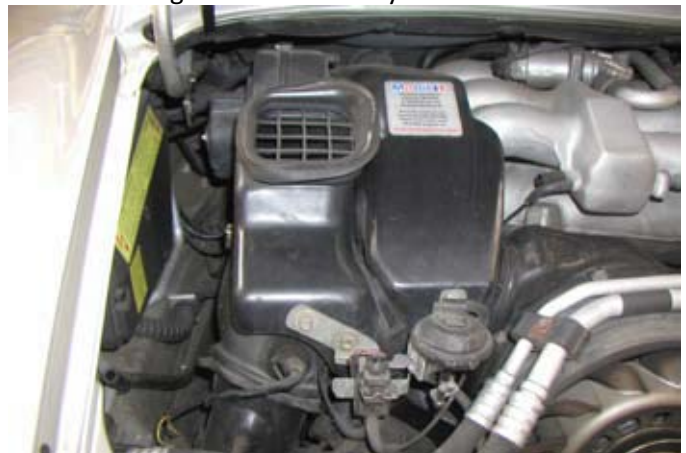
The resonance flap is hiding under all that black plastic!

- Remove the 2 mounting screws on the air intake snorkel (10mm socket). Push this hard plastic air snorkel to the left and pull it up and out of the car.
- Unplug the electrical connector from the front of the rubber elbow boot just below the two mounting screws you removed above. (Squeeze metal release bail on plug to unlock and pull off.)
- Loosen the forward hose clamp and pull the large rubber boot out of the car.

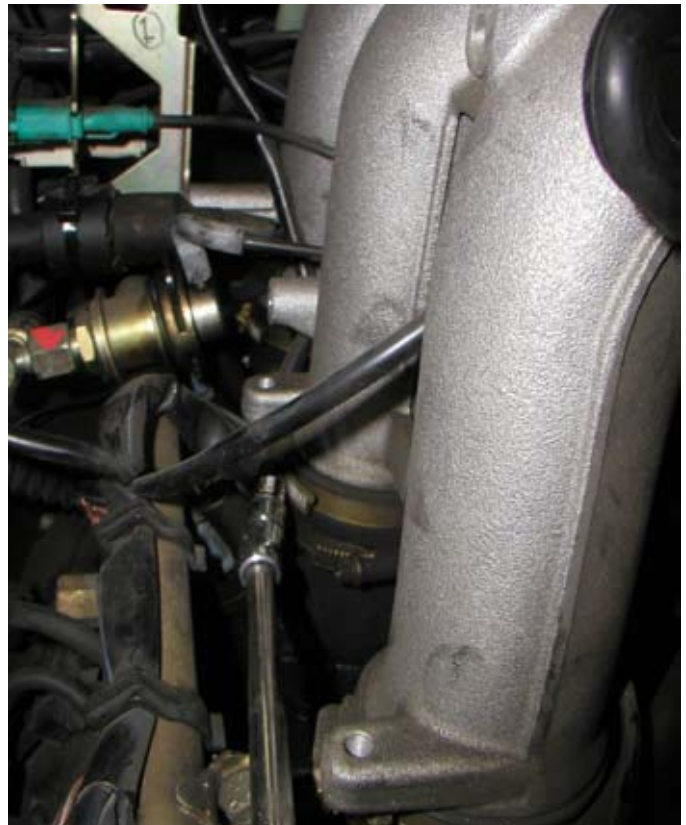
Loosening the upper clamps will make reassembly easier

- Loosen the hose clamps at the top of the rubber intake boots. Use an air nozzle to blow any dirt away from boots and/or manifolds as you don't want any dirt entering the engine when the manifold is lifted up.
