Nick's Porsche 996 (G.96) Transmission Rebuild Guide

Originator: NickHend

Date: July, 2016

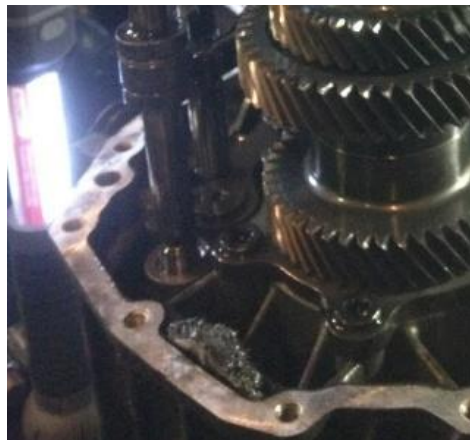
An easy way to check if the pinion bearing is starting to fail is to pull the drain plug from the base of the transmission, poke a finger in the drain hole, bend it toward the front of the car, and see if a thick grey substance is accumulating around the magnet. Figure 1: Pinion Bearing Grease Accumulation on Magnet shows the gunk like material that you are feeling for.

Figure 1: Pinion Bearing Grease Accumulation on Magnet

This is the grease from the sealed pinion bearing that has leaked out and gathered to the bottom of the transmission. My Transmission had both the typical pinion bearing noise and the pinion bearing grease accumulation; therefore I was confident that the pinion bearing needed replacement.

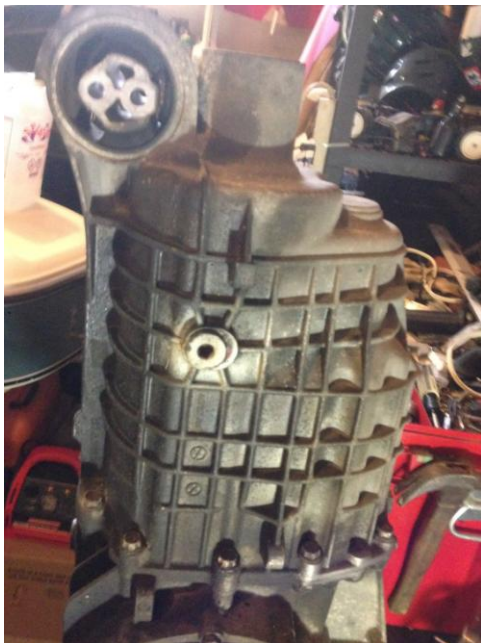
Once the transmission is removed from the vehicle, disassembly can begin. The first step is to remove the bolts holding the nose cone onto the transmission. Once these are removed the cone can come straight off.

Figure 3: Passenger Side, Nose Cone

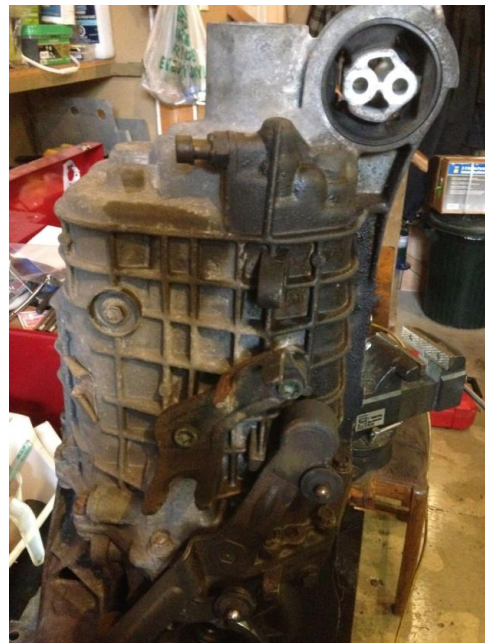
Figure 4: Drivers Side, Nose Cone

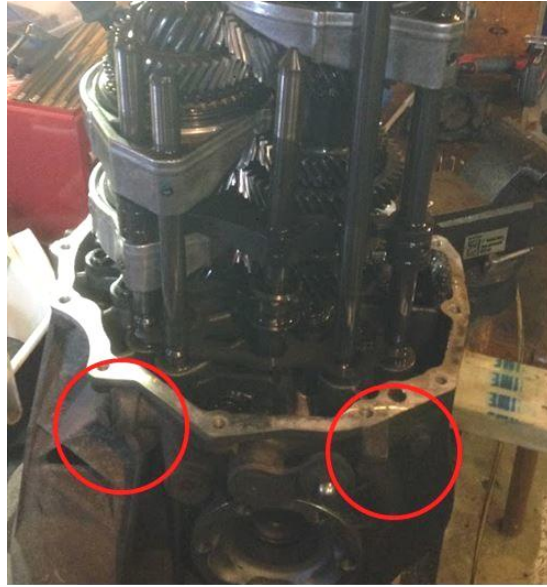
First, remove the 4 bolts on the outside of the transmission case that hold the shift rod ball and springs in place, as shown in Figure 5: Shift Rod Ball and Spring Bolts. Once each bolt is removed, remove the ball and spring, then bag and tag so you don't lose them.

Figure 5: Shift Rod Ball and Spring Bolts

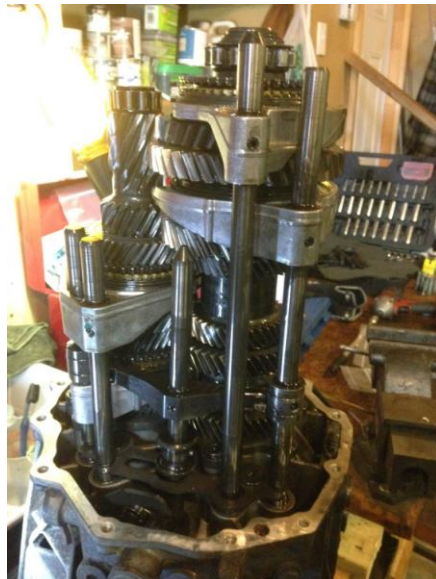
The shift fork is fastened to the shift rod with roll pins. I used a punch to hammer out the pin from the fork. Once the pin is removed, the rod can slide up through the fork, and then the fork can be removed. Be sure to tag each pin as removed for re-installation.

Figure 6: Shift Forks

Note: Use caution when removing the center fork (shortest) as there are 4 little washers that fit into a profile in the transmission case that can fall and go missing.

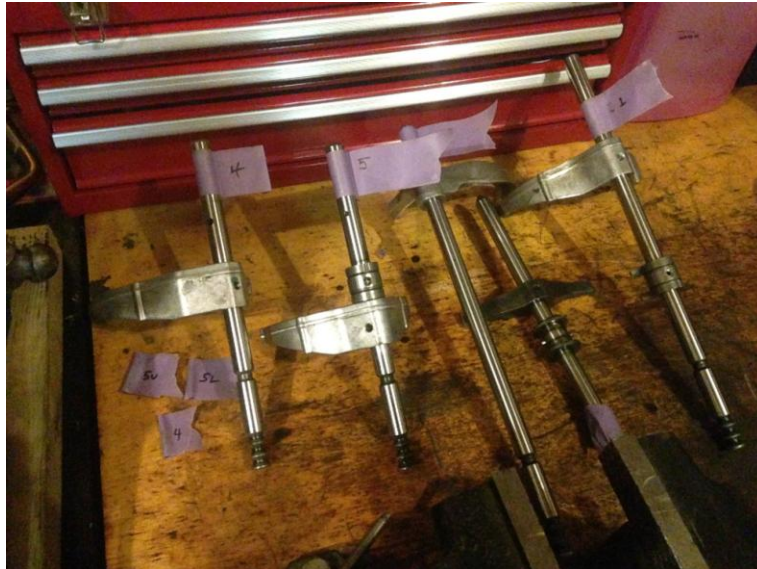
Figure 7: Shift Forks and Rods Removed

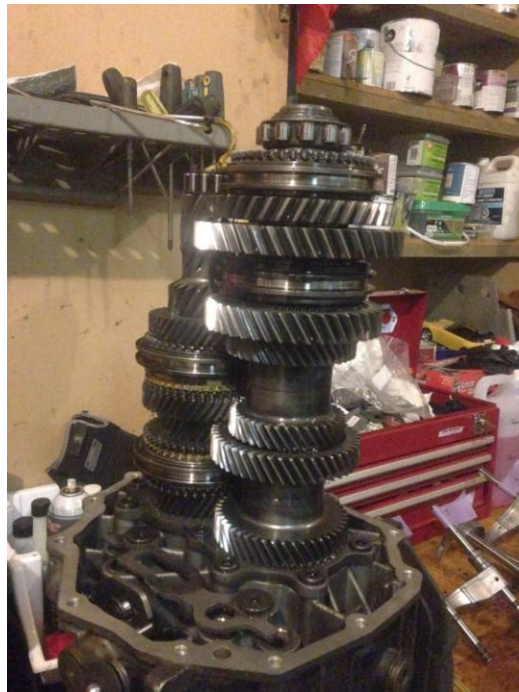
Now that the forks are out of the way, the gear cluster can be removed. Start with removing the torx bolts that fasten the cluster base plate to the housing.

Figure 8: Gear Cluster

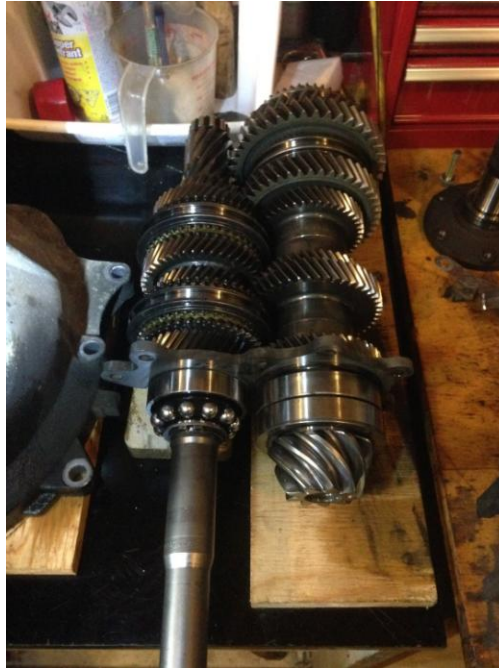
The cluster is now held in place by the tolerance fit of the pinion bearing and Mainshaft bearing in the case. To remove this, I heated the case slowly using a propane torch (not too hot, the case is cast aluminum), then used some pry bars to carefully remove from the case.

Figure 9: Gear Cluster Removed from Case

Once the cluster is removed from the case, it is time to start breaking down the gear stacks. Note that the pinion bearing is the larger of the two bearings (above the pinion gear in Figure 9: Gear Cluster Removed from Case). The pinion gear is fixed to the counter-shaft, so all gears stacked above the pinion bearing must be removed to replace the bearing which makes this job challenging.

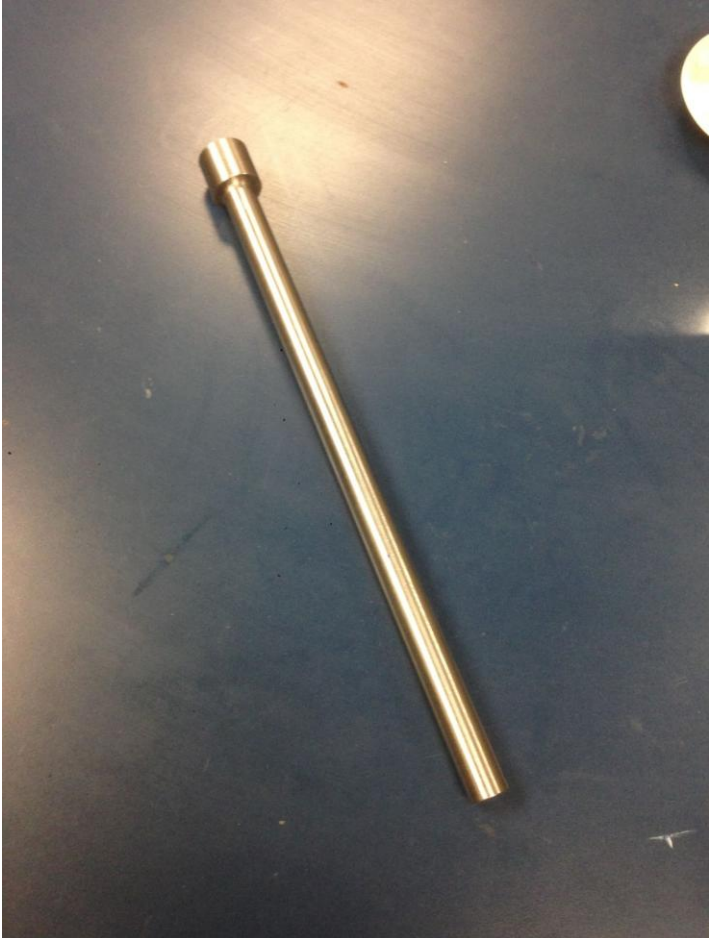
A special tool is required to start pulling gears off the counter-shaft. The counter shaft is hollow so a conventional puller has no surface to push on. I had the tool in the photo below made up. This tool serves two purposes – a surface for the puller to push on, as well as a support for the hollow counter shaft when high press forces will be needed to pull the tolerance fit gears.

Figure 10: Countershaft Support Tool

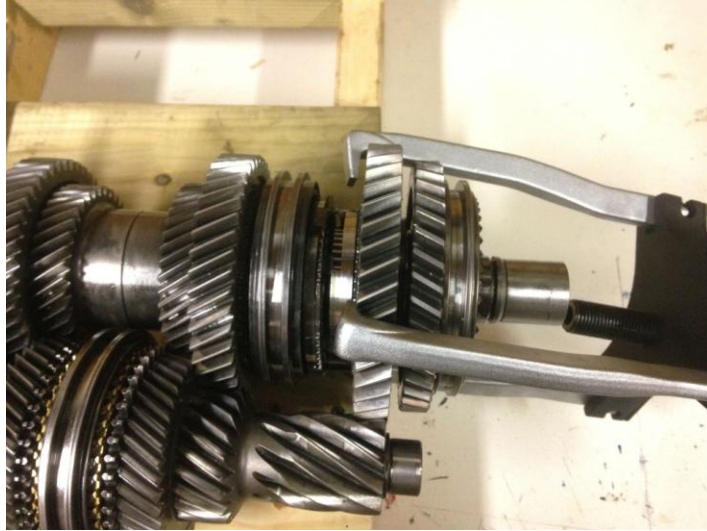
I started the process by pulling reverse, first and second gear off the stack. To do this, start by removing the large circlip at the top of the stack. Using a large gear puller, secure legs on first gear and pull using an air or electric impact gun. I used a 1/2" electric impact gun and was able to pull the gears relatively easily. When all components are free off the shaft, stack the assembly on the bench exactly as it came off, both the order and side that goes up/down. Take a lot of pictures while taking apart. If possible, try not to separate components as they are removed.

Figure 11: Pulling 1st Gear Assembly

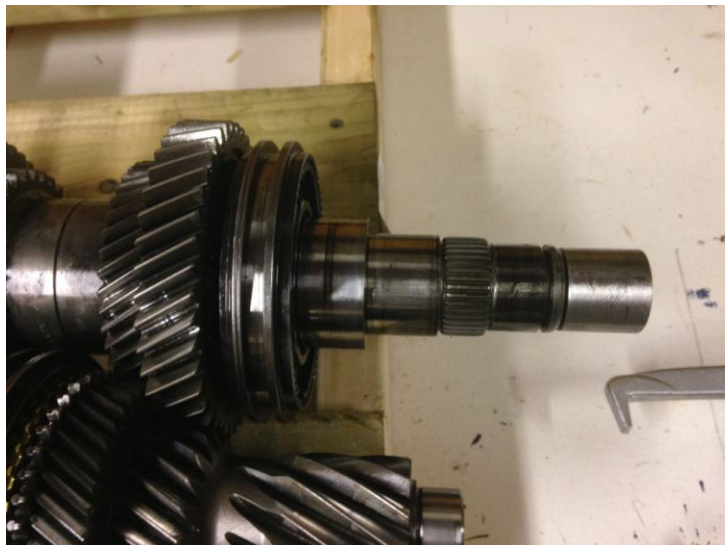
Next, remove second gear and associated components from the stack in the same method and first and reverse. Take extra caution to try and keep these assemblies together when removing from the shaft. The first and second gear shift sleeve has 3 little balls and spring loaded into the sleeve, if this comes apart the balls and springs will fly everywhere and you will spend a month of Sunday's looking for them.

Figure 12: 1st Gear Assembly Components Removed

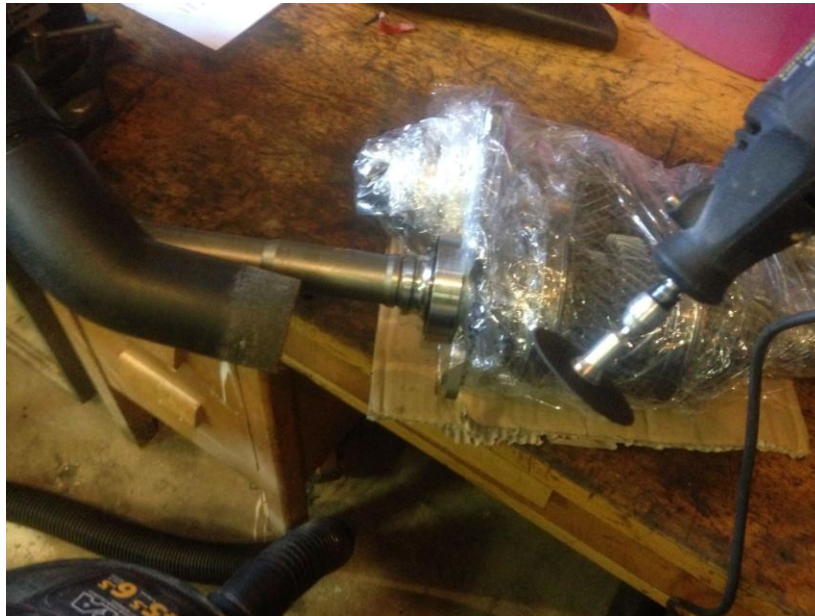
With the reverse, first and second gear assemblies removed, I went ahead and removed the mainshaft bearing to be able to separate the two shafts. Because there is very little room between the bearing and the cluster plate I couldn't figure out a way to press or pull the bearing off. To remove, I cut the outer race using a Dremel rotary tool. All the balls and cages can be removed, and then the mainshaft can be maneuvered out of the plate to isolate the countershaft.

Figure 14: Cutting the Mainshaft Bearing

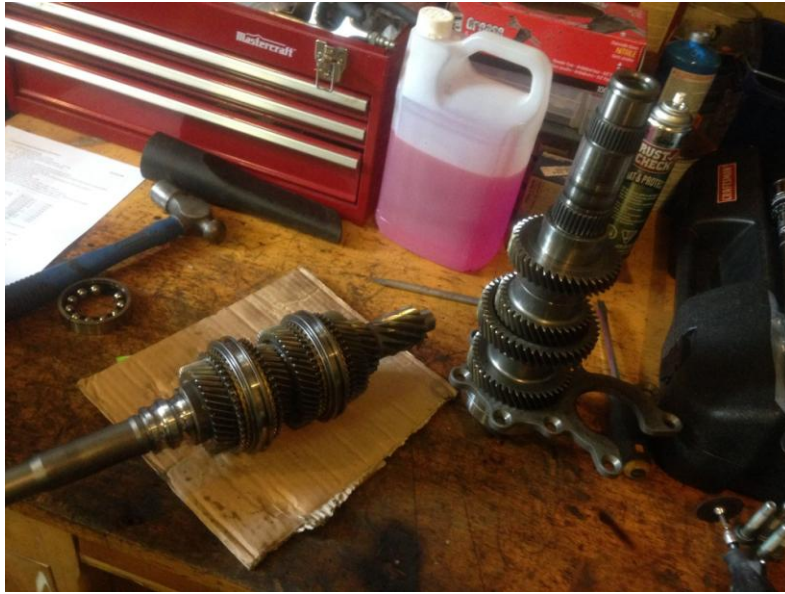
Figure 15: Mainshaft and Countershaft Separated

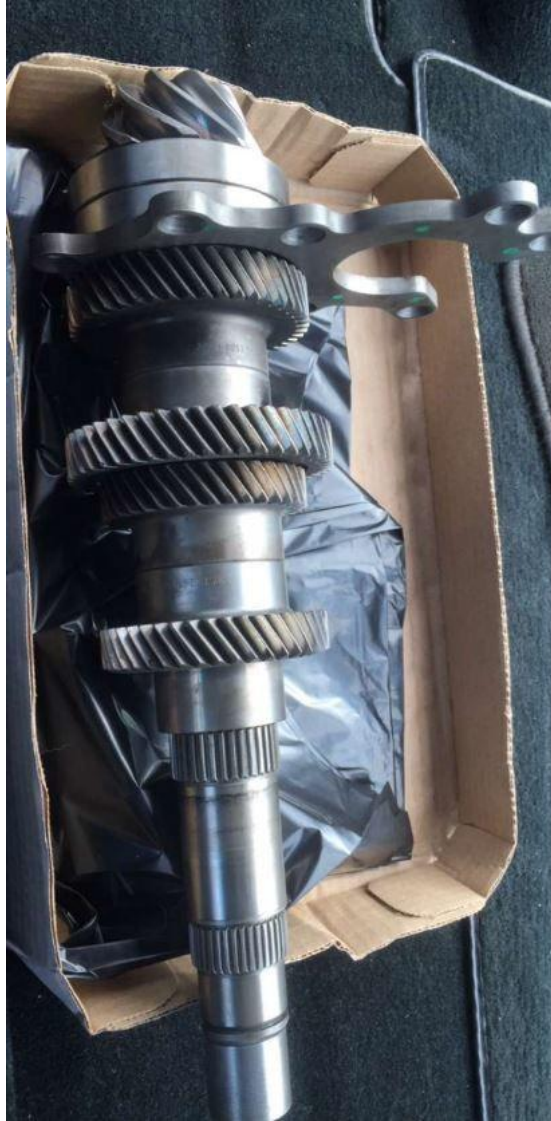
Here is the counter shaft with the new pinion bearing installed after picking up from the shop.

Figure 17: Counter Shaft with new Pinion Bearing

This is as far as I was able to break down the transmission myself. Gears 3-6 on the counter shaft take over 30 T of force to remove, so I brought it to a local automotive machine shop with the new pinion bearing. Although difficult, they were able to press the gears off, replace the bearing, and then heat the gears to re shrink onto the counter shaft.

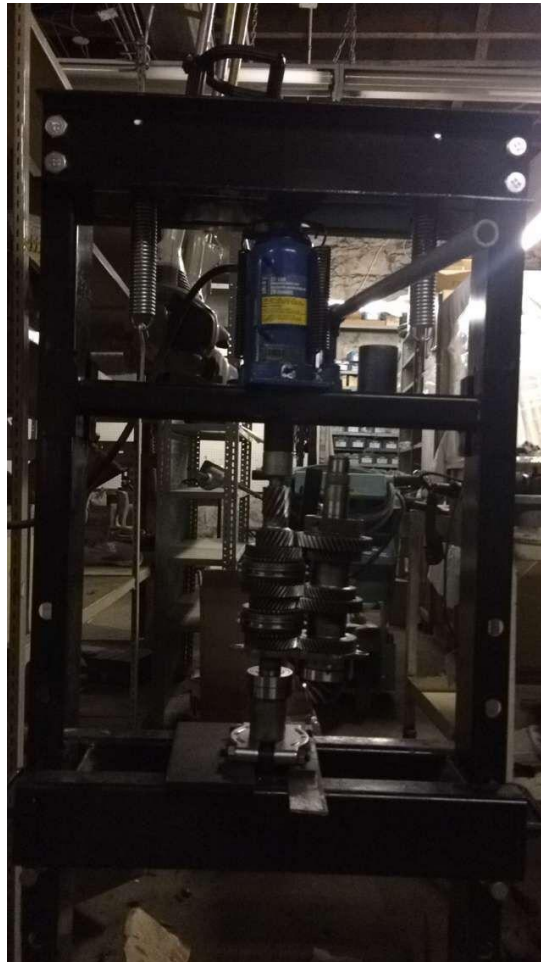
With the new pinion bearing installed, it's now time to start the rebuild. First step was to fit the countershaft and mainshaft back together. Once fitted, the new mainshaft bearing was greased, and pressed on using a 20 T shop press. Once lined up the bearing pressed on with ease. Install the spacer and circlip in position. The two shaft assemblies are now locked together.

Figure 18: Pressing Mainshaft Bearing

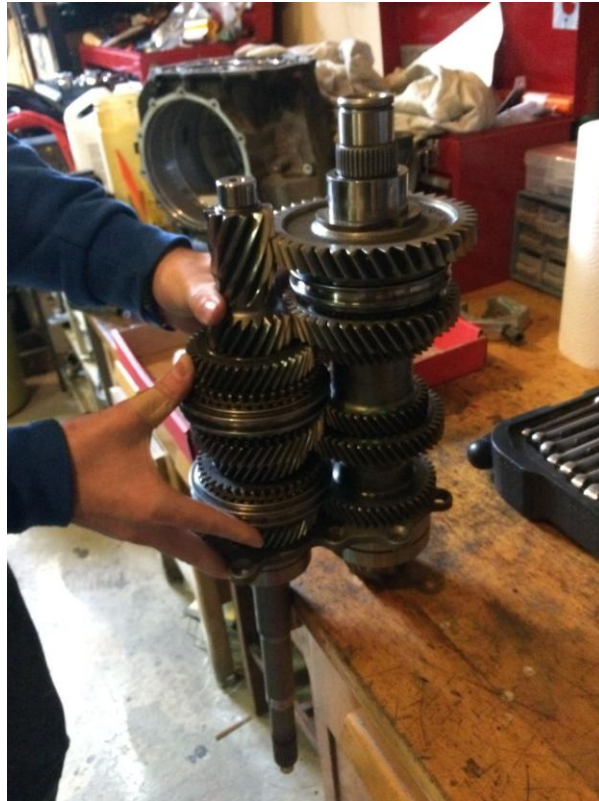
Some components that in the stack such as the bearing inner races, the inner portion of the shift sleeve, spacers and end bearing are a press fit onto the shaft, but fortunately don't require a press. Heating the parts in the oven at 350 F for 20 minutes expanded the components enough that they easily dropped onto the shaft in position. Once the parts are installed it's important to work quickly as once they contact they shaft they cool fast enough that after a couple of seconds it will be impossible to remove without a puller. I picked out the components requiring heat and put in the oven before starting to stack to speed up the process.

Figure 19: Stacking Components onto the Counter Shaft

1. The most difficult part of this job was loading on the balls and springs into the second gear shift sleeve. It took over an hour as the balls have a tendency to shoot out when attempting to load the spring to fit in position.
2. Once all components are installed, the top spacers and circlip should install in position. This will confirm correct spacing for proper shifting and for installation in the case.
3. At this point you should be able to slide the shift sleeves up and down to ensure the transmission is able to go in and out of each gear.

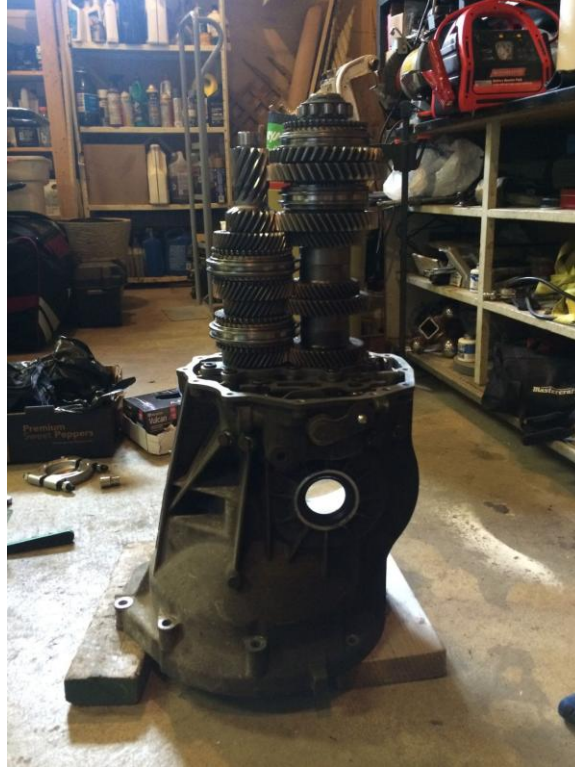
Now that the cluster is re assembled it can be installed into the transmission case. The bearings are a tight fit into the case, so I put the cluster in the freezer for a couple of hours and heated the case with a propane torch for a few minutes before installing. It took a bit of wrestling to set in position but once it's installed deep enough the torx bolts holding the plate can be installed and this will fit the cluster all the way down.

Figure 20: Gear Cluster Installed in Case

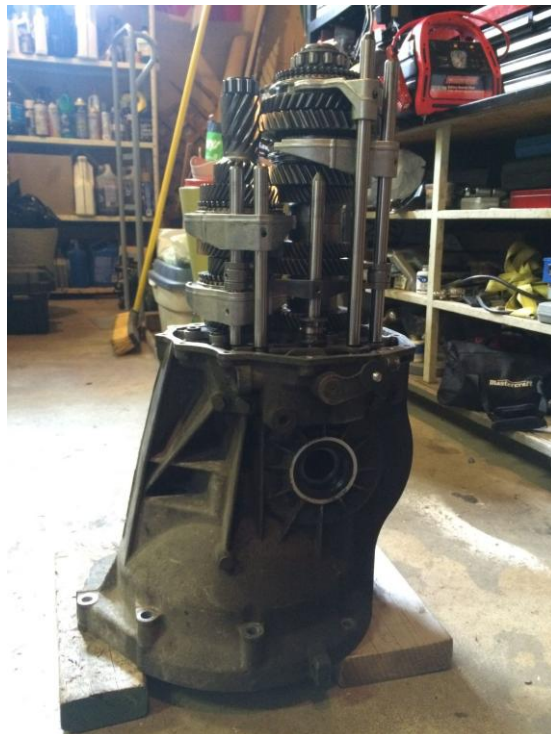
The shift rods and forks can then be installed reverse of the disassembly method. Don't forget to load the balls, springs and bolts into the transmission case after installing the rods.

Figure 21: Shift Forks/Rods Installed

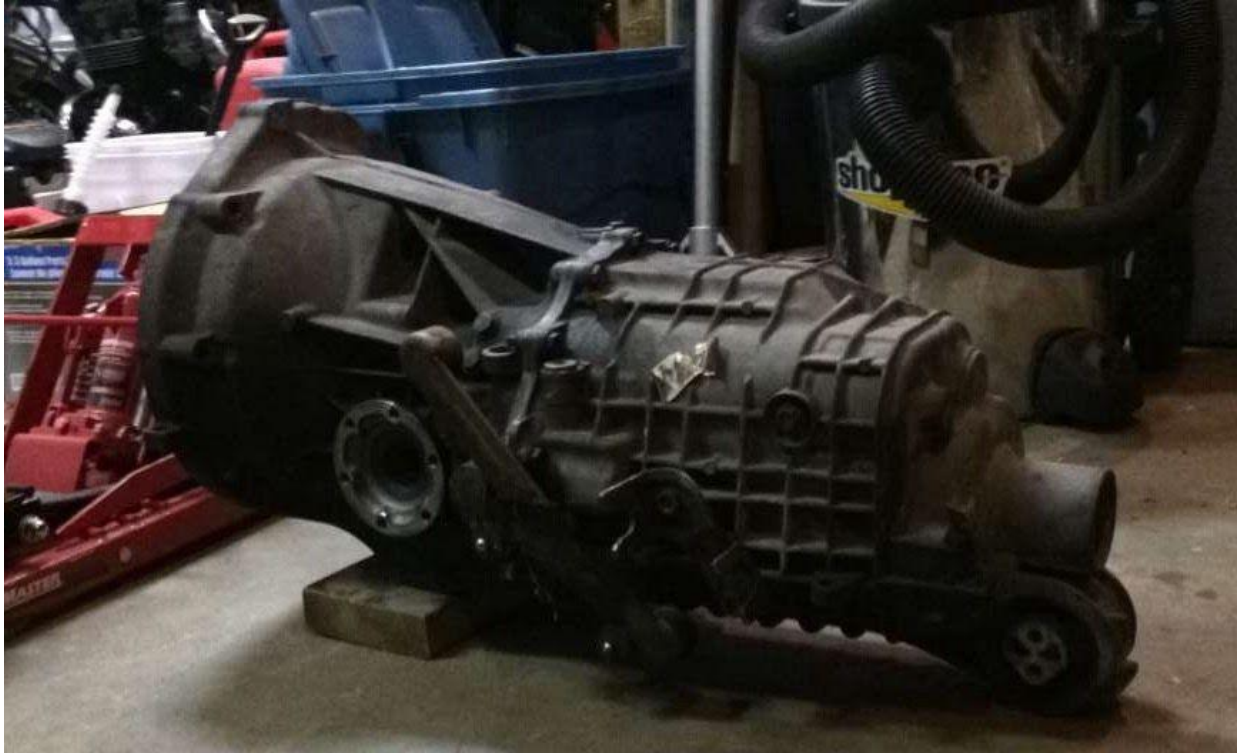
The last and one of the most difficult parts is installing the nose cone. The shift rods must fit into the nose cone in the appropriate location in the case and it can be difficult to line up when the nose cone is already on over. I tied zip ties around the base of the fork to pull on while installing the nose cone to achieve proper alignment. After around 25 tries the cone was installed. Then I was able to pull the nose cone off the housing approximately 1/4" to apply RTV to seal the two pieces together. Install the nose cone bolts and torque to finish the job.

Figure 22: Assembly Complete
