Unit #: **MINI COOPER 1.6L**
 Unit Location:
 Component: **ENGINE**
 Location:
 Serial #: **1.6 L 4 CYLINDER**
 Make:
 Model: **MINI JOHN COOPERS**
 OAS #:

Equipment Reliability and Lubricants Testing Services

Quality Control Report

Unit #: **PORSCHE 3.6L**
 Unit Location:
 Component: **ENGINE**
 Location:
 Serial #:
 Make: **PORSCHE**
 Model: **GT3 3.6L METZ**
 OAS #:

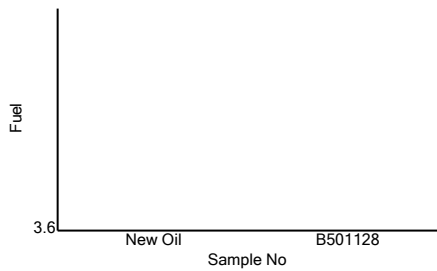
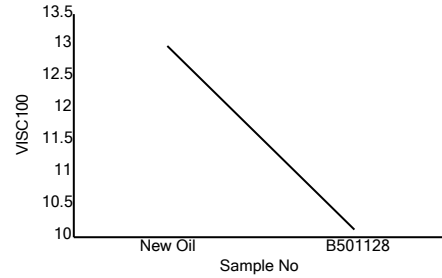
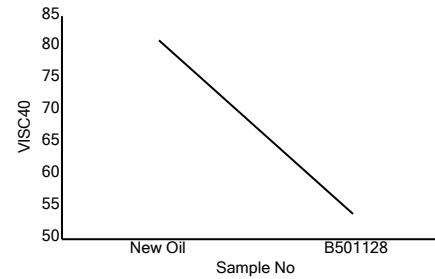
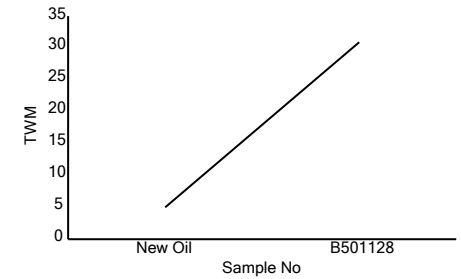
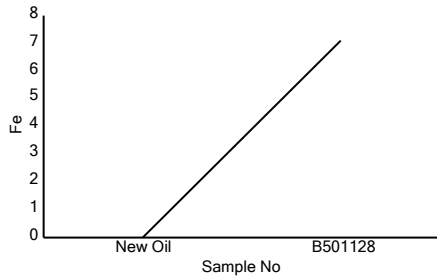
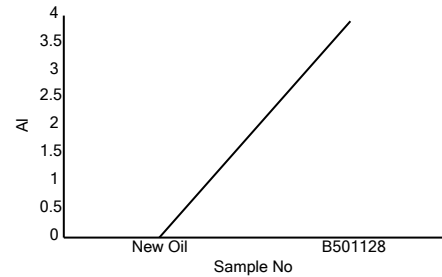
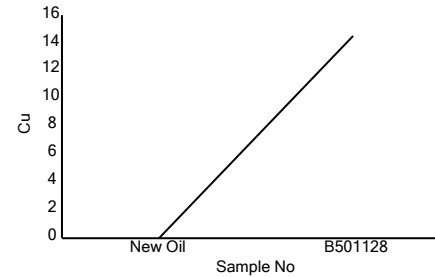
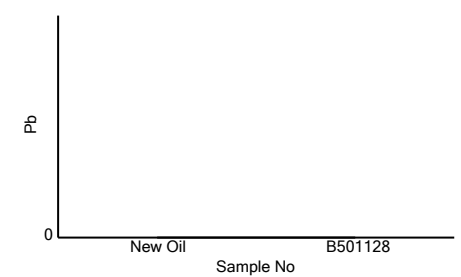
Trend Graphs

Fuel - Fuel Dilution

Fuel dilution may be due to excessive blow-by, excessive idling, cold weather starting, faulty injector, leaking fuel transfer pump seals or stop and go driving. Fuel dilution may be correlated with decreased oil viscosity.

VISC100 - Viscosity at 100 C

Lower than expected viscosity may be due to contamination with lower grade oil, fuel or degradation due to shearing or extended drain intervals.

VISC40 - Viscosity at 40 C

Your Sample Rank: 9

Fuel dilution indicates contamination of the sample with fuel. Identify and evaluate the source. Consider changing the oil.

Lower than expected viscosity may indicate contamination or degradation of the oil. Verify the identity and grade of the oil in use. Identify and evaluate the cause. Consider changing the oil.
