## Drivetrain - Classification Data Missing From Transfer Case

Cayenne

66/11 ENU 3913

Spare Parts Requirements for Transfer Case/All-wheel Drive Control unit: Missing Offset and Gradient Values on the Transfer Case (66/11)

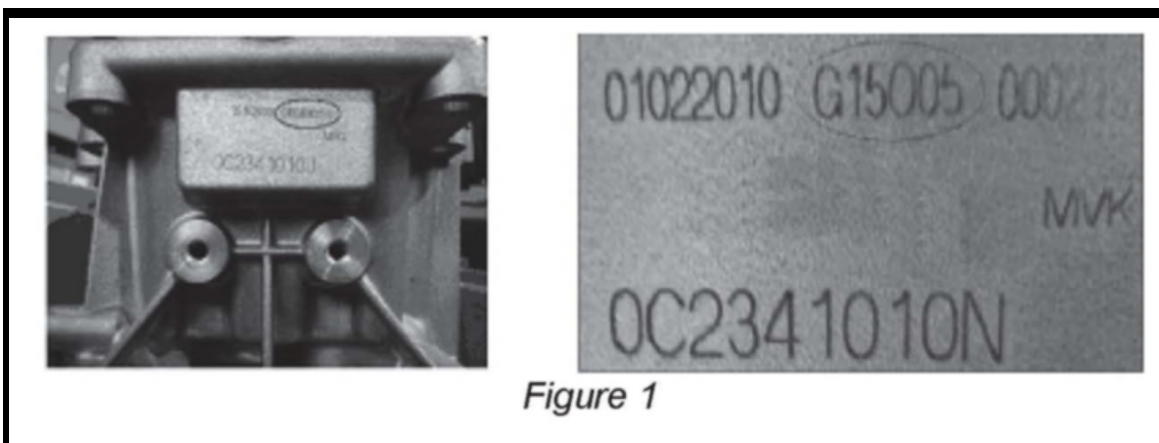
Since the classification data always relates to and is matched to the transfer gear, it is engraved on the transfer case; => Figure 1 shows 15 as the gradient value and 05 as the offset value.

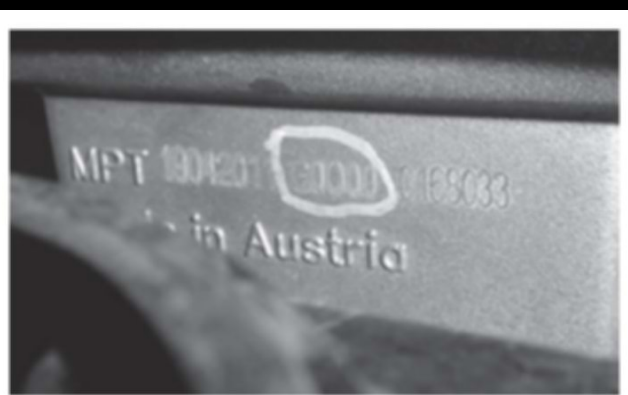
Figure 2

Due to a production error, only "0" might be engraved instead of the correct classification data, => Figure 2.

If this is the case, the correct classification data must be read out of the all-wheel drive control unit or may have to be queried from the Technical HOTLINE.
