Engine Oil Leak (123/15)

Oil leak on 2nd generation V6 diesel engine

Vehicle Type: **Cayenne V6 Diesel 2nd generation (92A)**

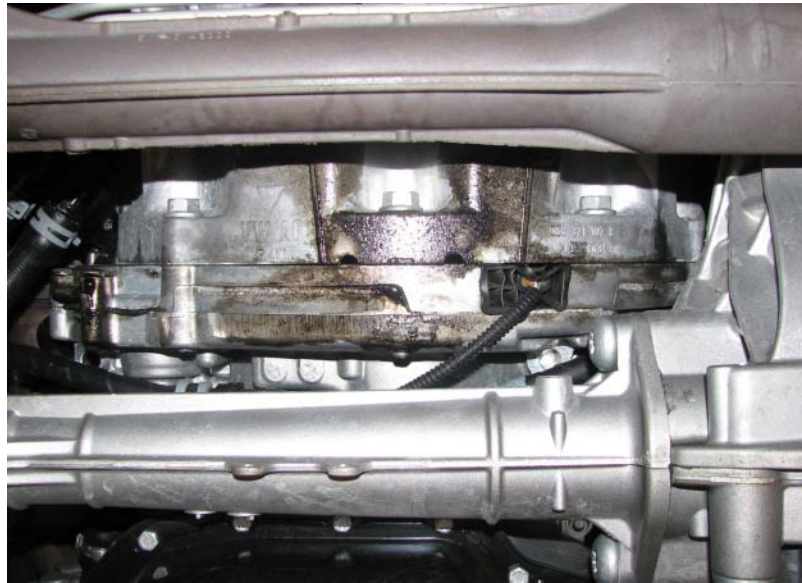
Concern: **Oil leak ("sweating", drops of oil) on engine in oil guide housing area** ⇒ *Example of oil leaks on the engine*

- 1 Oil sweating, drops of oil

*Example of oil leaks on the engine*

Proceed as follows in the event of a complaint:

⇒ **Before doing any other work**, the oil leak/oil contamination area on the engine must always be cleaned and sprayed with a suitable leak-locating agent/leak detecting spray (commercially available).

Then, perform a test drive.

After the test drive, check the engine for oil leaks.

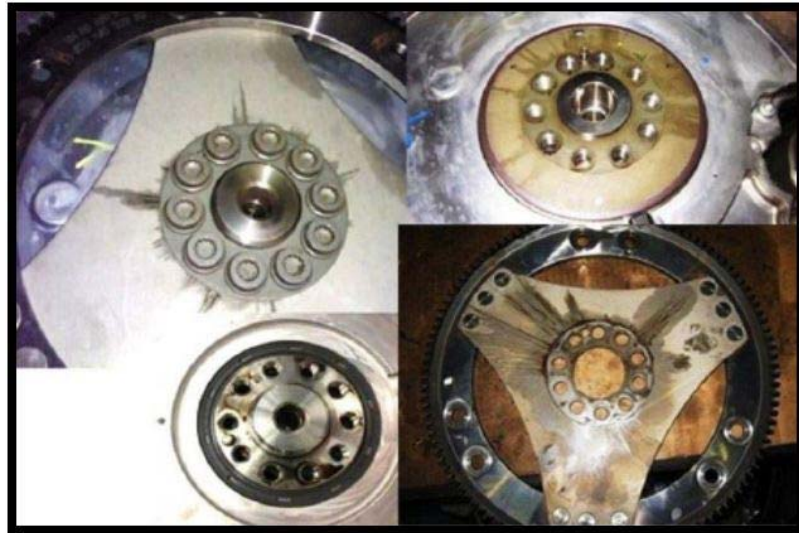
*Oil leak on flywheel/drive plate*

- Measure 3:
- 3 Oil leak via the thread of the fastening screws for the flywheel/drive plate in the crankshaft
    - 3.1 If an oil leak is found in the flywheel/drive plate area ⇒ *Oil leak on flywheel/drive plate* , the new fastening screws must be fitted as follows.
    - 3.2 Thoroughly clean threaded bores in the crankshaft flange using workshop equipment.
    - 3.3 Apply the screw locking agent 5 threads behind the existing fixed sealing compound in the marked area ⇒ *Screw-locking agent -red rectangle-* all the way around the new fastening screws.

- 3.4 Screw in all fastening screw using a ratchet wrench and tighten hand-tight.
- 3.5 Remove emerging sealant immediately after screwing in the fastening screws.
- 3.6 Once all fastening screws have been tightened hand-tight, the fastening screws must be tightened immediately to the prescribed tightening torque.

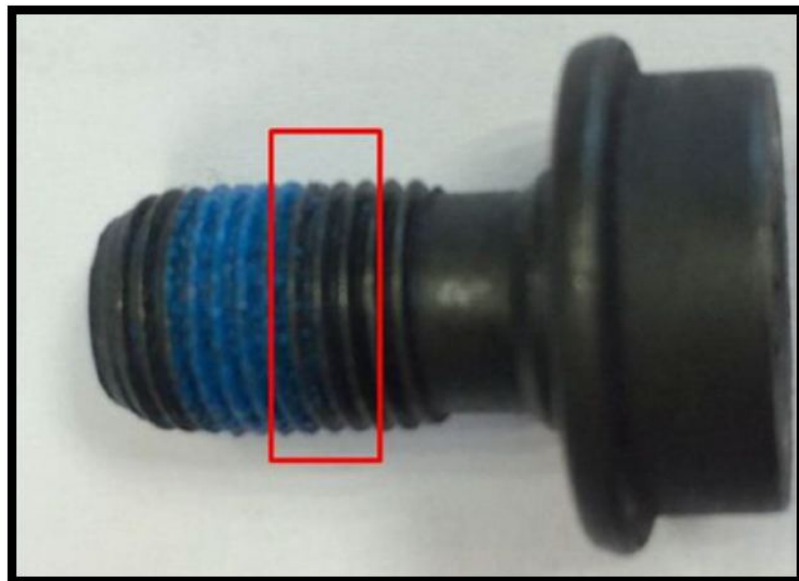
*Screw-locking agent*

A pneumatic or battery-operated screwdriver must not be used to screw in the fastening screws because these devices operate at too high a speed and as a result, the sealant cannot get into the thread.

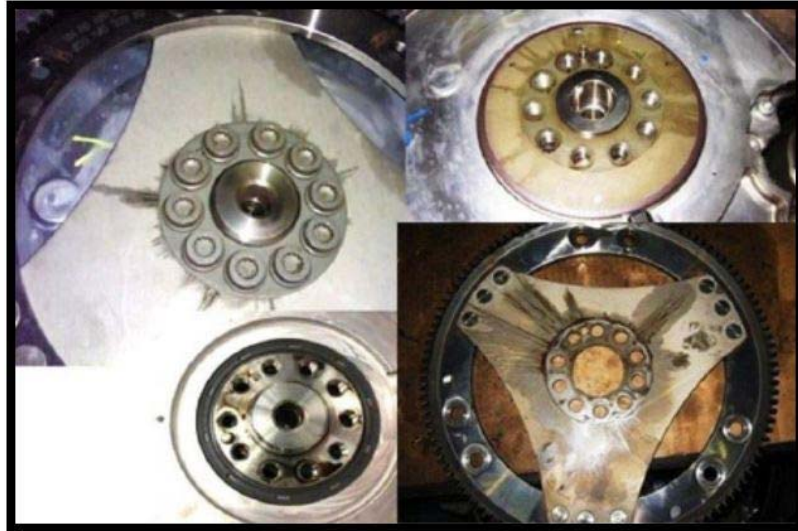
*Oil leak via the crankshaft/flywheel sealing ring*

- Measure 4:      4      Oil leak via the crankshaft/flywheel sealing ring
- 4.1      If an oil leak via the crankshaft/flywheel sealing ring is found, the sealing ring must be replaced.  
             ⇒ *Workshop Manual '135955 Replacing crankshaft sealing ring (on transmission side)'*
- 4.2      The crankshaft/flywheel sealing ring must only be replaced if an oil leak via the sealing lips can clearly be detected.

- 4.3 The crankshaft/flywheel sealing ring is replaced as part of the procedure for re-sealing the lower chain housing cover.
