Warranty Information

D460

Timing Chain Cover Repairs

Model Line: Cayenne - V6T & V8 engine

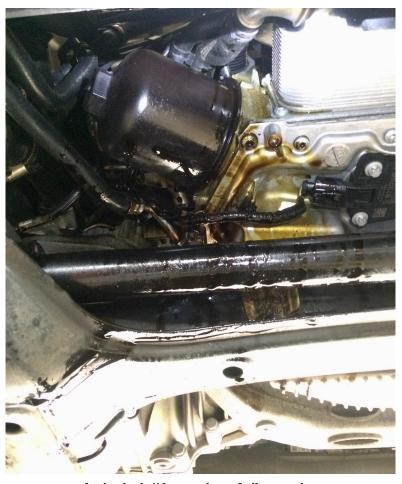
Active leak #1 overview of oil on engine

Information: If an oil leak is identified from the timing chain cover and it has been found that any part on the timing cover

has failed, then the engine must be removed and the entire timing chain cover resealed per the WM instruc-

tions.

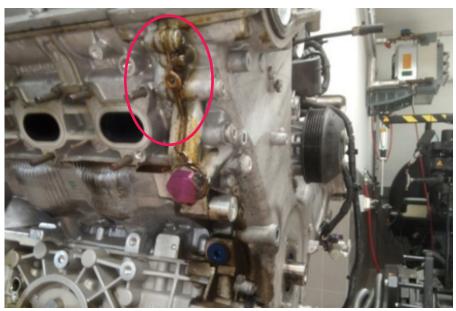
A picture of the location and source of oil leak with engine clearly removed is required
