## Porsche Plastic Body Repair

ONE 993 TURBO OWNER FOUND HIS PLASTIC TAIL WARPING FROM EXCESSIVE HEAT AND CAME UP WITH A SIMPLE FIX — ONE THAT MIGHT INTEREST 964 AND 993 OWNERS WITH WARPED FRONT BUMPERS, TOO  
STORY AND PHOTOS BY GARY WOLFGANG

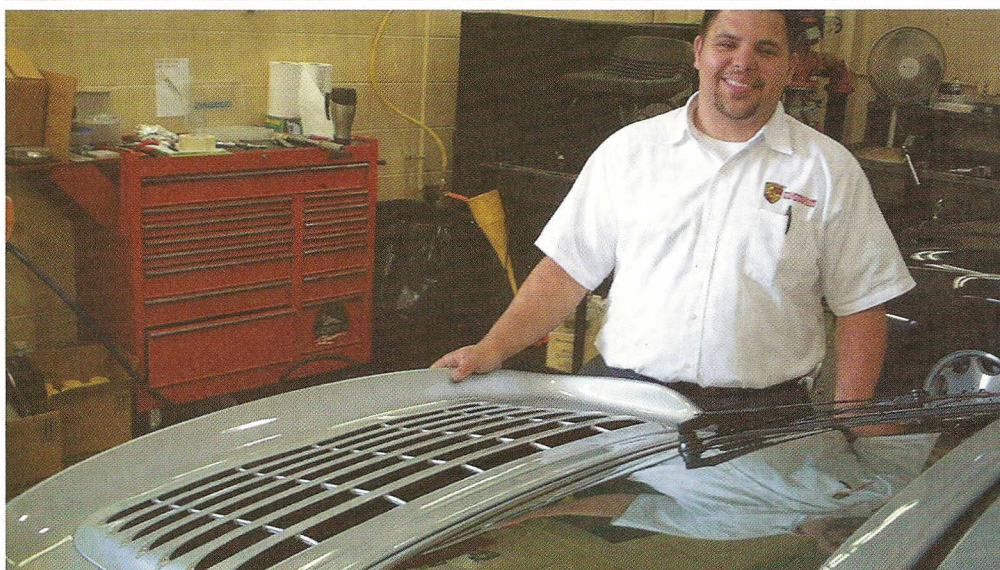
Jon Yetter, Service Manager at Sun Motors Porsche, stands proudly with his first "restructured" 993 Turbo wing. Perhaps it's not his last?
