Barry Hart, Technical Director, Hartech Automotive

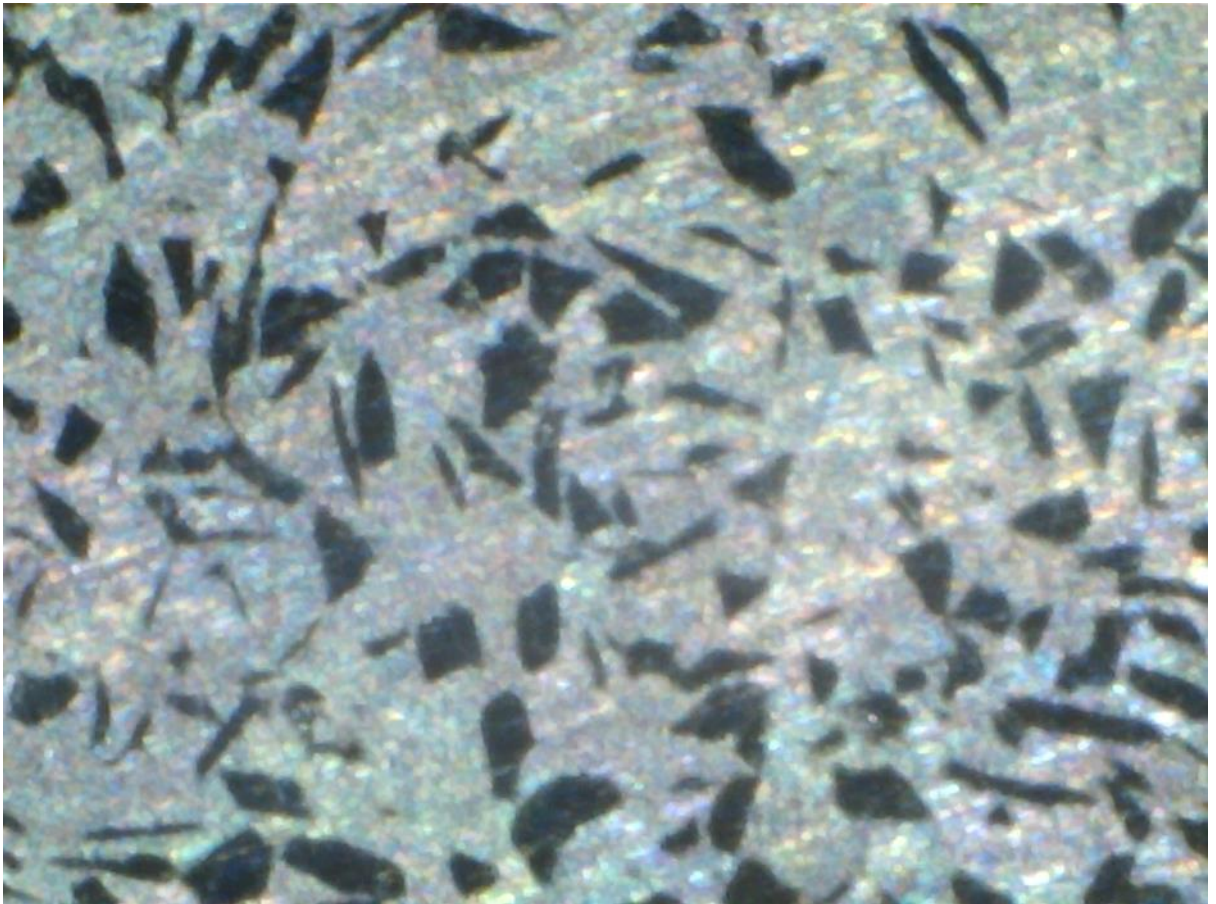
- (4) Wikipedia “Chevrolet 2300 engine” explains more about the casting process and states “plating the piston skirts was necessary to put a hard iron skirt surface opposite the silicon block to prevent scuffing” (another word for scoring) with pictures that apply equally to the Porsche engine.
- (5) Hypereutectic bores have small (about 0.001”) hard sharp particles of silicon embedded in them held in place by the aluminium substrate and honed to a smooth surface finish.

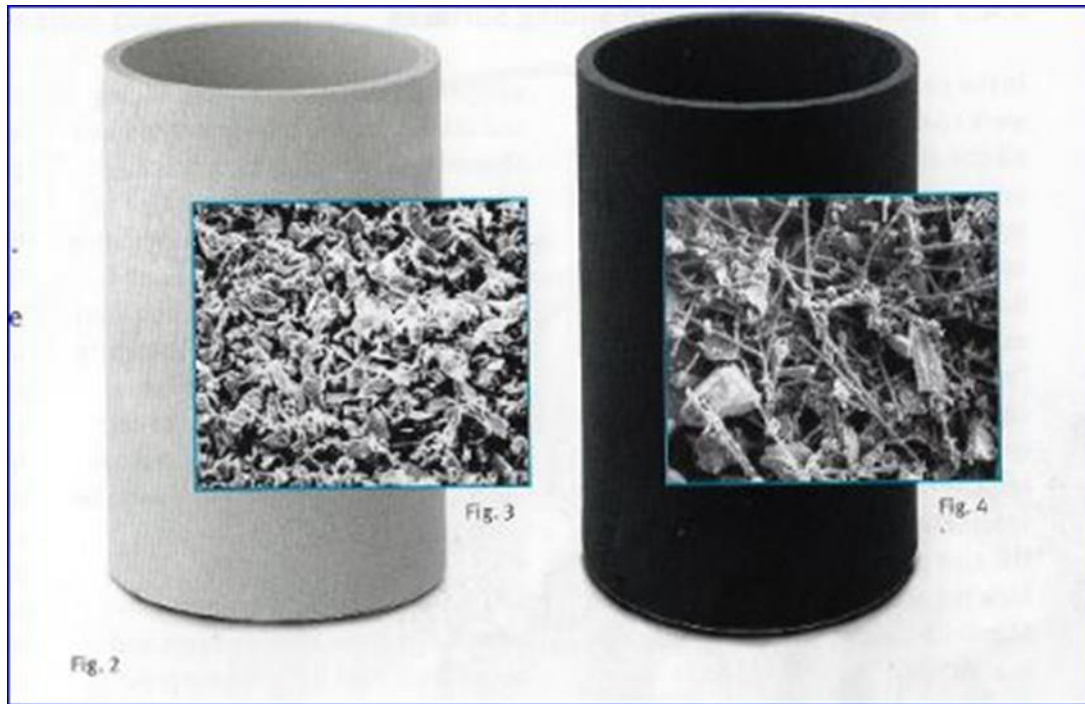
- (7) With Porsche trying to emerge from possible bankruptcy in the early '90's (caused by years of out-dated manufacturing systems) the idea emerged to only place the silicon where it is needed – at the cylinder surface (hence the name change to **LOK**al a**SIL**icon) a brilliant idea enabling the rest of the block to be machined much more quickly with less tool wear and changes.
- (8) They did this by suspending the silicon particles in a tube (displaced by a bonding agent).

- (9) The tubes (called pre-forms) were then held in the casting mould but the molten aluminium could only permeate the preform and burn off the bonding agent at extremely high pressure (15,000 psi) and this needed metal moulds to withstand the pressure (and in turn resulted in the “open deck Gen 1 cylinder block design - which is another long subject). Our investigations reveal this method to result in less even silicon particle distribution and bonding strength than Alusil.
