Auto Assets Inspection Report

Customer:	Evan Adwar	License:	
Vehicle:	2007 Porsche 911 Turbo, 5-Speed Automatic, RWD, 3.6L H6 DOHC 24V TURBO	VIN:	WP0AD29917S783317
Inspection date:	12/22/2020	Odometer:	31,948 miles
Repair Order:	62088	Last Visit:	12/22/2020

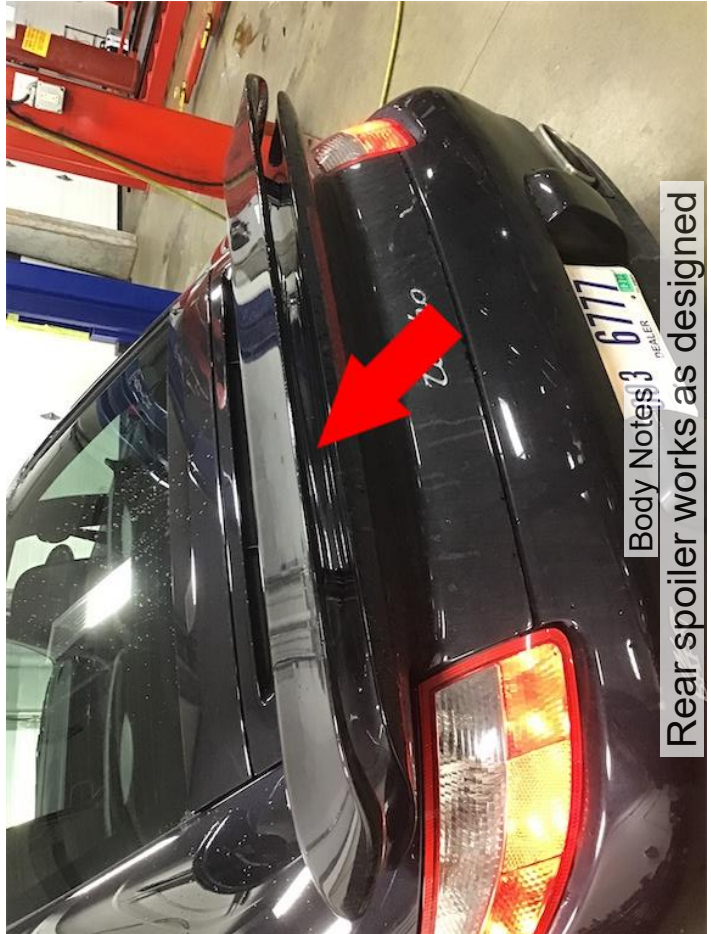
Body Notes
Rear spoiler works as designed
