# **W301-Replacement of Engine Wiring Harness**

911 Carrera (993) / 911 Carrera 4 (993)

# Replacing the wiring harness for the naturally-aspirated engine

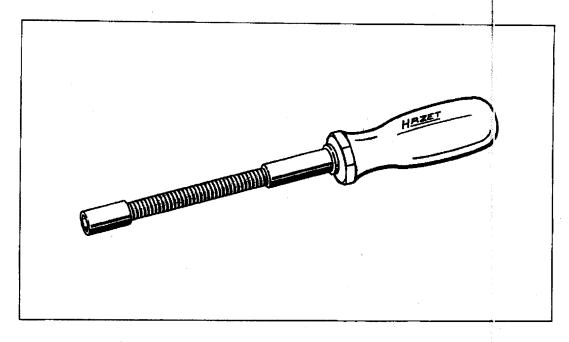
#### Tools

item	Designation of the tool	Remarks
		Refer to Workshop Equipment Manual, Chapter 2.4, No.: 73-1

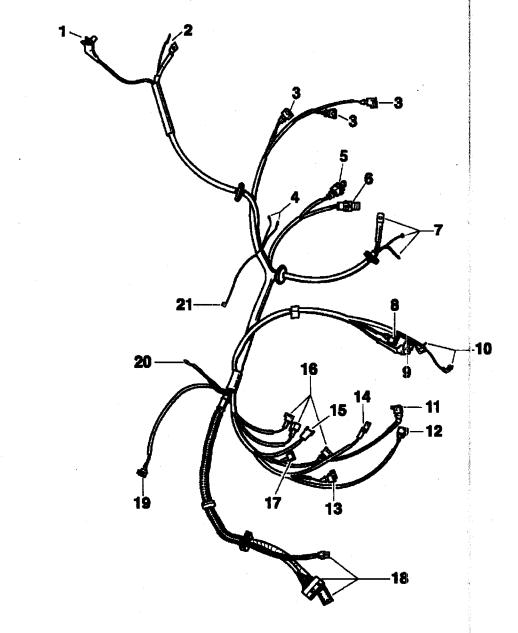
#### Wiring harness connections
