Secondary air injection (SAI)

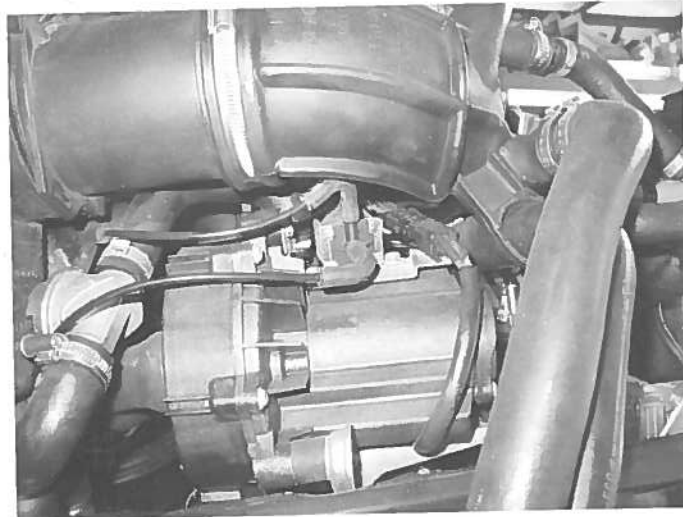
Normally aspirated secondary air injection pump assembly.

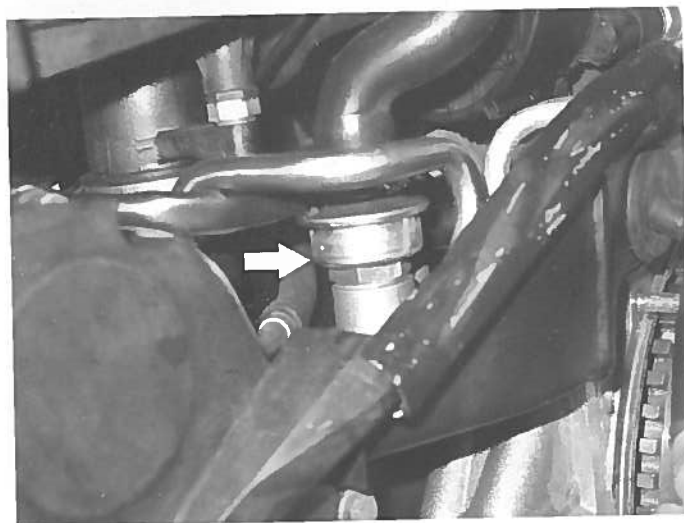
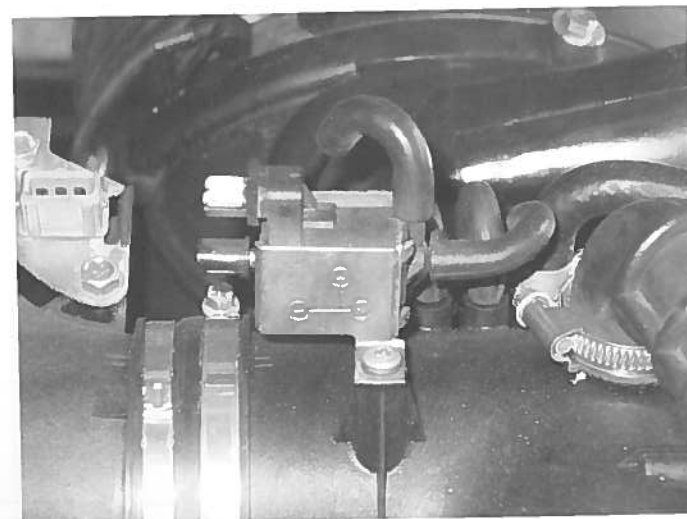
Secondary air injection pump solenoid (change over) valve activated by the DME (ECU).

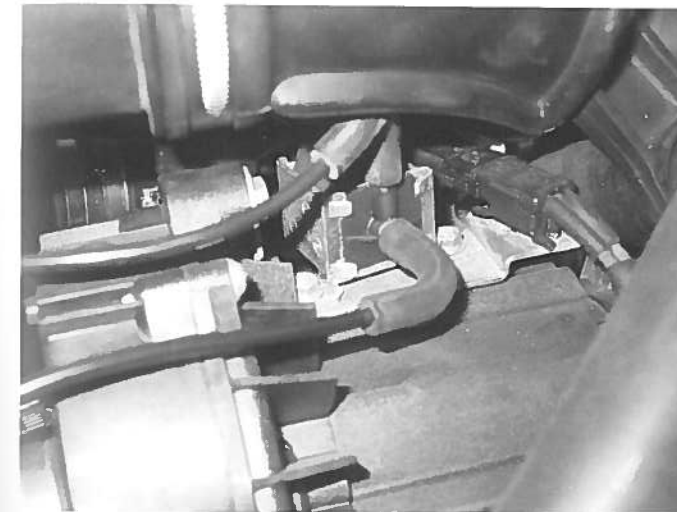
Secondary air injection pump solenoid (change over) activated by the DME (ECU) for the turbocharged engine which is identical to the normally aspirated engine.
