Disclaimer: I am not a professional automotive technician please feel free to use this list of items at your own risk. Many times a lot can be learned by simply watching a qualified professional work on your 993:

Things to consider when Buying / Servicing / Replacing / Upgrading a 993.

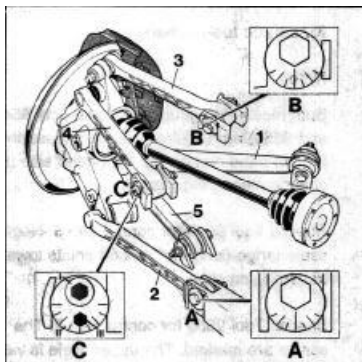
There is lots of talk of the need for the rear kinematic adjustment unique to the 993 during an alignment. It turns out that one of the reasons that this and the other settings need to be looked at during a routine alignment has to do with the adjustments slipping out of position especially if you track your vehicle. With this in mind I would take a cell phone picture up-close of the rear suspension setting positions at time of a known good alignment and periodically check the settings through visual inspection from time to time. The settings for the rear suspension are labeled A, B & C in the below illustration from the shop manual.
