LATE 944 DASH RECOVER

As of January 3, 2020

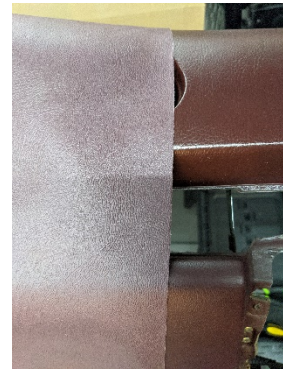
The dash wasn't too bad to start with; several deep cracks and a couple of minor cracks.

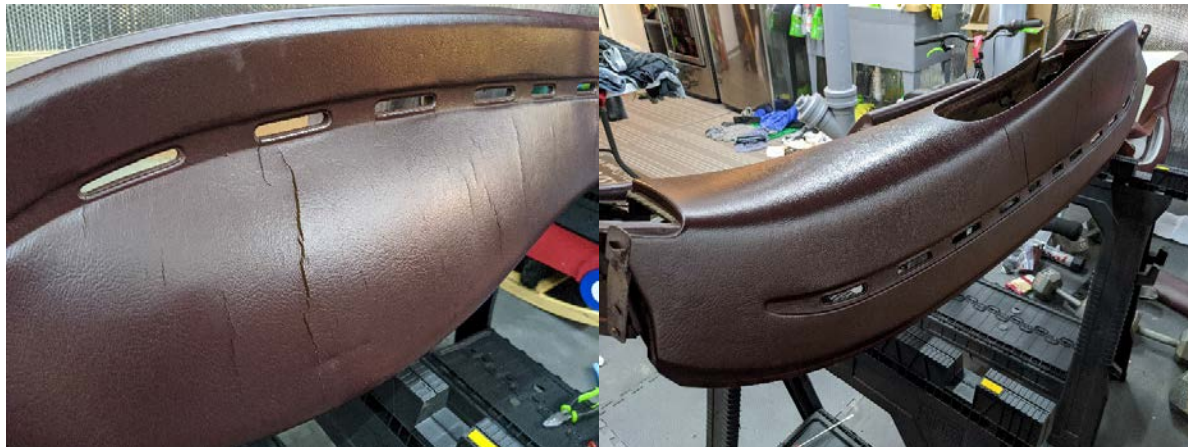
First, remove the defroster vent underneath the dash. You need to do this so you can mount the dash vent trim. Removal is straightforward. First, bend the tabs around the outside holding it into place. Second, you'll need to gently pry all the way around in order to break the plastic away from the sticky gunk Porsche used to seal it; I used an upholstery tool.

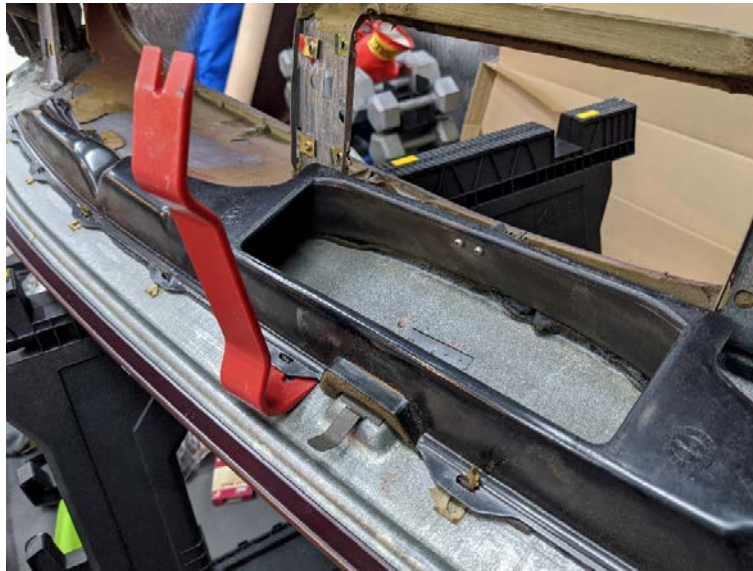
Once the plastic is off, you can roll the black stuff up into a ball using your fingers. Use mineral spirits to get any remaining or stubborn sealant. For those that have removed their taillights, I'm pretty sure this is the same gunk that seals them to the body.

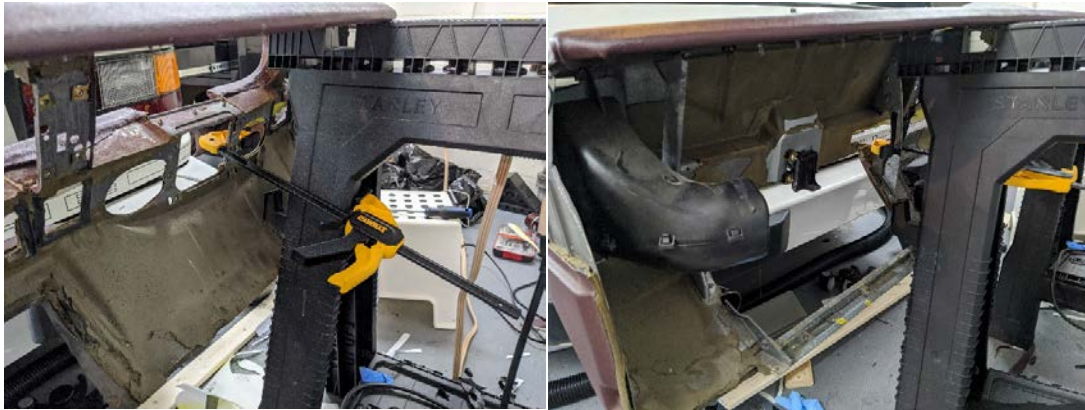
Now to begin! Stripping the old cover off the dash is straightforward. I used a razor blade and occasionally a heat gun, and it took about 20 minutes.

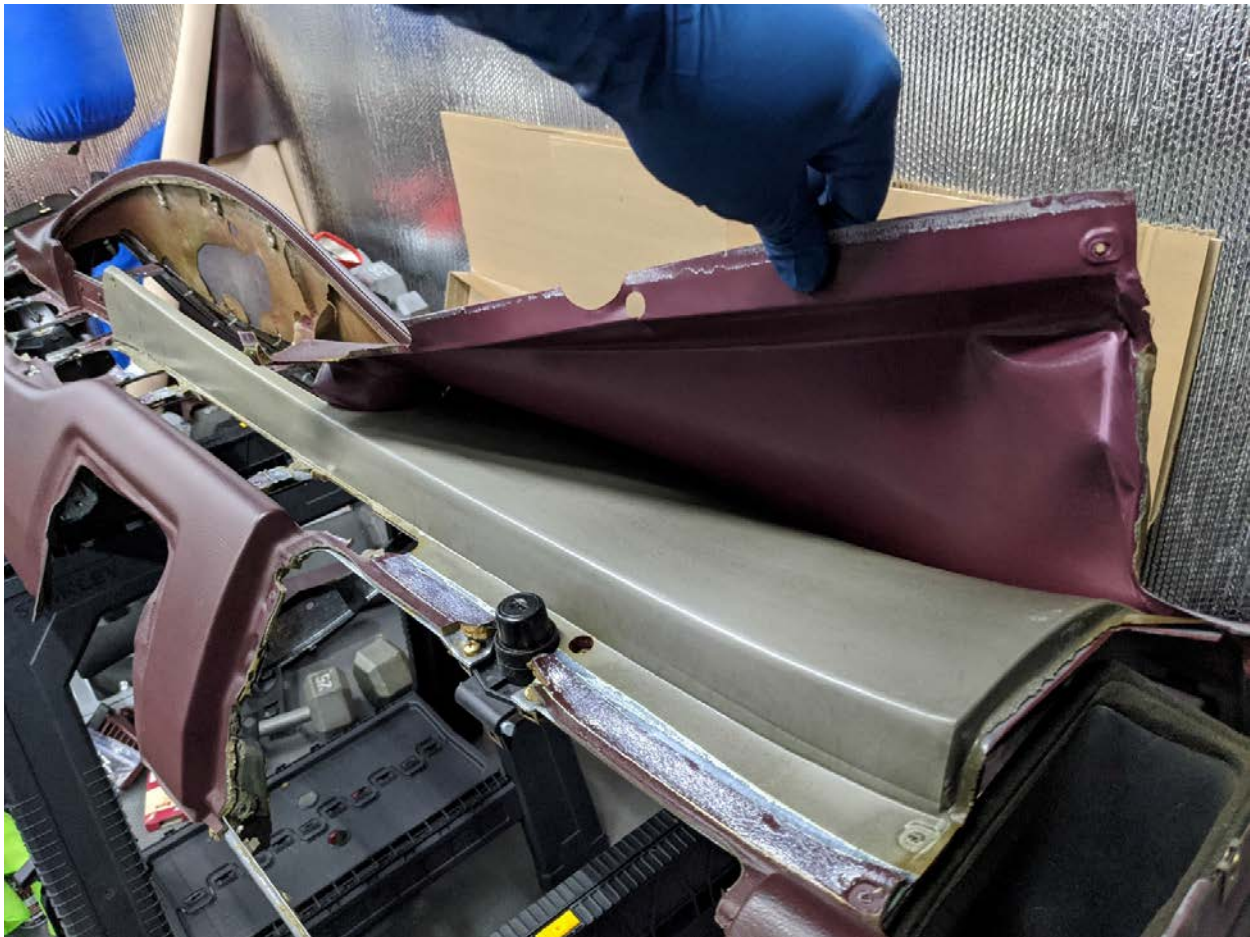
Underneath the cover, the left side (over the instrument cluster) had two types of damage. First (and obviously) the cracks. Second, the underlying foam had stuck to the dash cover, leaving a pitted finish.

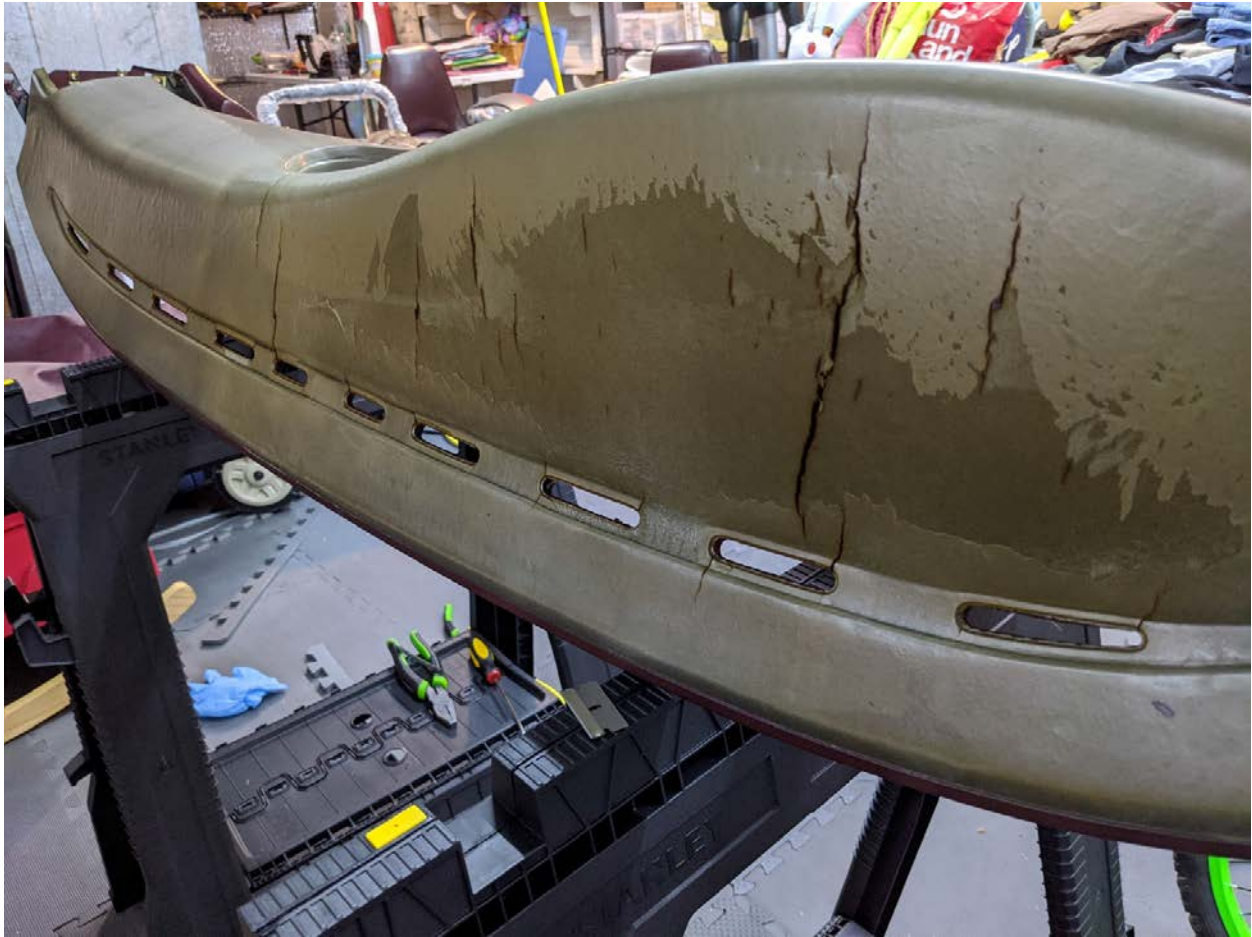
Note that there is a pressed-on color-matched piece of aluminum trim along the front of the dash. This stays on – Classic 9 recommended simply laying the fabric (and foam) over it instead of removing or removing/reinstalling.

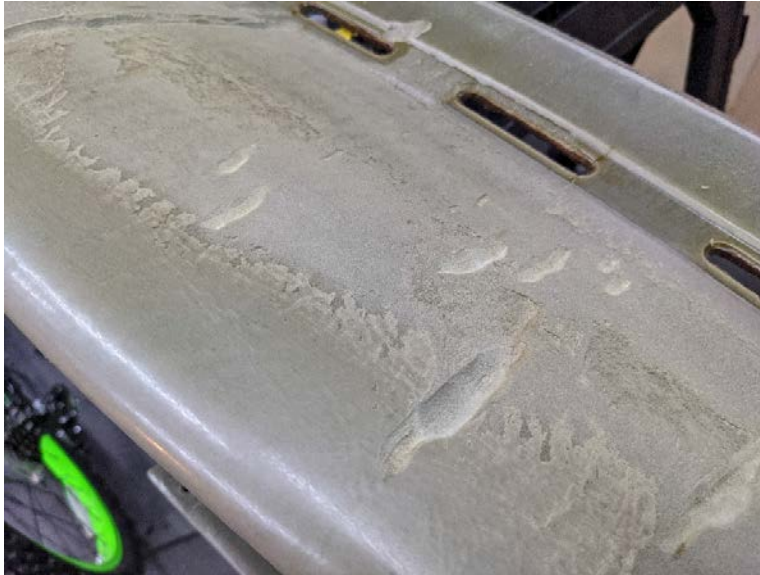
Next step was to grind out the cracks. I used a rotary tool (e.g. Dremel). I started with a grinding cone to make a "V", but ended up using a ball bit in most places. The cracks were deeper than expected, and the edges around the cracks were higher than the surrounding surface. Going a bit wider with the grind seemed the surest way to make leveling the dash easier when filling the cracks back in.

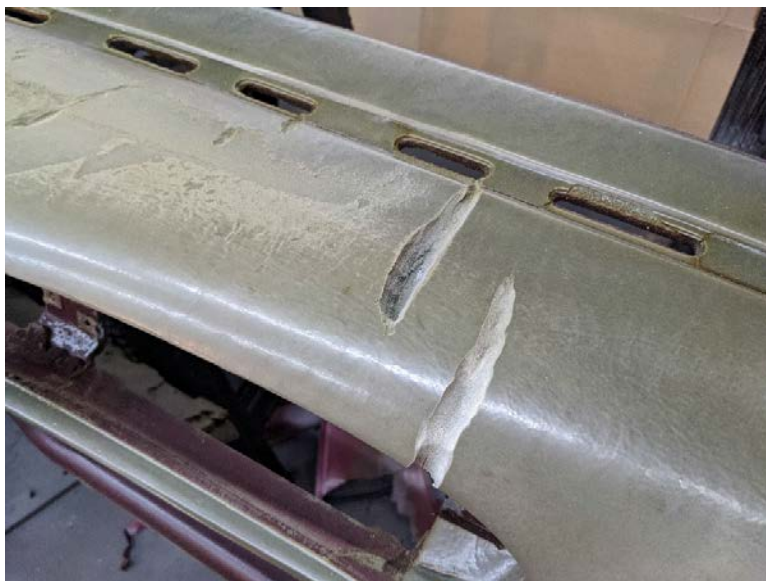
The one crack that concerned me the most went all the way through the front of the overhang on the top of the instrument cluster. The front line of the dash on the 944 is awesome, and I wanted to preserve it as much as possible. I actually didn't remove all of the crack; I was concerned about recreating it and most of it would be covered by the instrument cluster trim. Note that the crack next to it was also very deep. Underneath, I found a couple of voids (bubbles) in the foam that may have contributed to the cracking.

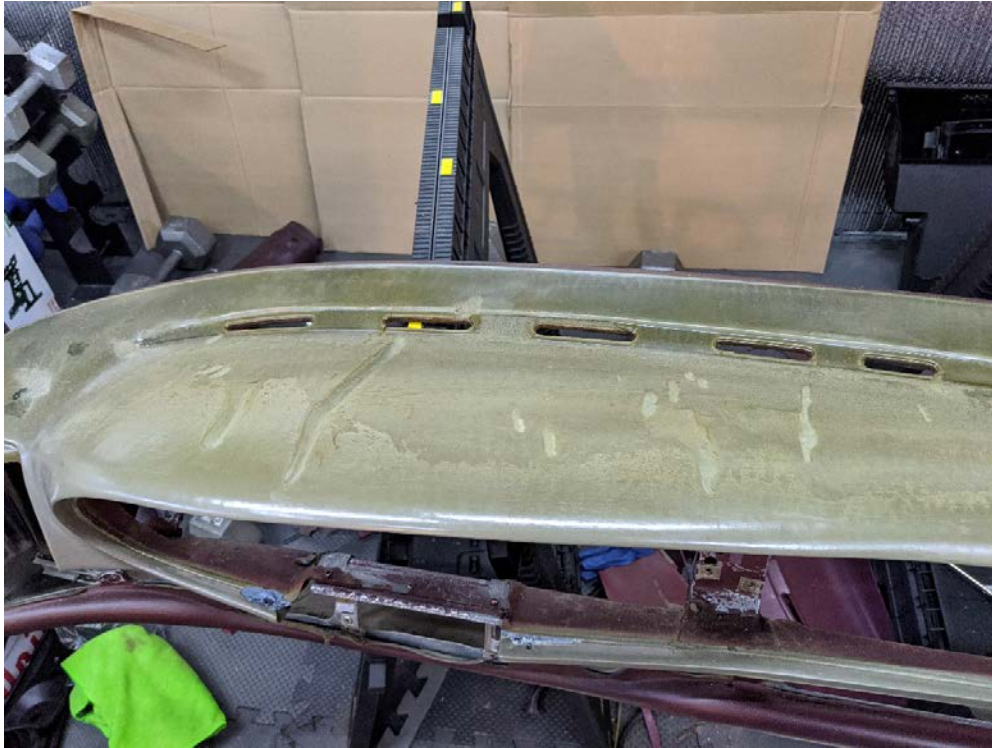
Next, I sanded the dash with 100 grit and a sanding block to remove the damaged foam. Note that the dash has a membrane-like cover from the initial casting. In some places, it had started to separate from the underlying closed cell foam. A bit of sanding will remove it and help ensure the filler adheres to the foam. The foam was more resilient to hand sanding than I expected; a bit of pressure helps.

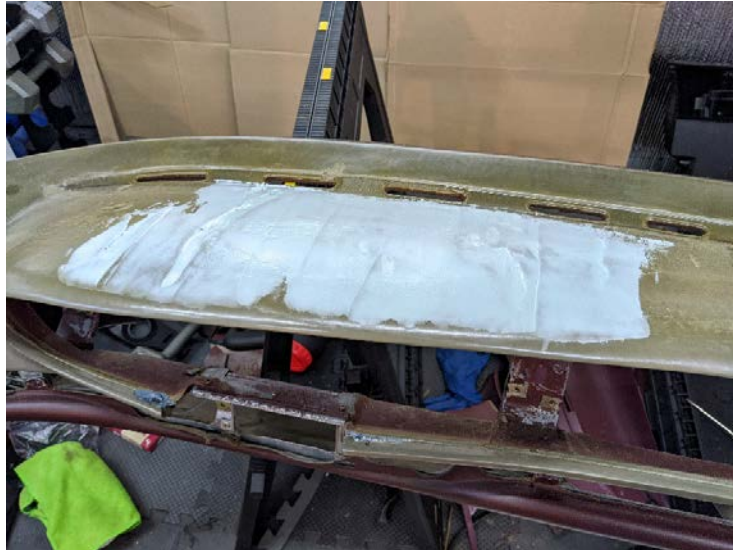
Since I'm not a body filler (or dash repair) expert, between shrinkage and coverage it took me six coats to get the dash where I wanted it. I sanded between each coat, and ended up using an orbital palm sander with 120 grit for most of the smoothing. Don't sand the foam with the sander; it will cut through it quickly.

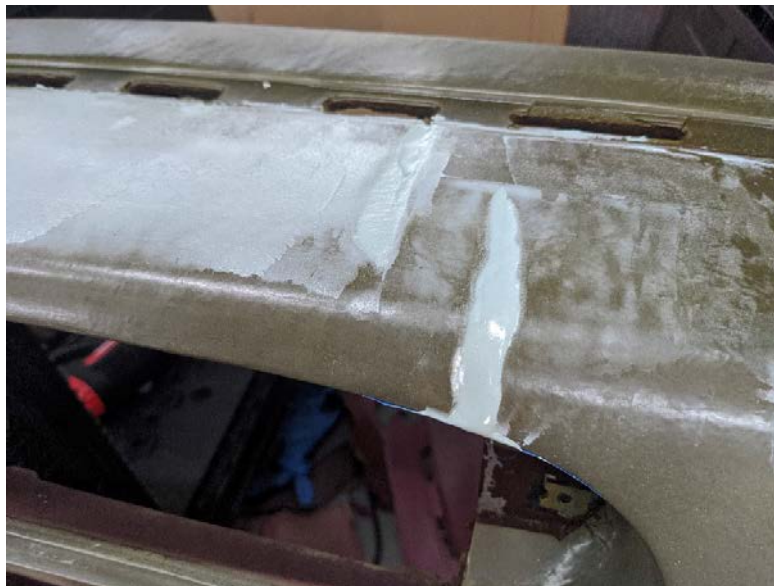
Because the Evercoat 411 doesn't do vertical well (too liquid), I put a piece of painter's tape over the crack at the front of the dash. It worked beautifully, and removed cleanly once the filler cured.

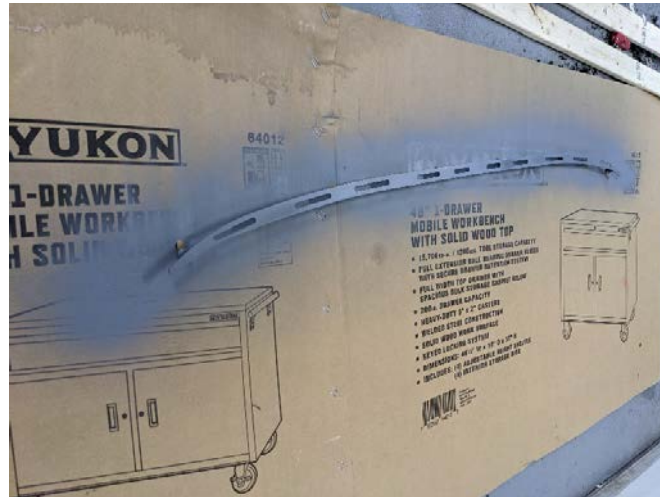
The next big step was prepping the trim piece and removing foam on the dash so it will fit. Ideally, paint your trim piece before beginning. I used two coats of primer and four coats of paint (two semi-gloss black, two flat black). I originally tried going with semi-gloss black but it was still too glossy, hence the two additional coats of flat black.

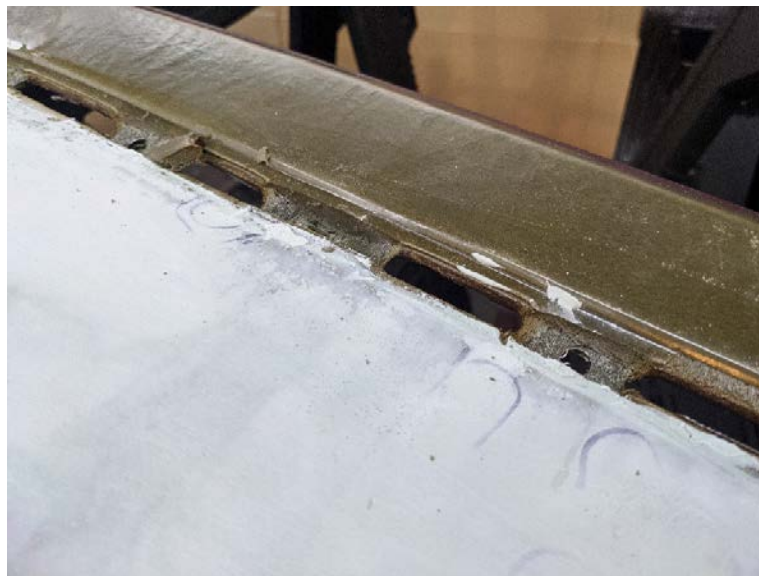
Drill the holes for the trim. I simply eyeballed it into position, then drilled 3/8" holes where each of the studs will go; the nuts will cover the hole and it isn't structural.

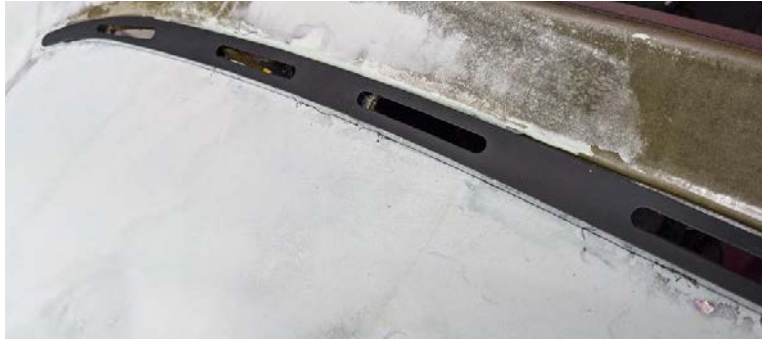
The next step is where precision is critical. You have to cut away all the foam (down to metal) where the trim will go. According to Classic 9, you trim 1/8th of an inch all the way around the trim. I had some success by pushing the trim into place over the foam, then putting a fine Sharpie into the hole in a washer and tracing around the trim.

My initial cut was made using a utility knife with a sharp blade. It worked in both the foam and the thinner filler material. Once it was cut, running a flat blade screwdriver along the edge of the cut (and against the underlying metal) cleared out the foam. I used a rotary tool with a sanding drum to clean up several places where the foam/filler didn't cooperate, and followed it with hand sanding with 100 grit to get the edges as consistent and sharp as possible.

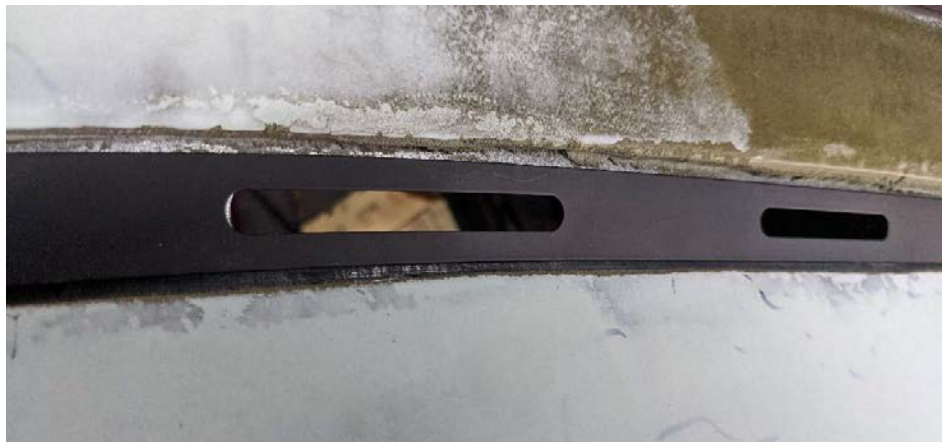
This was an iterative process; I put in and took out the trim multiple times and marked up the areas where improvement was needed. Once I was happy, I sanded all around the cut to provide a rounded edge. While you are removing the foam, reach underneath and pull the flashing that surrounds each of the vent holes; it's of no use and may show through the completed project. Checking for an even 1/8" gap around the trim:

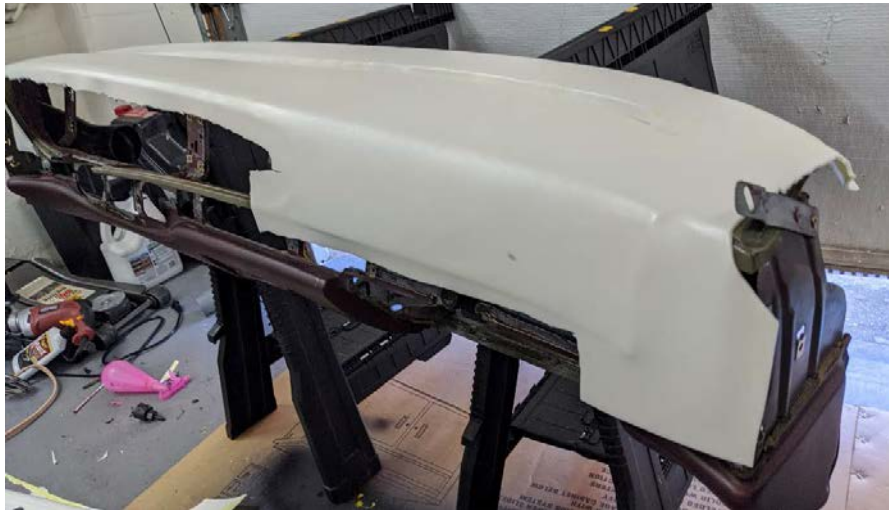
Foam applied:

I started at the left side of the dash, which is the most complex portion. I glued down one portion at a time, but be careful because once the both sides touch, they will stick and the foam will tear if you pull hard. If you must, start separating them and then hit the seam quickly and lightly with an heat gun while slowly pulling up. Also, make sure the glue is dried to tacky before attaching the foam. The contact cement doesn't evaporate well below between the two non-porous surfaces, so you may get bubbles. I stabbed my bubbles with a razor blade and pushed out the air.

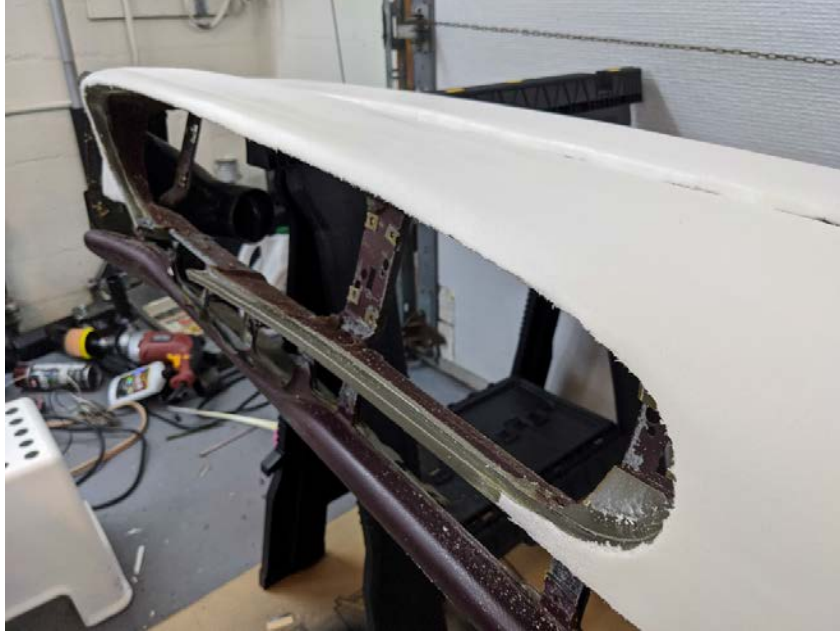
Next, I sanded the edges of the foam to make a clean edge wherever it ended. 100 grit worked fine, but expect the foam to be a bit “hairy” once you’re done. It doesn’t sand cleanly. On top, I sanded the areas around the left vent where it was a bit wonky and on the top of the cluster where I had fixed several bubbles. Foam sanded:

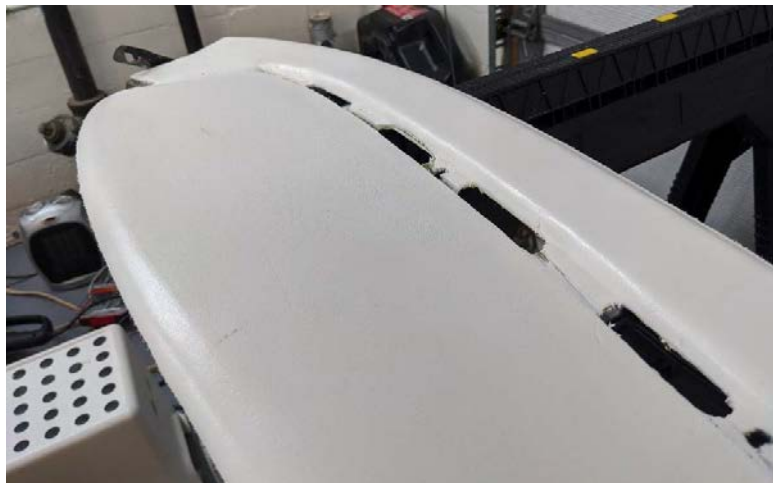
One thing I would do differently was addressing the vent trim hole. I tried to press the foam into the ditch, and it had limited stretch and started to tear. I ended up having to run a knife down the middle of the vent to get it to press up against the sides. If I had to do it again, I would simply lay it over the top of the ditch, run a razor down the middle, then push it up against the sides. Putting the foam in the middle isn’t necessary, and this would have greatly simplified the installation.

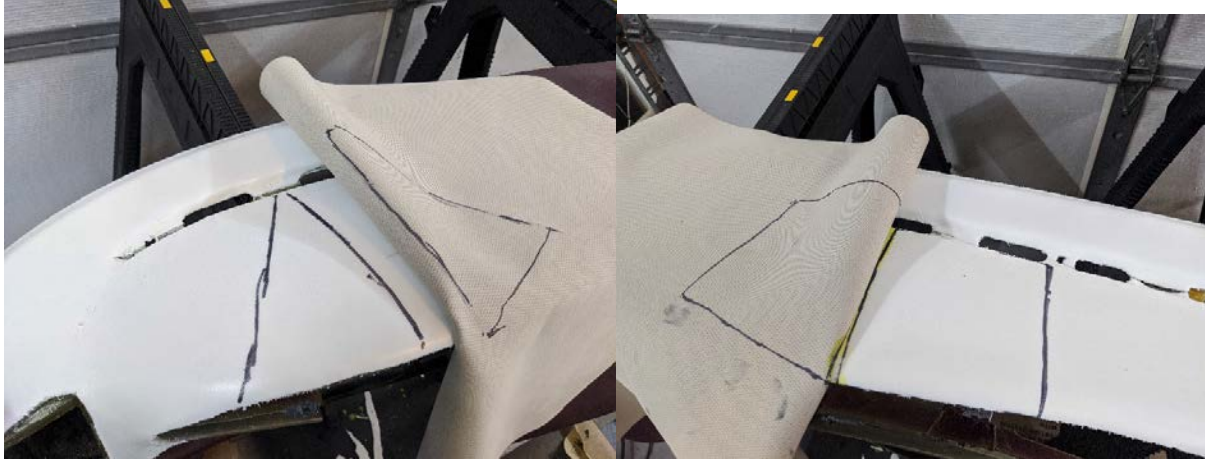
With the foam attached, it's time for the main event: attaching the cover itself. This proved to be far simpler than applying the foam because it was more pliable and flexible. To attach the cover, I did so a small section at a time. I used a technique I saw on Youtube that served me well ([upholstering video link](#)).

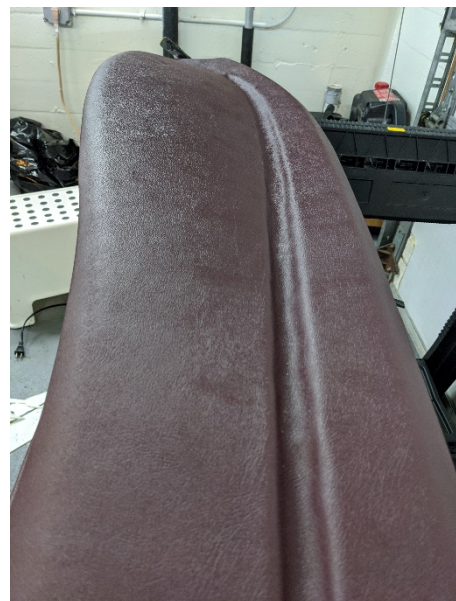
To address the vent trim, I only glued the fabric up to the channel. Once I did the area over the instrument cluster, it went pretty quick. To address the channel, I glued it up, pushed it against the near edge, the bottom, then the front edge of the channel. The excess was wrapped and glued over the aluminum trim piece.

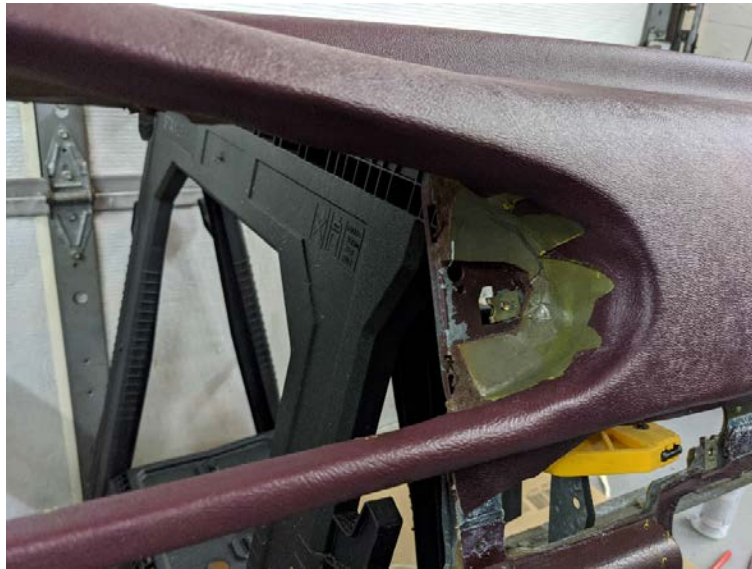
I left wrapping the cover into the instrument cluster for last. This went much better than expected. Trimming the fabric, I left a little more than an inch of fabric beyond the edge of the cluster then made cuts perpendicular to the line of the cluster. Hitting it quickly with the heat gun after applying glue, the fabric folded easily into the inset and left a clean edge.

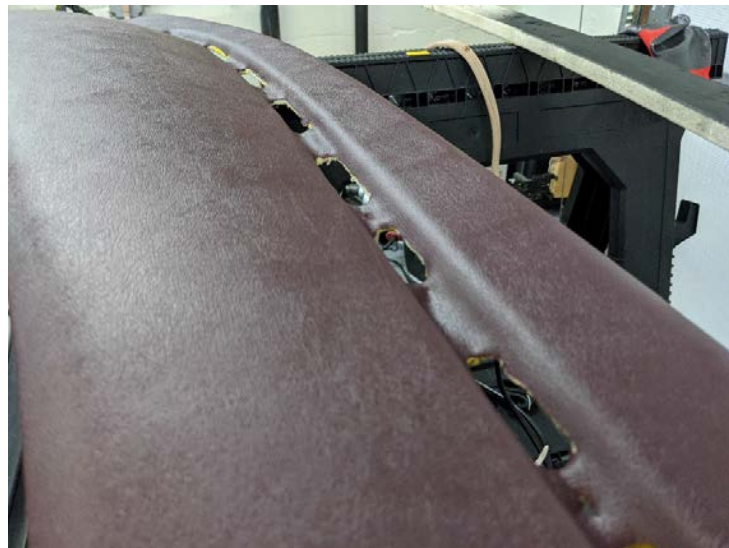
Now that the cover is installed, you have to cut the holes for the dash vent trim. Use an Exacto or scalpel if you can, and trim conservatively – if you overcut you can't repair. I followed the contours of the metal holes as best I could.

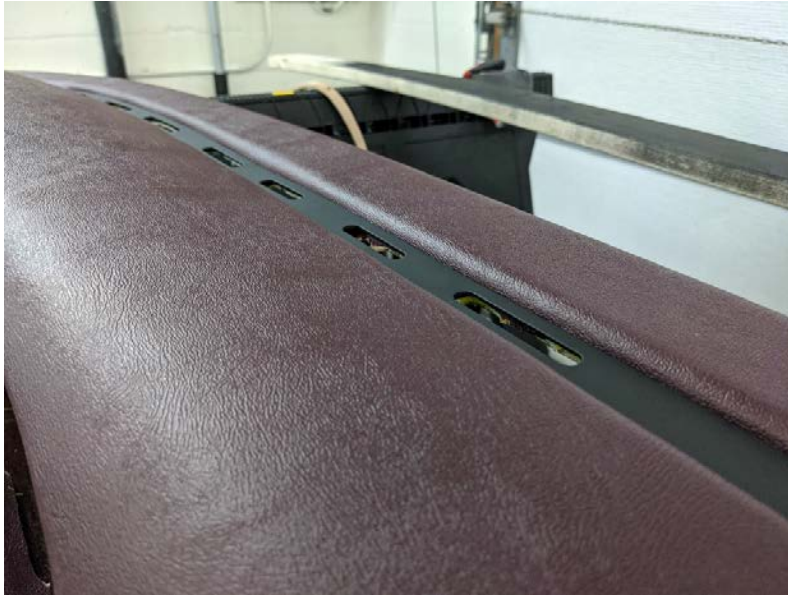
Test fitting the trim piece, I noticed that depending on the angle, I could see the white edge of the foam inside the dash vent.

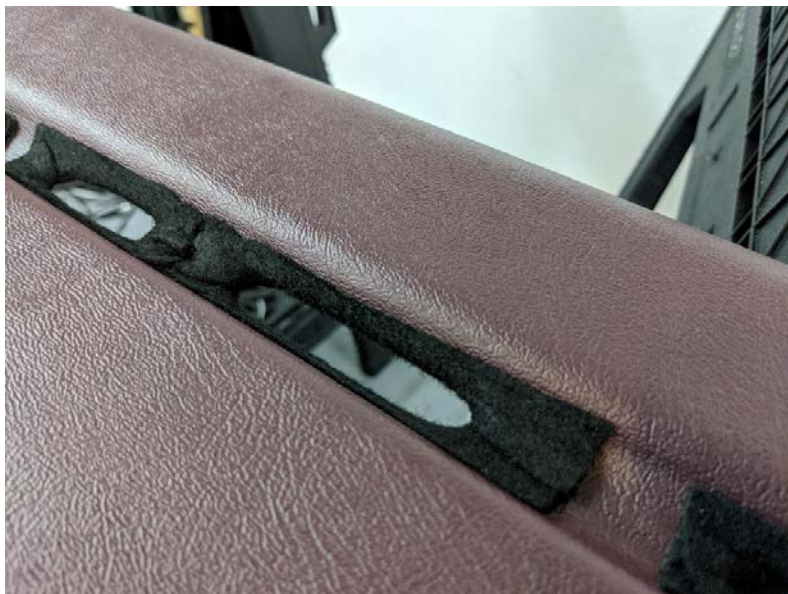
Although the original dash had the same “feature” (i.e. exposed foam below the cover), I decided to try to cover it. I thought about paint, bed liner, PlastiDip, and couple of other options, but settled on cheap sheets of adhesive felt. I cut two strips, put them on either side, then shaped them to the vent hole.

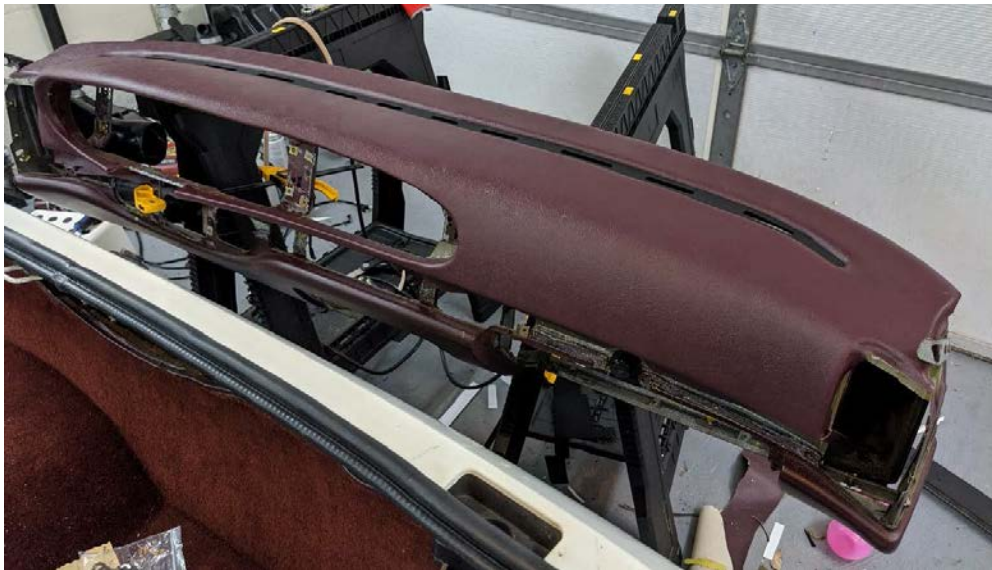
Final product:

Bottom line, this went much better than I expected it to, and looks much better. The only thing that concerns me is that the vent trim may settle, but the silicone should take care of that.
