Y-Connector Replacement

By Bob Fuelleman

Here's a step-by-step history of how I found and fixed the broken part. The subject vehicle is a 1989 928S4. The repair was performed in July 1998, with this document following. The pictures were taken with an inexpensive Epson digital camera, with some supplemental lighting to improve the images.

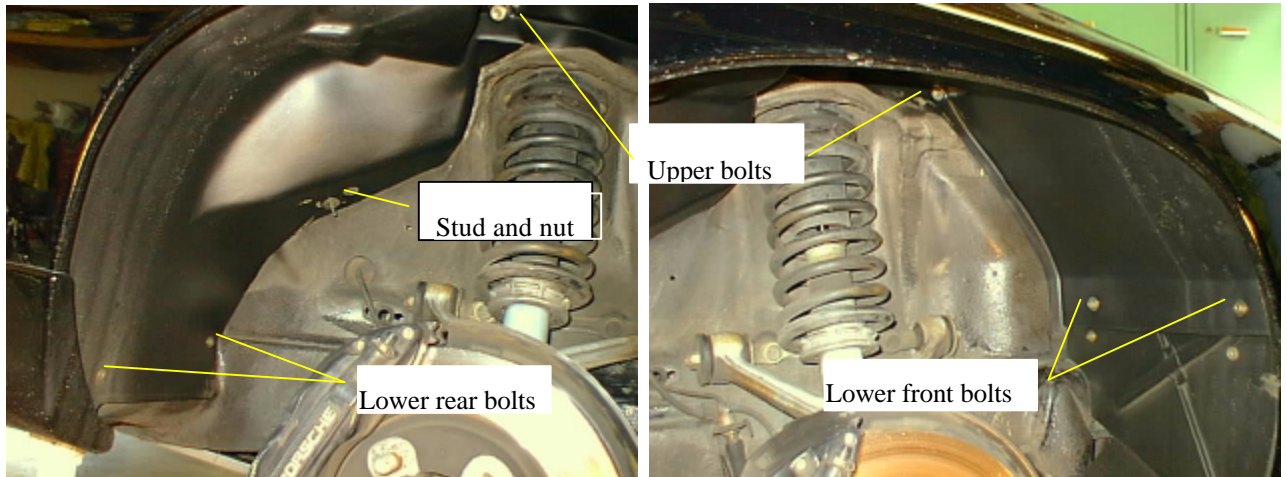
A pair of self-tapping bolts at the rear bottom, another pair just above the spring seat at the top, and a pair of larger bolts at the front hold the black plastic liner in where the liner overlaps the front plastic panel in the wheelhouse. There is also a nut that threads onto a stud to the rear of the spring assembly. Remove all six screws and that nut, and carefully remove the liner.

The easiest method for liner removal involves lifting the outside lip of the liner clear of the rolled fender lip, starting at the front corner. Reach in to the inner edge of the liner at the front bottom, and pull it slightly towards the rear of the car. At the same time, pull the lower outer front edge toward the rear slightly, and wedge a finger in between the edge of the liner and the fender lip. You'll then be able to work the edge of the liner free almost all the way to the rear lower corner. Once the edge is free as far back as you can get it with your finger, reach in and pull the liner down over the stud, and then slightly towards you so that it stays clear of the stud. Then roll the whole liner forward in the wheelhouse so the rear corners come clear of that large lower lip. Store the liner in a safe place while you proceed with the repair.

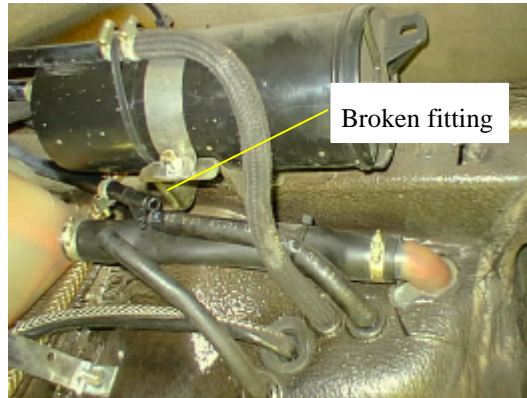
In the next picture, you can clearly see the broken “Y” fitting. The plastic hose from the carbon canister holds the remains of the old fitting, while the two forward hoses have the broken plastic stubs inside.

In this picture, you can see that the hose clamps have been removed from the front hoses, and the clamp on the rear hose has been loosened. The bolt that holds the carbon canister in the bracket has also been loosened, so that the canister can be moved forward to access the hose clamp on the other end of that rear hose. The plastic wire ties were later cut, freeing the hoses when the canister was moved.

Slide the canister forward in the bracket far enough to loosen the clamp on the canister end of that rear plastic hose. As you can see in the picture, the fitting on the canister is not barbed, so the hose slides off easily with the clamp loose. Once the hose is clear of the canister, you can remove the plastic “Y” fitting from the front end. I grabbed it with a pair of pliers and pulled hard to get it out.

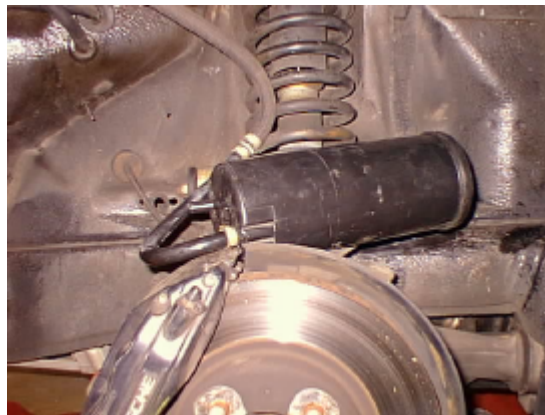
The broken stubs in the rubber hoses were a little tougher. I ended up cutting the hoses just behind the broken stubs, and making up the lost length with the replacement vent hose back to the canister. If you are going to use the old plastic canister hose, you’ll need to extract the broken stubs from the hoses.

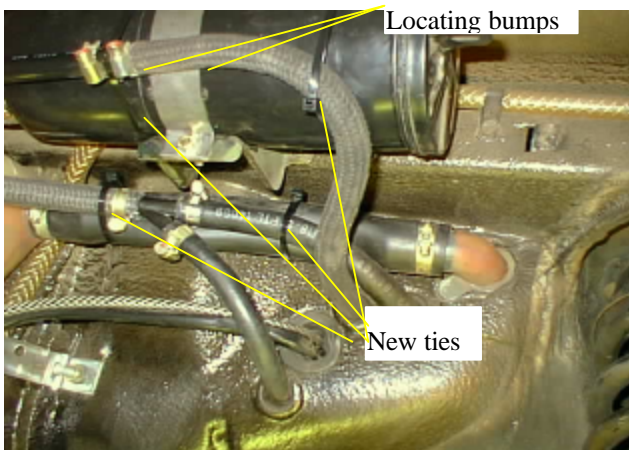
Assemble the hoses to the replacement “Y” fitting, using the original hose clamps. The routing for the replacement hose takes the strain off the new “Y” fitting. The hoses are tied to the plastic washer bottle hose.
