Things to consider when Buying /
Servicing / Replacing / Upgrading a
993.

8/4/2016

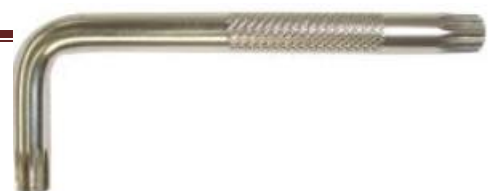
- **Belts Shredding** – It is advisable to keep a set of fresh replacement belts as they also fail without notice and you will probably find that an on-the-road garage does not have these specific belts on hand. I also augment my factory tool kit with the few additional tools, three new pulley bolts (900.976.004.01) and

a couple of extra AC compressor mounting nuts (964.126.311.00) to make belt changes easy. In this way if I am stuck out in the middle of nowhere I can replace the belts DIY. A special 12 point splined wrench (999.571.052.02) that fits on the fan center shaft is needed to replace the belts. Many times this tool, supplied with the tool kit, goes missing. Check your kit and make sure you have it or a similar spline socket tool in case you or a technician needs to replace you belts when you are on the road. Recently I have read that some replacement aftermarket alternators use a slightly different from OE style of spline socket on the end of the Alternator shaft. For this reason verify that the tool you have fits onto the end of your vehicles alternator/fan pulley shaft. Use care to make sure you have removed all the belt shrapnel from the failed belt(s) including debris that may have gotten into the fan when replacing the belts. If you ever replace the belts yourself on-the-road use care to reassemble the pulley components, including the shims, in exactly the order they were on originally as to not inadvertently lock the alternator pulley to the fan pulley. When you put it all back together verify that the two engine pulleys spin independently before tightening the belts down.

In addition to the above one can consider the pulley update listed in Porsche Service bulletin 1378, "In case of alternator belt failure or belt noises in conjunction with pulley"
