## **ACS222 Wire connection inspection/repair procedure**

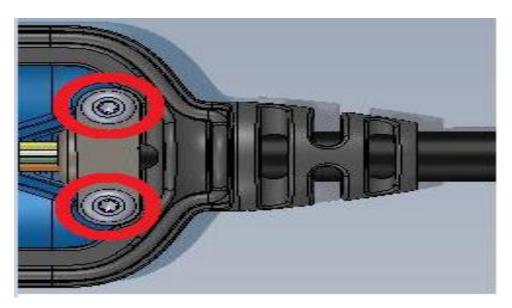
- 4. The part highlighted in 'red' is the cable which comes in and is held in place using the cable clamp.
- 5. With a bit of luck, you will notice that the Molex connector is partially disconnected and will need fixing back into position. You may wish to loosen the cable clamp screws to do this properly as referenced in the image below.

- 6. If successful, please carefully fit the top shell back into position (NOTE Please be careful not to trap the wires when doing this) and refit the 4 screws from earlier.
- 7. Refit the sticker (if in a suitable condition to do so) and two rubber bungs. The camera should be operating once again.
