Auto Assets Inspection Report

Customer:	Evan Adwar	License:	
Vehicle:	2007 Porsche 911 Turbo, 5-Speed Automatic, RWD, 3.6L H6 DOHC 24V TURBO	VIN:	WP0AD29917S783317
Inspection date:	12/22/2020	Odometer:	31,948 miles
Repair Order:	62088	Last Visit:	12/22/2020

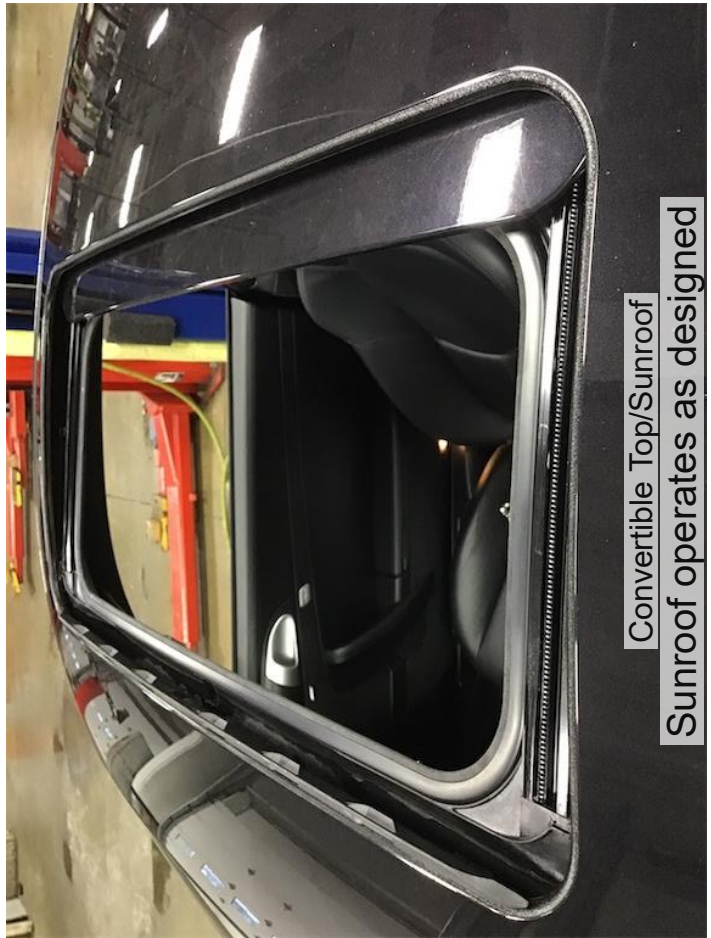
Convertible Top/Sunroof
Sunroof operates as designed

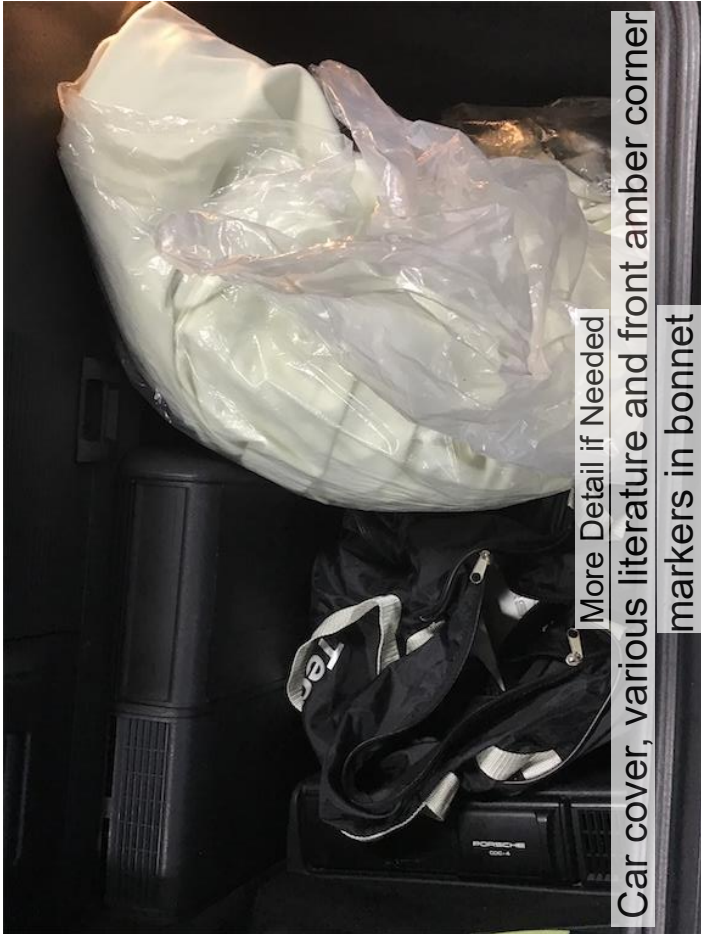
More Detail if Needed
Car cover, various literature and front amber corner markers in bonnet

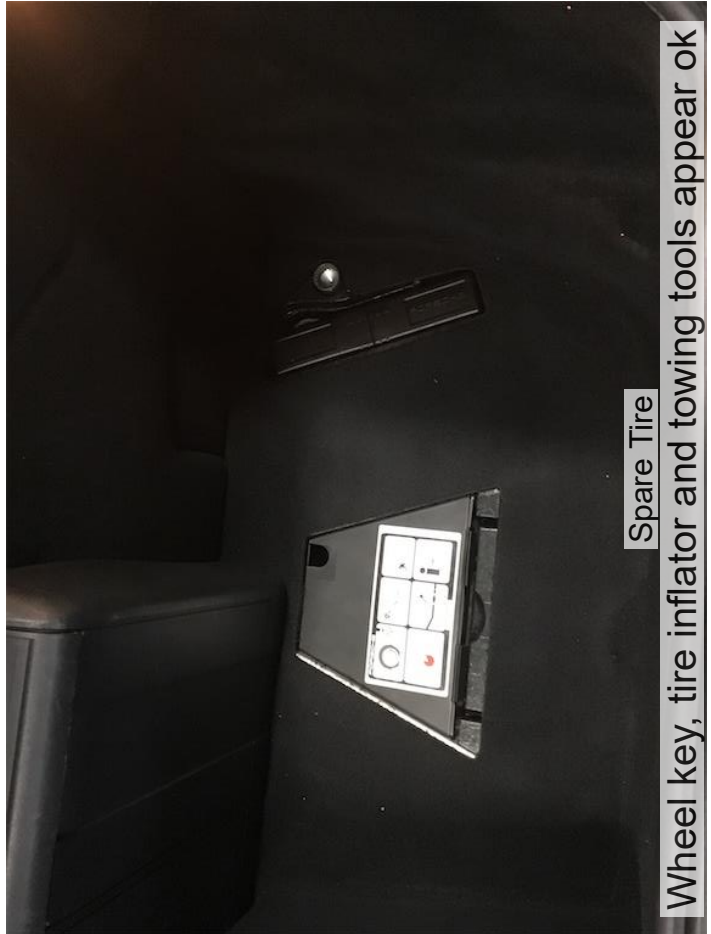
Spare Tire
Wheel key, tire inflator and towing tools appear ok

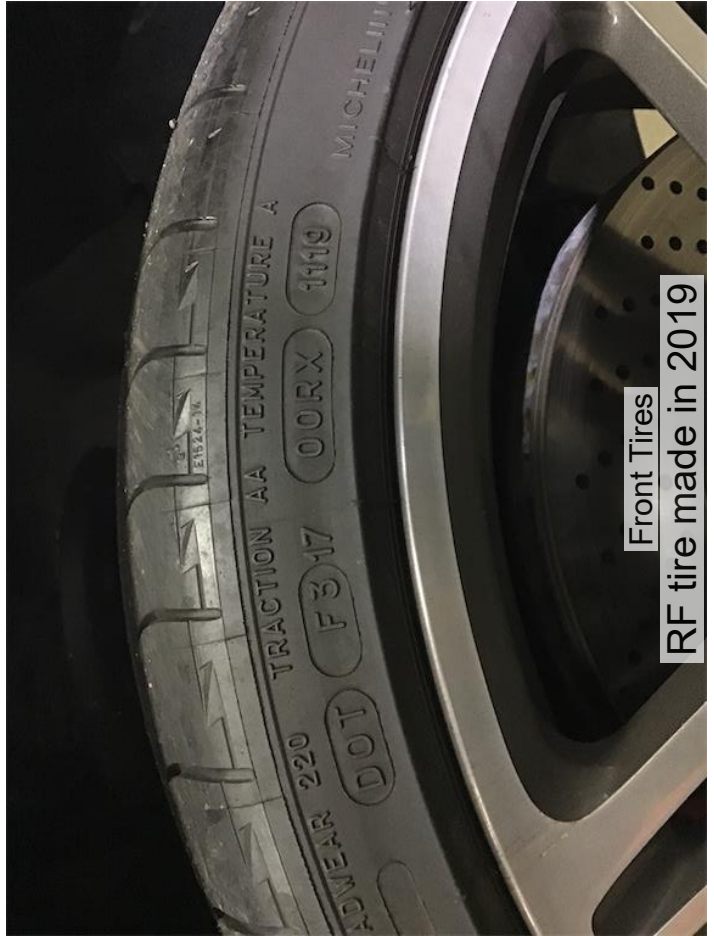
Front Tires

RF tire made in 2019

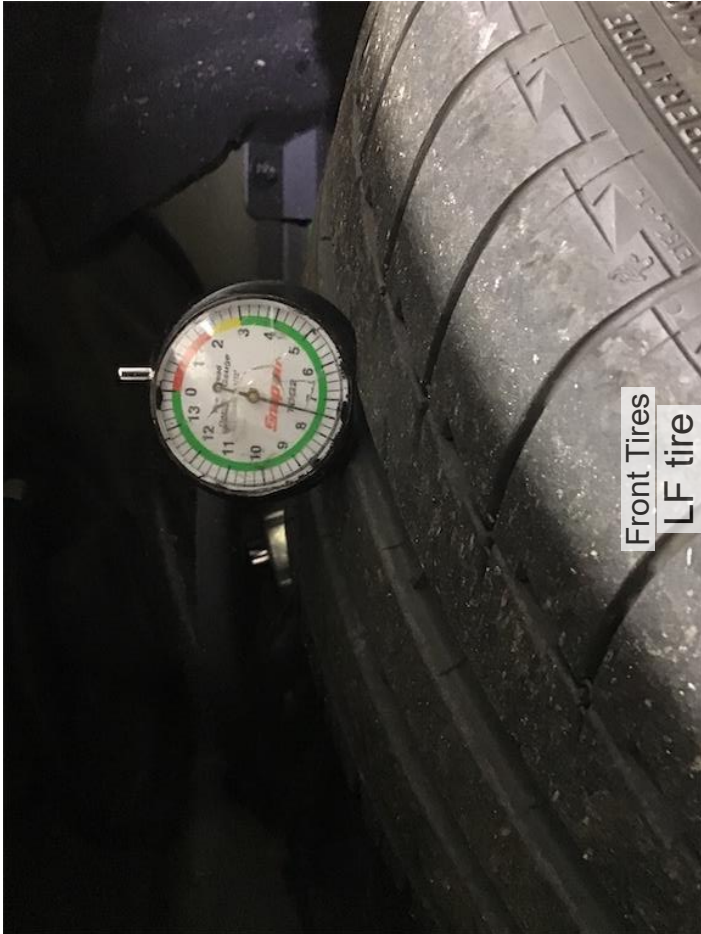
Front Tires

LF tire

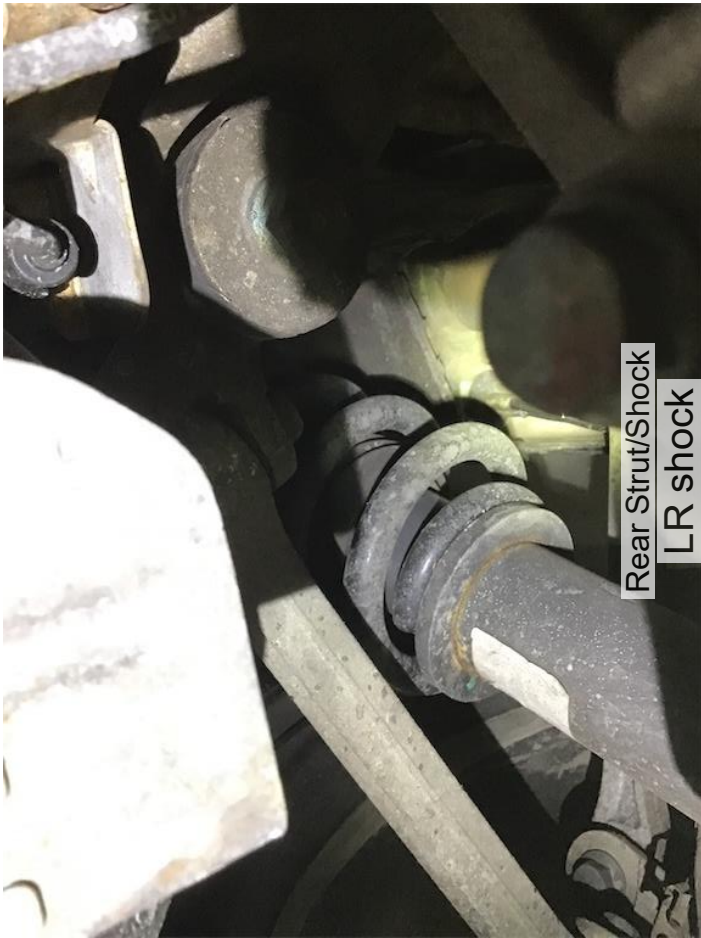
Rear Strut/Shock
LR shock

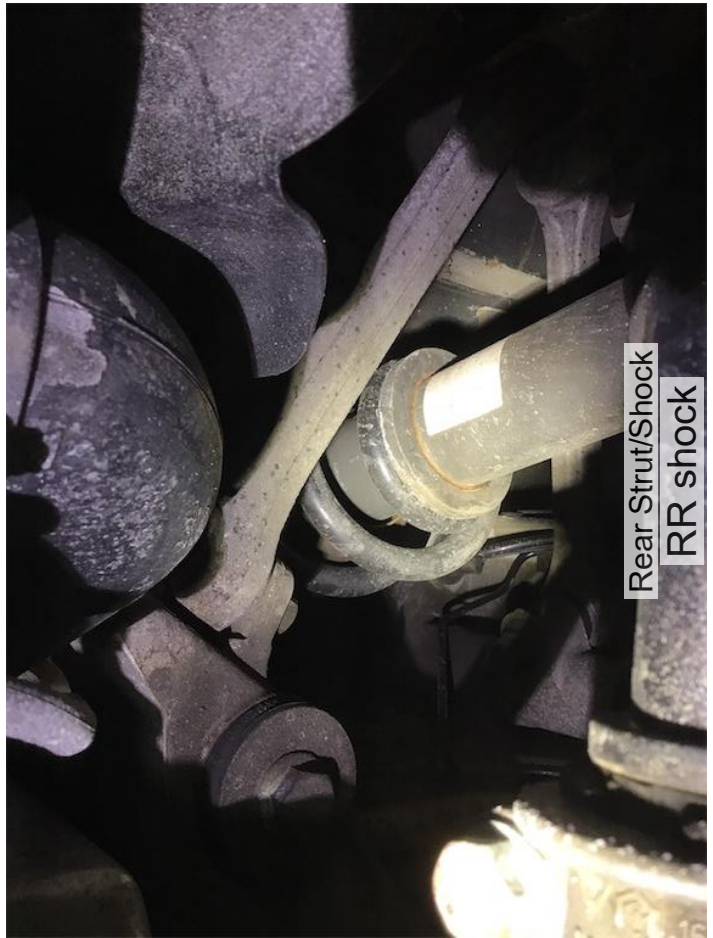
Rear Strut/Shock
RR shock

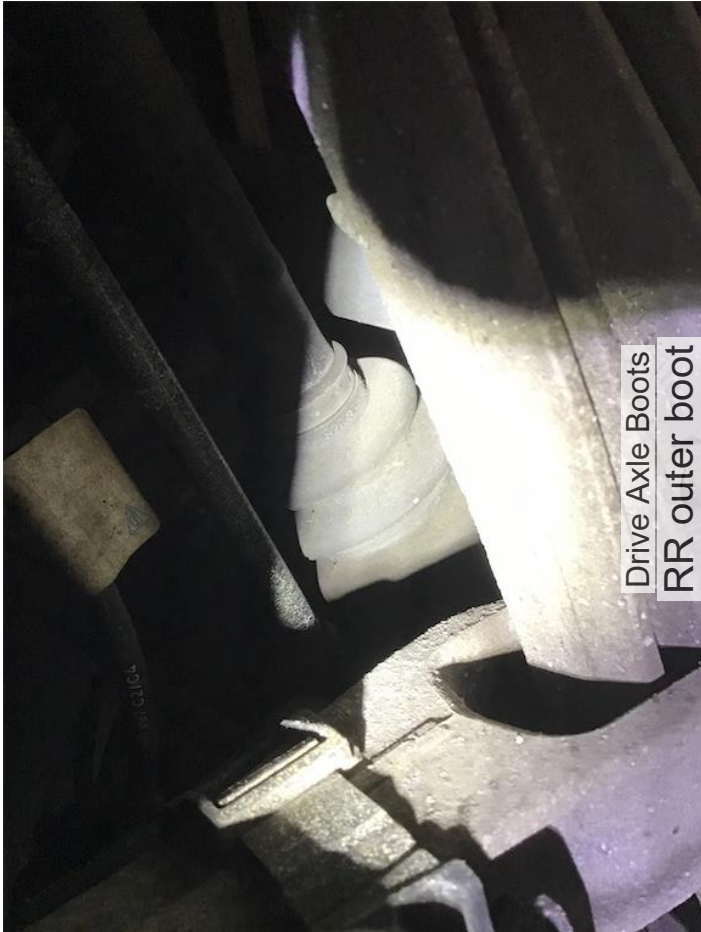
Drive Axle Boots
RR outer boot

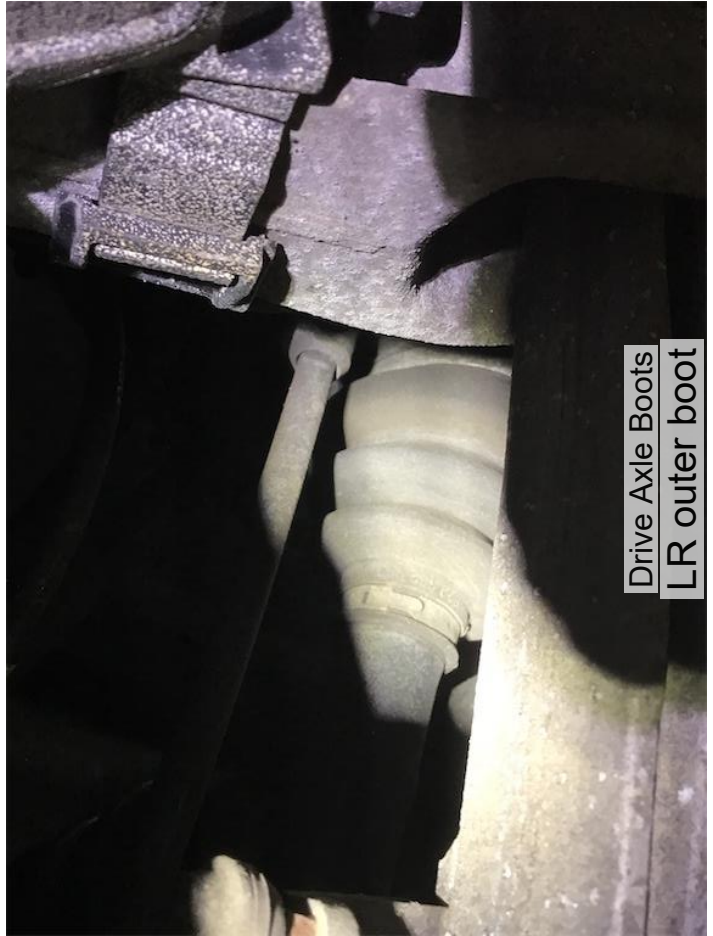
Drive Axle Boots
LR outer boot

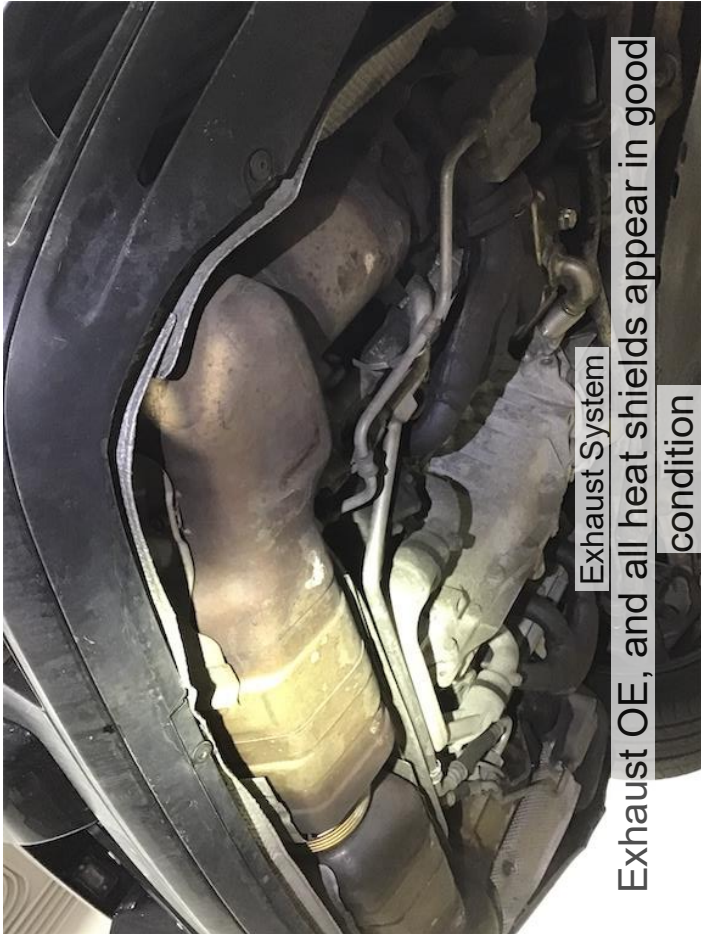
Exhaust System
Exhaust OE, and all heat shields appear in good condition

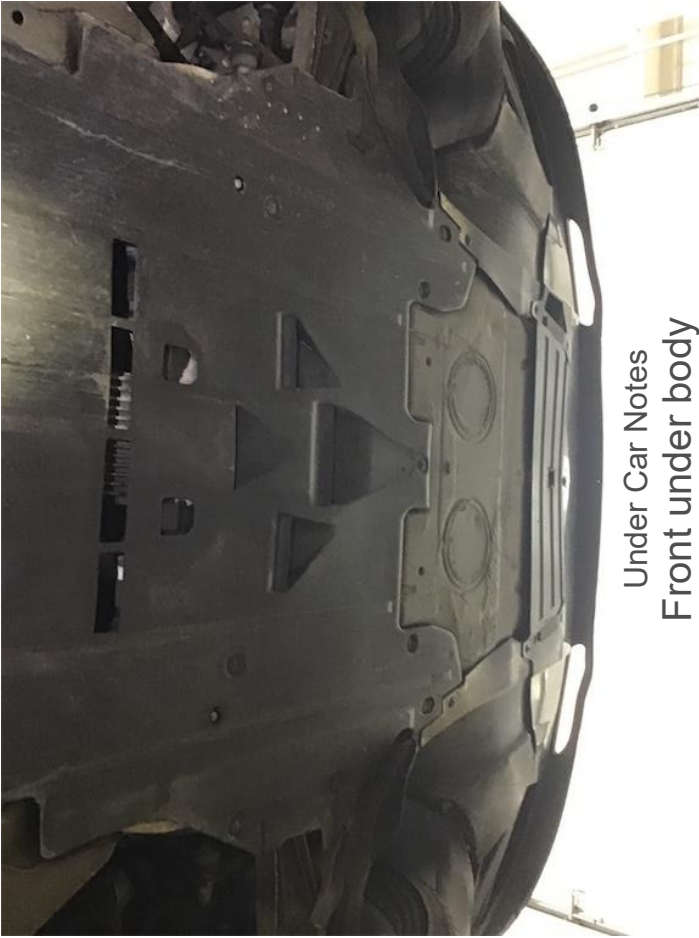
Under Car Notes
Front under body

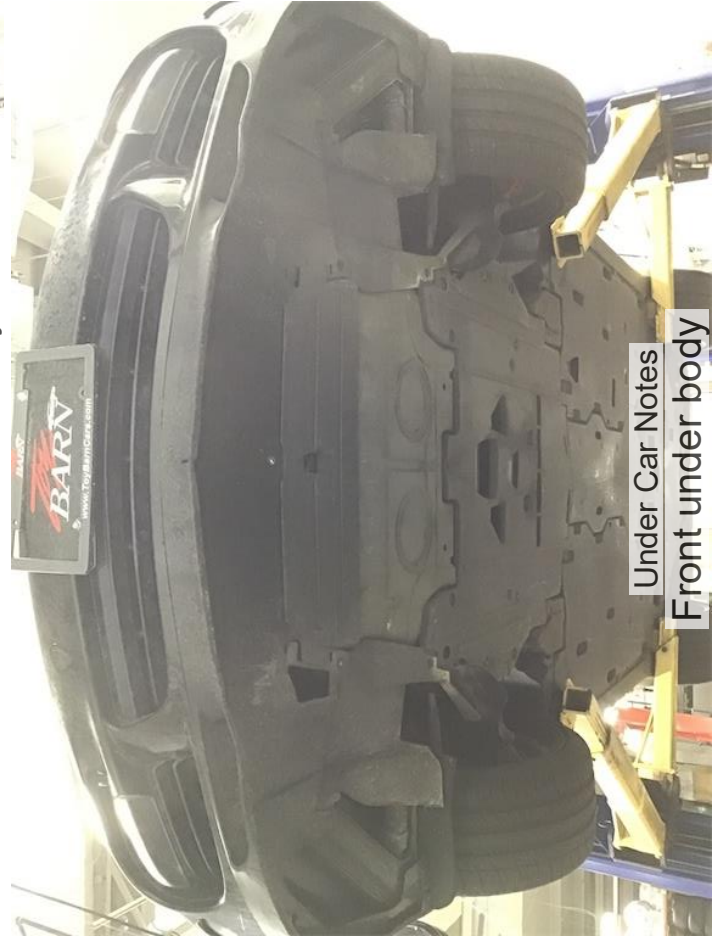
Under Car Notes
Front under body

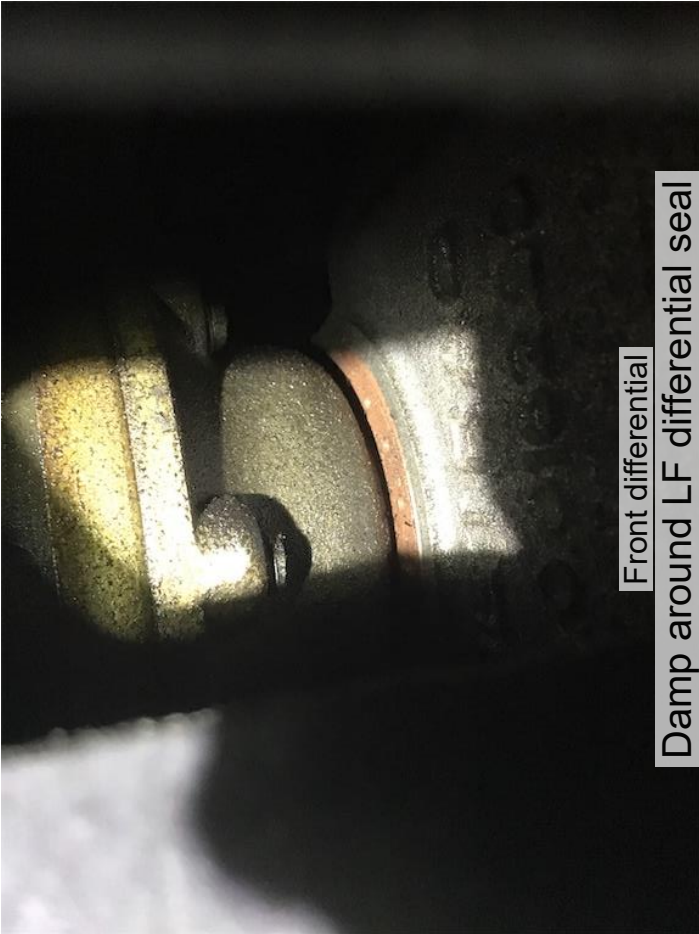
Front differential
Damp around LF differential seal
